Distance protection in 150/60 kV transformer 60 kV feeders

two real blackout case studies

Bak, Claus Leth; Lind Hansen, Magnus; Nissen, Jens Ole

Published in:
The Journal of Engineering

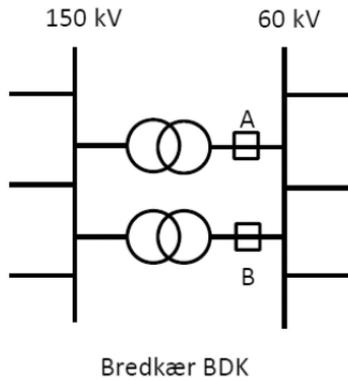
Fig. 1 Single line diagram of two-transformer supply of BDK 60 kV busbar. A and B are distance relays

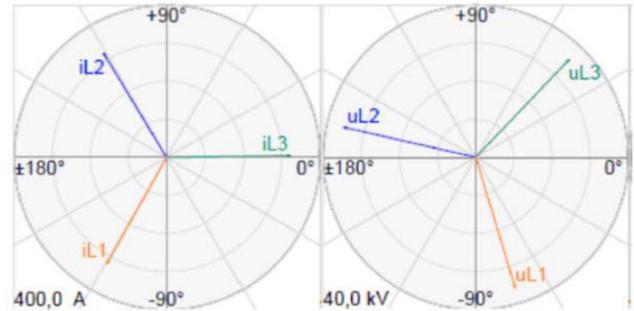
Fig. 4 KT31 currents (left) and voltages (right) at the instant of trip

Using SIGRA fault record current in L3 at instant of trip was $I_{L3trip} = 321.6$ A $\angle 1^\circ$ and phase voltage in L3 $U_{L3trip} = 35.54$ kV $\angle 46^\circ$, see Fig. 4. These are not at all faulty condition values, i.e. current is around one-third of the rated current for the transformer and the voltage is a normal phase voltage. Therefore the first indication is that this is not a faulty condition, but a wrong relay zone setting which has led to the relay tripping for normal load impedance.

Which corresponds to $Z_{fault,sec} = 184,2 \angle 45^\circ \Omega$ in secondary values. From Fig. 2, it is concluded that the relay detects FORWARD direction. This caused some confusion as the SCADA system at that time showed the power flow to be from 60 kV towards 150 kV. Further analysis showed that the relay was set wrong regarding current transformer polarity due to confusion between being installed in a feeder (where FORWARD is towards line) as being installed in a transformer feeder (where FORWARD is towards busbar). Therefore the measured fault loop impedance (only showed for phase L3) was measured in the FORWARD direction.

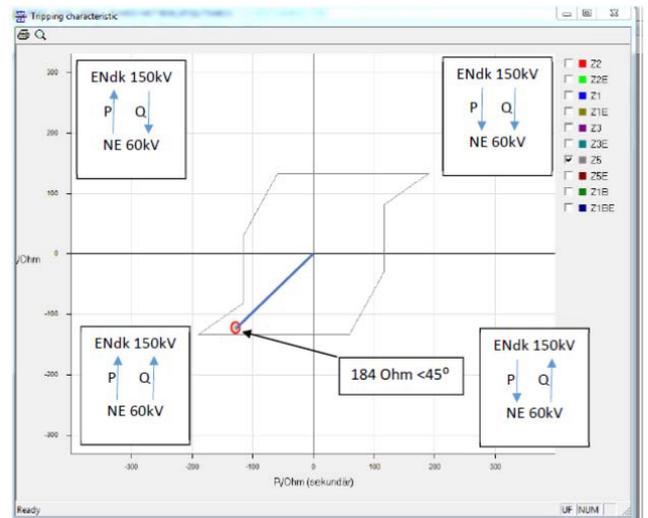
Plotting of the measured impedance in the zone setting graph from DIGSI revealed the cause of the trip, see Fig. 5

As can be seen the intended normal three-phase load (in this case power flow to transmission level due to wind power production in the area) has entered non-directional zone 5 and led to trip. This is caused by a wrong assumption when operating transformers in parallel using the doubled reach (see Section 2.2) to compensate for the underreach caused by the parallel operation. This assumption is actually wrong in two ways as the doubling of the reach should be exactly the opposite, i.e. in half to accommodate the trip of one transformer to be taken over by the second for a shorter period, i.e. the doubling of the load and thereby the half of the load impedance.

Fig. 5 R-X graph shows the measured impedance in secondary values to just enter zone 5 in reverse direction. NE means NordEnergi (distribution 60 kV) and ENdk is TSO (150 kV). The arrows indicate power direction

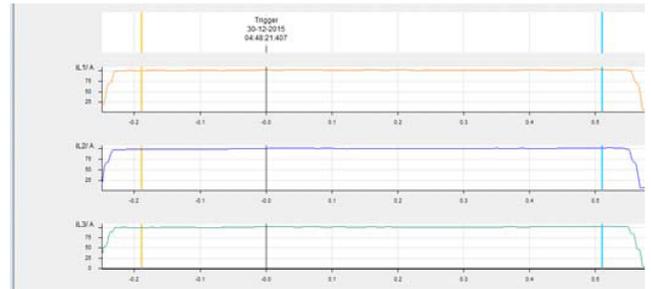
So the transition to backup OC depends from the absence of VT voltage. Address 2913 was set rather low and it is likely that induced noise in the disconnected and non-grounded VT signal cables have led to a voltage at relay voltage terminals not always being below this set value. Furthermore address 1202 (for distance function enabled) was set to 100 A. At the time of the trip the load current was precisely exceeding this value, see Fig. 11.

So by sheer coincidence measured VT voltage fluctuated (due to noise) to a value higher than threshold (2913) disabling backup OC and load current exceeded 100 A (1202) enabling distance leading to a measured impedance virtually zero due to the missing voltage. This caused zone 1 trip with the correct time delay 0.5 s

Fig. 11 Load current around instant of trip for KT31
