Assessment of pre-fabricated bathrooms from the 1990s

Morelli, Martin; Brandt, Erik

Published in:
1st International Symposium on Building Pathology (ISBP 2015)

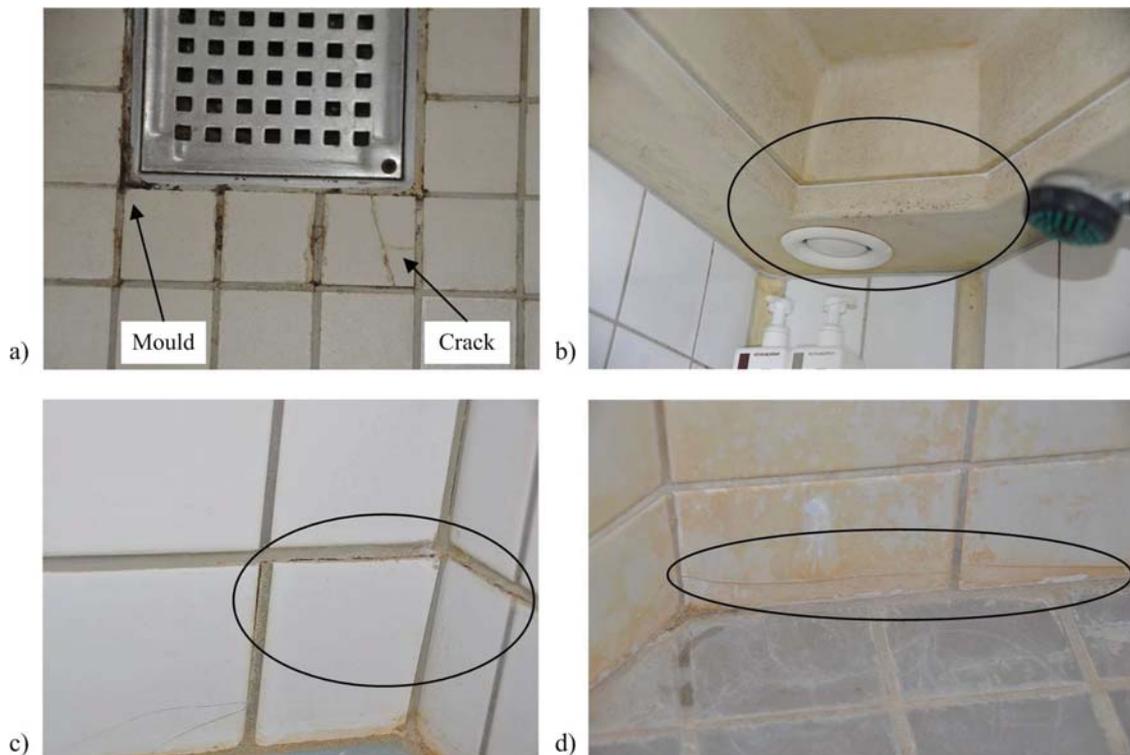
The inspections lead to the conclusion that in general the conditions of the bathrooms were good e.g. all bathrooms had a basin and shower unit without moisture sensitive materials. However, the resilient silicone sealants were often attacked by mould especially in the wet zone, loss of adherence and cracks, as shown in Figs 6a and 6c. Mould growth was also detected in the ceiling and mortar joints in

the wall of one bathroom as shown in Fig 6b. The mechanical ventilation was judged very low in this particular bathroom contrary to many other bathrooms. Other failures registered in the wet zone were holes that were not repaired after removal of hooks etc. Cracked tiles were registered close to the gully (Fig 6a) and for the heavy-weight assembly kit with fibre reinforced concrete bottom on the wall about 30 mm above the floor (Fig 6d). This bathroom floor was constructed with a small plinth and the cracks were observed at different locations in each bathroom.

Figure 6. a) Black discolouration in resilient silicone sealant around floor gully due to extensive mould growth; and cracks in tiles on floor. b) Mould growth in a ceiling made from fibre reinforced concrete due to low ventilation (high relative humidity). c) Loss of adherence and crack in resilient silicone sealant. d) Cracks in wall tiles in the height of the plinth.

Perhaps the most critical failure was registered in the heavy-weight assembly kit of fibre reinforced concrete bottom with a plinth. As the crack was observed on different walls but in the same height in

the three inspected bathrooms, the crack might be related to the plinth on the bottom element (Figs. 4b and 6c). However, the cracks could also be related to movement in the building. As no destructive inspections were conducted, the correct reason for the crack cannot be stated.

In general the quality of the bathrooms is high considering their age of 15-20 years. Many of the failures registered could have been avoided with increased maintenance, e.g. replacement of tiles with cracks and silicone sealant with mould growth. One reason for the high quality of the bathrooms relates to their layout, where the wet zone is separated from critical assemblies and moisture sensitive materials such as wooden panels are kept in the moist zone. The influence of mechanical ventilation is important to the indoor environment in these small bathrooms without venting opportunities to the outside. This is assessed to be the reason for mould growth in the ceiling of one bathroom with reduced ventilation as compared to the other bathrooms. Again this might be related to the occupant's ability of maintaining the bathroom and the ventilation system i.e. the fan.
