## Hydraulic Response of the Wave Energy Converter Wave Dragon in Nissum Bredning

*Determination of Hydraulic Response of the Wave Energy Converter  
Wave Dragon placed in Nissum Bredning*

Jens Peter Kofoed & Peter Frigaard, Aalborg University

December, 2004

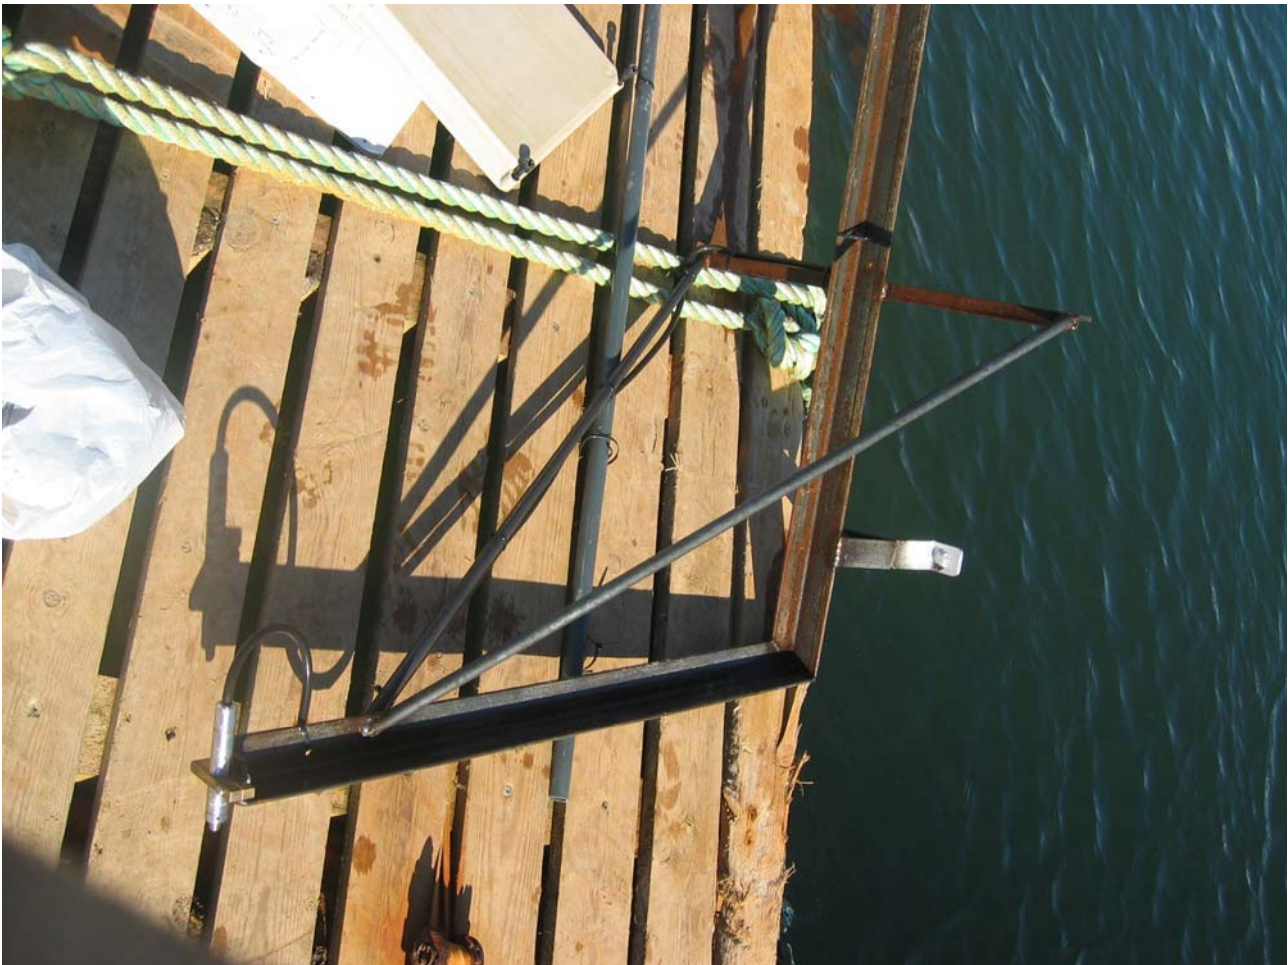
Figure 2.1: New pressure gauge on frame prior to installation on mooring pile.

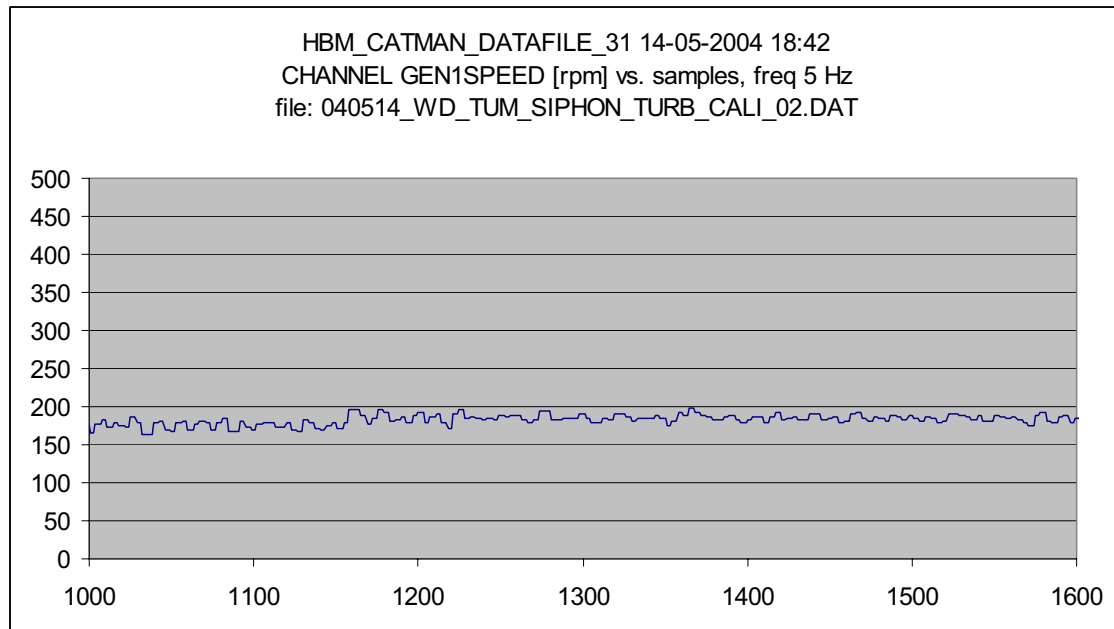
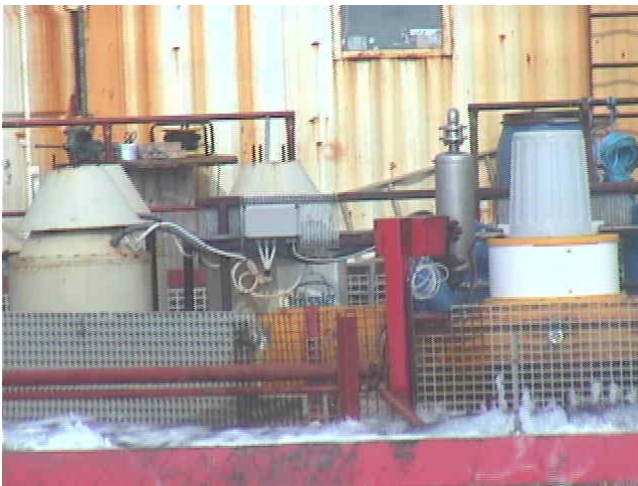
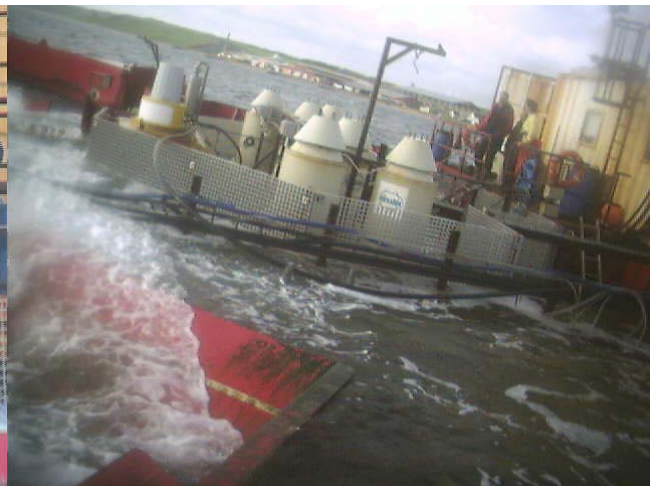
During the operation of the turbines after the refurbishments considerable oscillations in the turbines speeds has been seen. Below there are three figures with plots of turbine speed and pictures from the day.

Figure 3.4. Turbine calibration by TUM after restoration of TURB 1.

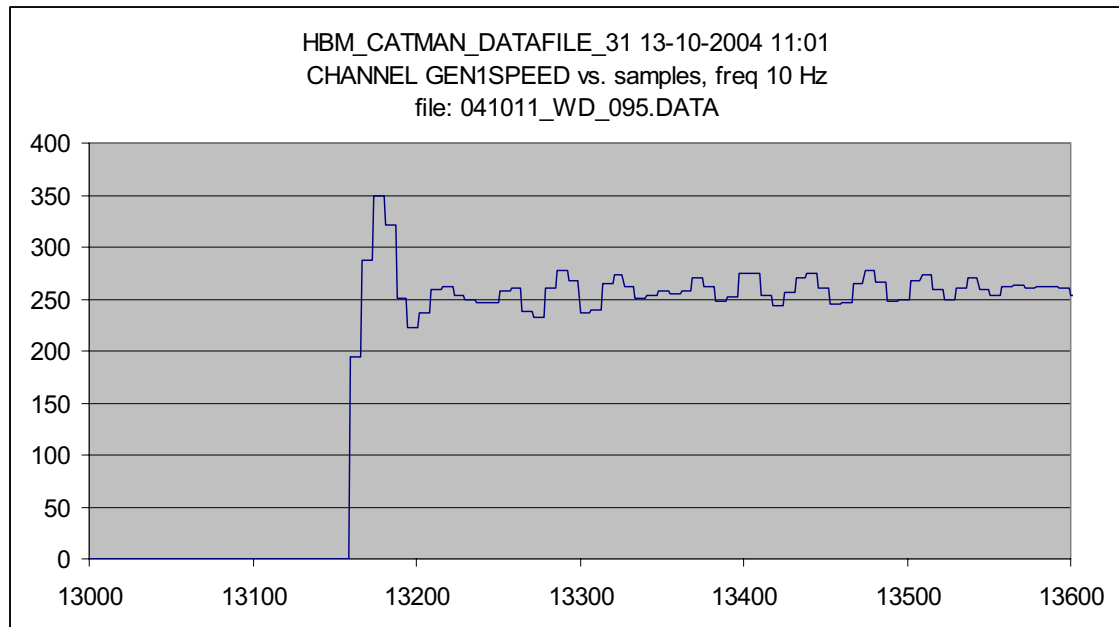
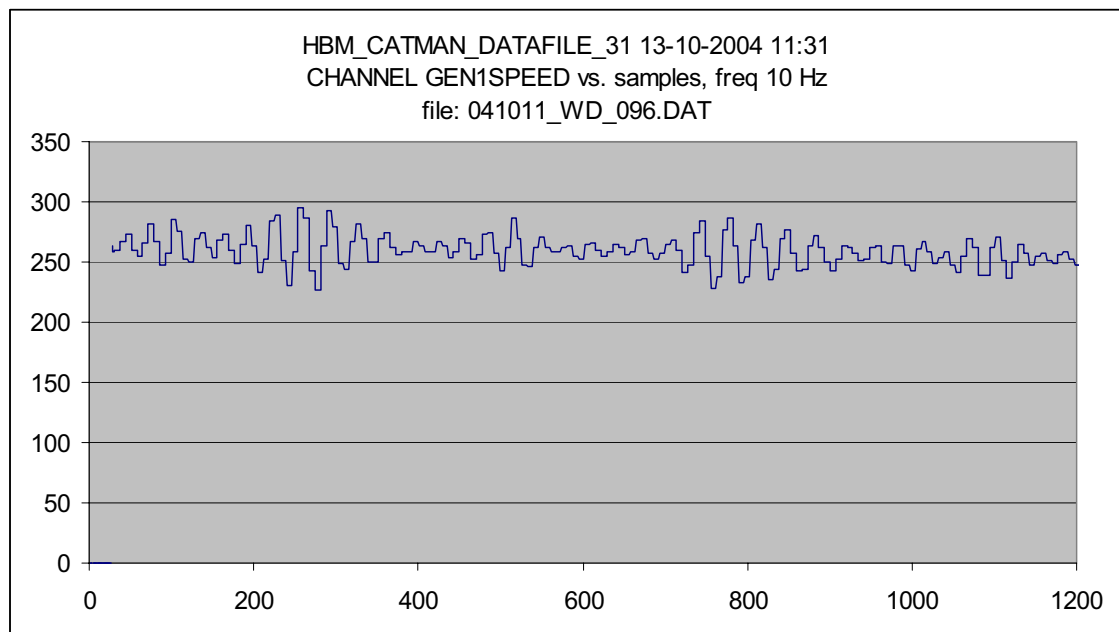
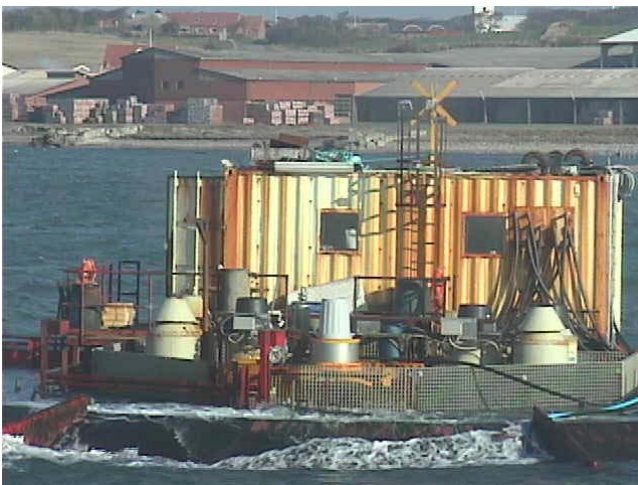
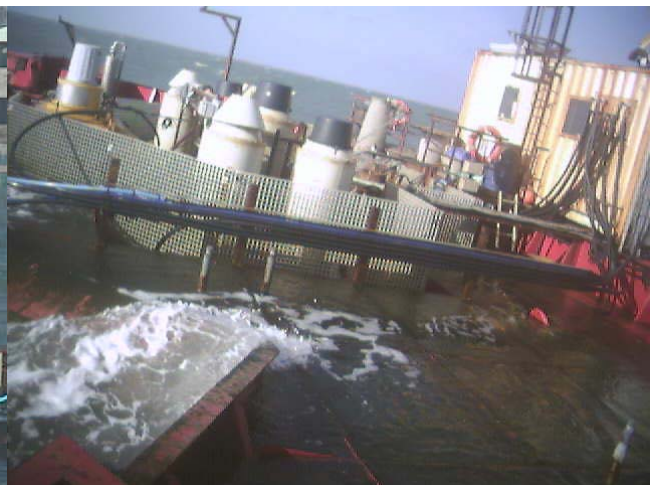
Figure 3.5. Turbine testing by TUM after restoration of TURB 2 and 4.

The change in the turbine speed oscillations are pronounced from figure 3.4 to 3.5 and 3.6. The period of the oscillations are not far from the wave periods, for what reason it seems fair to say that the oscillations are tricked by the changing turbine head due to waves propagating under the platform. West Control was at WD-NB in July 2004 to change some burned IGBT's (transistors) and at this time the EEPROMS containing the West Control programming of the inverters was also replaced. A change in the programming might be responsible for the increased sensitivity to oscillations in the turbine head. This item is currently being investigated.

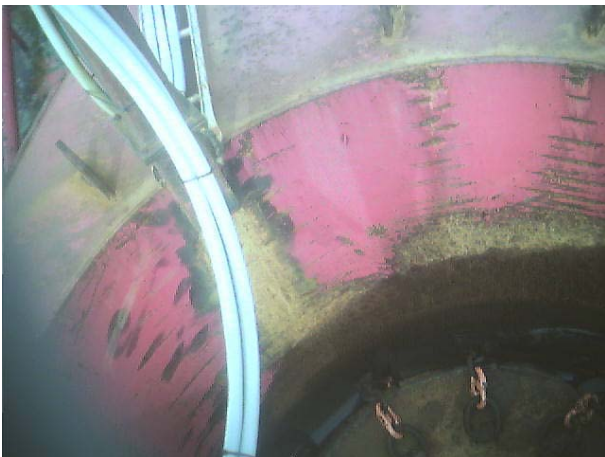
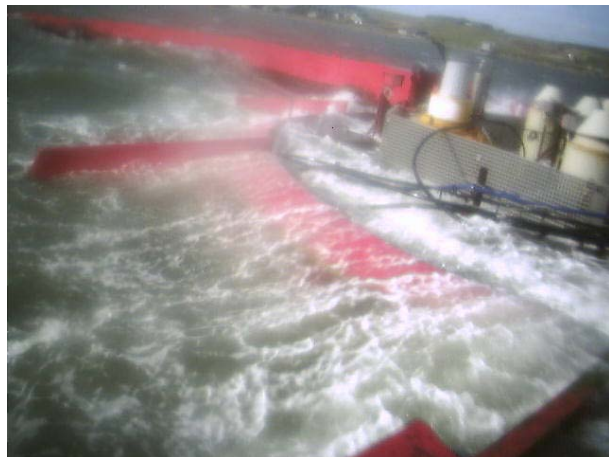
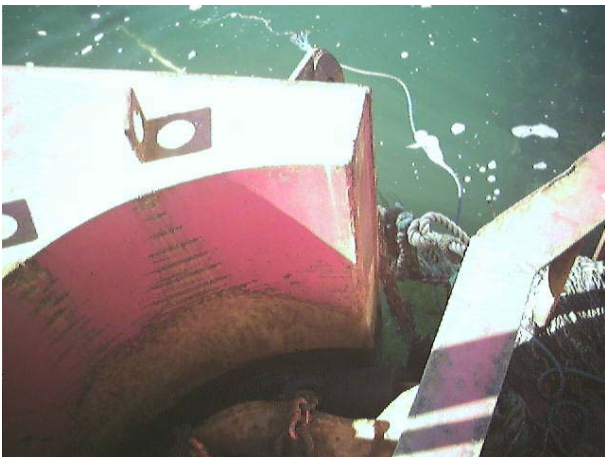
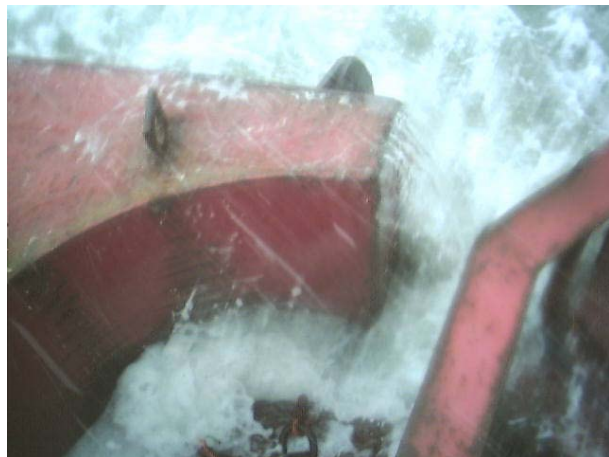
Before repair of the port side fender arrangement planned in the autumn 2003 was carried out, heavy weather caused dislocation of the port reflector and consequently damage/puncture of the port side shoulder. This led to flooding of a large buoyancy chamber. Further description is given in appendix A, date 03.10.08-09.

Figure 7.1. Pictures captured by WebCam2 on the port shoulder.

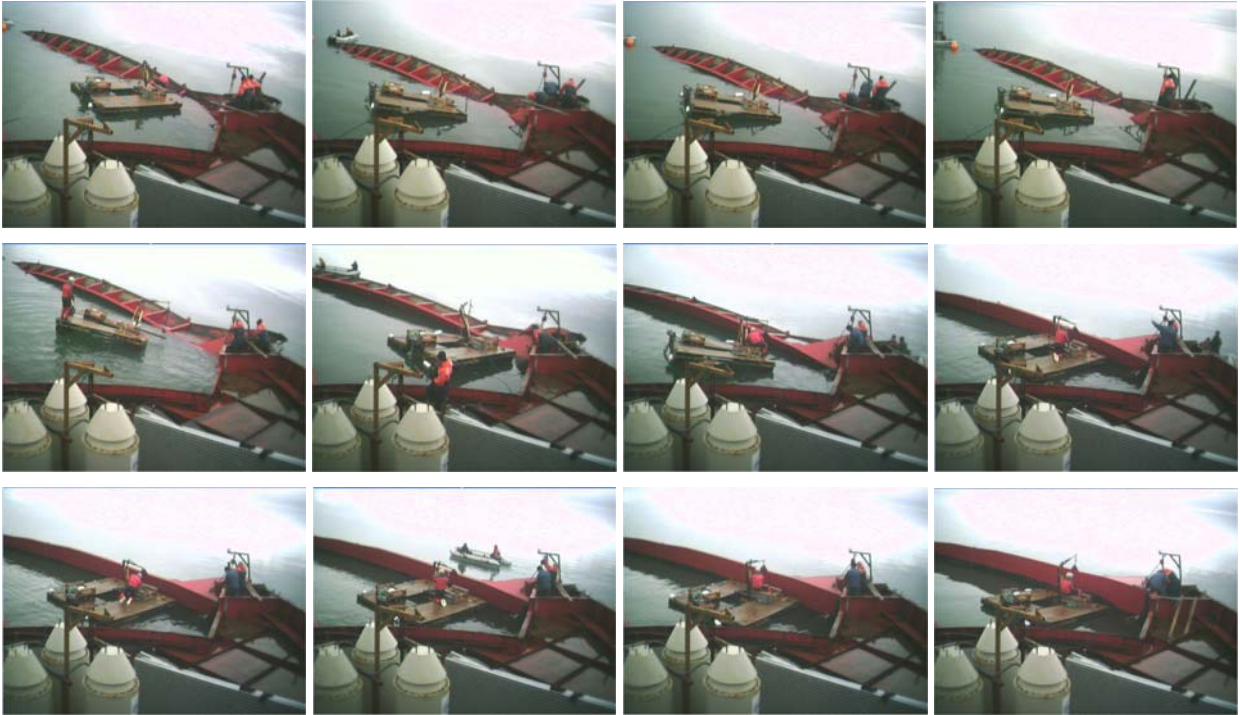
Between Christmas and New Year 2003 the starboard reflector was dislocated due failure of back rope between back of reflector and back corner of platform. The reflector was reinstalled the following day with calm weather, see figure 7.2.

Figure 7.2. Reinstallation of starboard reflector after dislocation, occurring between Christmas and New Year 2003.

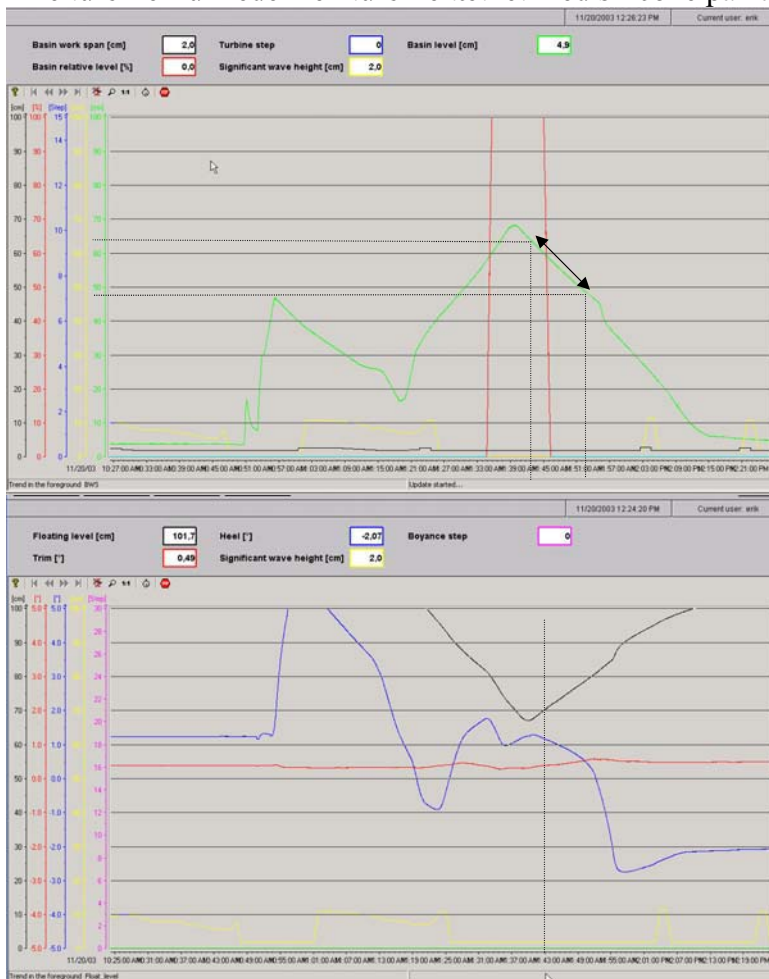
På 10 minutter (11:43 til 11:53) ses vandspejlet at falde med stort set konstant hastighed fra et niveau på 64 cm til 47,5 cm, d.v.s. 16,5 cm.

Idet netto bassinarealet er beregnet til at være  $165,5 - 6 = 159,5 \text{ m}^2$  bliver læk tabet  $2,63 \text{ m}^3$  svarende til 44 l/s eller en mistet elproduktion på ca. 300 W ved højt flydeniveau.

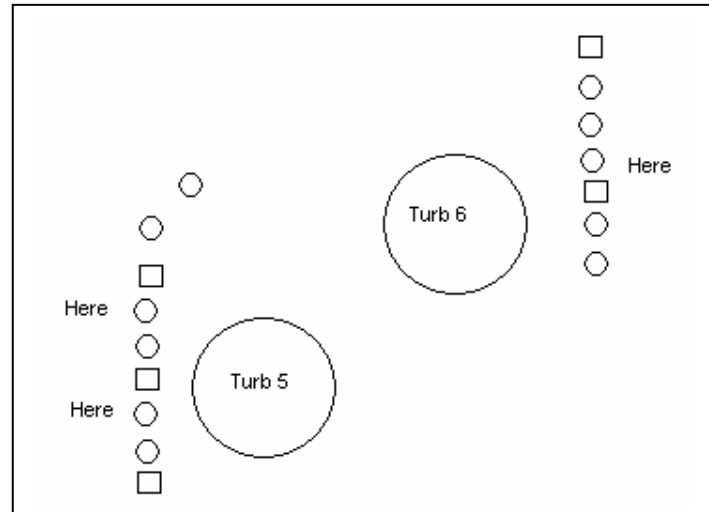
Tried to fill holes in the bottom of the turbine area, but had trouble making the filling stick in the holes. There was too much water in the turbine area. It is necessary to remove all the water from turbine area to be able to fill holes, but the wind was too strong to do so. Tree holes were filled as illustrated:
