## **An Experimental Study of a Midbroken 2-Bay 6-Storey Reinforced Concrete Frame subject to Earthquakes**

# An experimental study of a midbroken 2-bay, 6-storey reinforced concrete frame subject to earthquakes

A 2-bay, 6-storey model test reinforced concrete frame (scale 1:5) subjected to sequential earthquakes of increasing magnitude is considered in this paper. The frame was designed with a weak storey, in which the columns are weakened by using thinner and weaker reinforcement bars. The aim of the work is to study the global response to a damaging strong motion earthquake event of such buildings. Special emphasis is put on examining to what extent damage in the weak storey can be identified from global response measurements during an earthquake where the structure survives, and what level of excitation is necessary in order to identify the weak storey. Furthermore, emphasis is put on examining how and where damage develops in the structure and especially how the weak storey accumulates damage. Besides the damage in each storey the structure is identified by a static load at the top storey while measuring the horizontal displacement of the stories and also visual inspection i

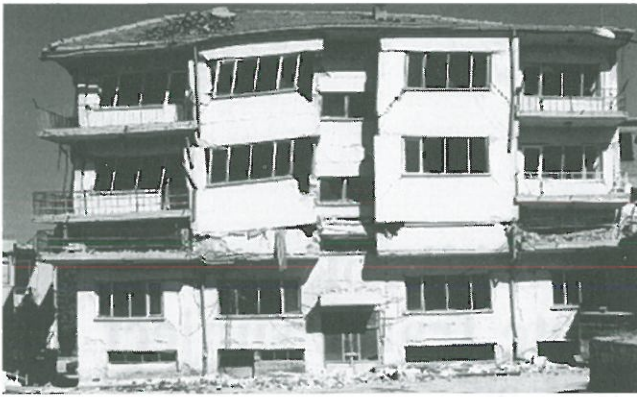
Fig. 1. Collapse of an intermedia floor due to the October 1995 Earthquake, Dinar, Turkey.

bars are left extended through the next storey and finally through the concrete deck at the roof. When the construction work is resumed, perhaps years later, these extended reinforcement bars are used to connect and anchor the new structural components to the existing building. Recent earthquake events in Turkey and Greece have shown that such structures have a tendency to fail in the storeys where such a connection is performed. The same kind of failure mode was also seen in the Kobe 1995 earthquake, where mid-storey collapses were caused by a sudden change in stiffness and strength of the storey columns. An example of such a failure can be seen in Fig. 1.

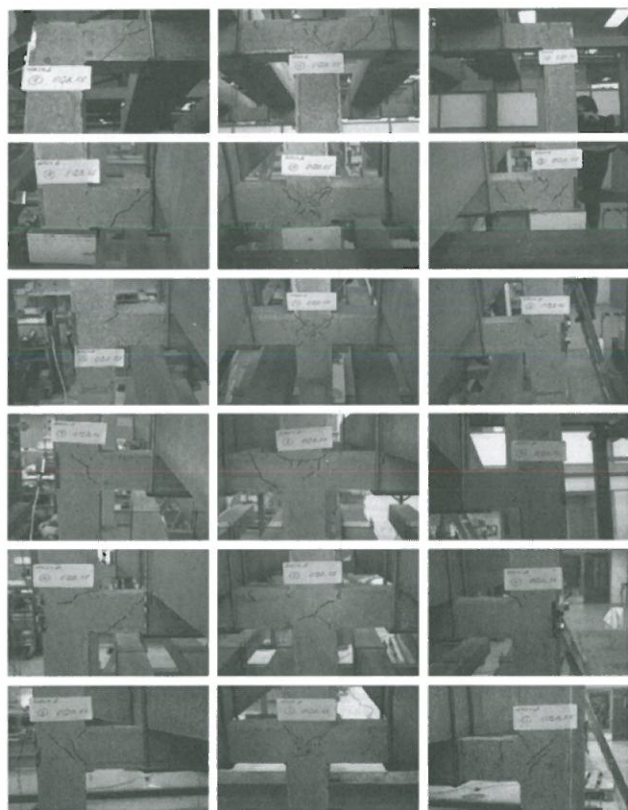
EQ3 resulted in some heavy damage at the nodes of the second and the fourth storeys which can be seen from the pictures in Fig. 18. Other than this heavy damage, most of the nodes had significant shear cracks. All three columns of the fourth storey of frame AAUWb had horizontal shear cuts where the maximum shear force is supposed to be. Storey 2 also had the same kind of damage.

fifth storeys are the most damaged, while storey six has the least damage. In particular, the shear cuts seen in all three columns of the fourth storey prove that this storey has weaker columns than the others and the columns are almost in the ultimate limit state of their load bearing capacity.

Fig. 18. Photos of all nodes in frame AAUWb.
