# First-generation Low-energy Buildings: Quality of the Thermal Envelope

T. Valdbjørn Rasmussen

*Department of Construction and Health, Danish Building Research Institute, Aalborg University, Hørsholm, Denmark*

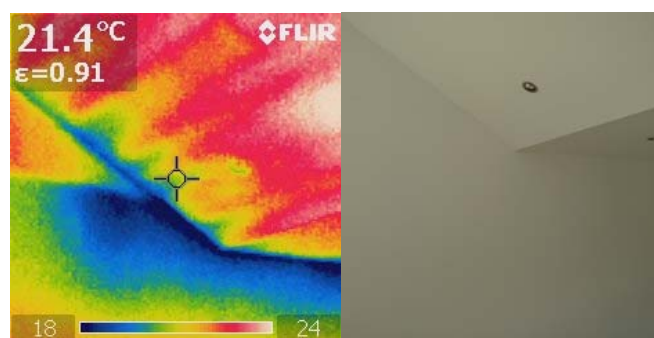
Category number six, of seven categories, shows cold areas in the thermal envelope along ceilings. The category includes inhomogeneity in the thermal performance of the thermal envelope at the ceiling. A thermographic picture illustrates a failure as the result of gaps in the joint between the wind barriers, see figure 1.

Figure 1. On the thermographic picture to the left, the dark blue colour represents 18 °C and the light red colour represents 24 °C. The picture to the right is an ordinary photo.
