# Failure Analysis of a Degraded 1.2 kV SiC MOSFET after Short Circuit at High Temperature

Paula Diaz Reigosa, Francesco Iannuzzo, Lorenzo Ceccarelli

Department of Energy Technology, Aalborg University, Pontoppidanstraede 111 DK-9220, Denmark  
pdr@et.aau.dk, fia@et.aau.dk, lce@et.aau.dk

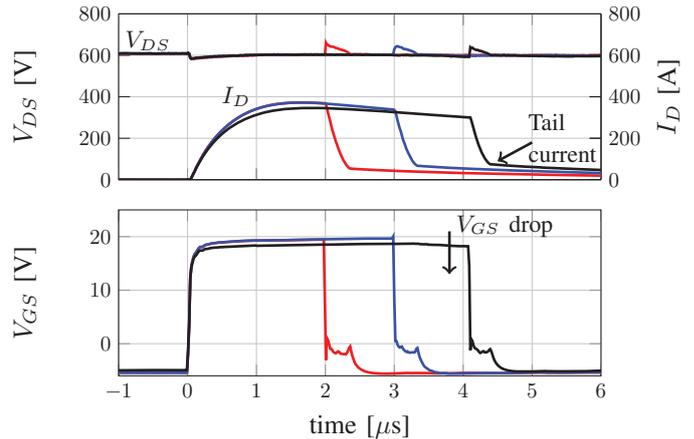
The waveforms of a typical short circuit test can be observed in Fig. 2, where the drain voltage, drain current and gate voltage are shown. The tests have been performed under a high temperature of  $T_j = 150^\circ\text{C}$  and bias voltage of 600 V. The drain voltage exhibits negative and positive peaks related to the current variation through the circuit stray inductance. The drain current peak is 380 A and then decreases according to the junction temperature increase, which is a well-known phenomenon related to the positive thermal coefficient of MOSFETs. Furthermore, it is worth to note that two abnormal phenomena take place, which can be recognized as two different failure indicators: (1) the occurrence of a large tail current at turn-off, which is not typical of unipolar devices and it does not occur under normal conditions, and (2) the significant reduction of the on-state gate-source voltage  $V_{GS}$ , indicating that a large leakage current is flowing through the gate. The latter failure indicator is only observed when the device is tested with a short-circuit pulse duration of 4  $\mu\text{s}$ . After the last test, the SiC MOSFET shows a permanent damage because the device cannot recover its initial state, but the device is still functional. From these results, one can give a

Fig. 2. Short-circuit tests with increasing time of a 1.2-kV/90-A SiC MOSFET:  $V_{DC} = 600 \text{ V}$   $T_j = 150^\circ\text{C}$ .

first conclusion that a conductive path between the gate and the source has been formed. The assumption that a new resistive path has been originated will be validated through the physical inspection of the device in the following section.

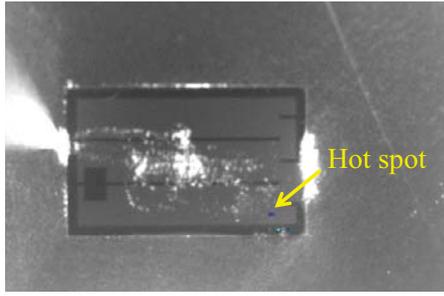
In this section, the electrical behaviour will be correlated with the physical failure analysis of the 1.2-kV/ 90-A SiC MOSFET. To do so, a thermal analysis followed by a Focused Ion Beam (FIB) cut have been performed on the degraded SiC MOSFET in order to find possible damages on the gate oxide. First, the package material has been removed by high-temperature etching, and then, an Indium Gallium Arsenide (InGaAs) infra-red camera has been used to find possible hot spots. The principle is to apply a voltage on the drain terminal, for example up to 150 V, and connect the gate and the source terminals to ground. If the SiC MOSFET has a defect, a leakage current will appear from drain to source or drain to gate, which it can be detected with a very sensitive infrared camera. The infra-red camera can penetrate to the device with a certain depth, so it is possible to observe the chip surface and the structure underneath. The results can be observed in Fig. 3, where two hot spots can be identified. The hot-spot analysed in this paper is the one localized in the active region, which is highlighted in in Fig 3.

Fig. 3. InGaAs infra-red image of the degraded SiC MOSFET.

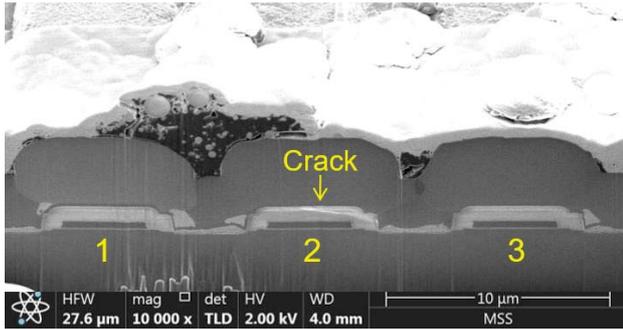
A Focused Ion Beam (FIB) at the hot spot location is used to obtain the vertical cross-section of the SiC MOSFET structure, whose image is revealed in Fig. 4. The image shows the physical structure corresponding to three cells, where one of the cells appears to be cracked on the field-oxide region. This cell in particular is further magnified in Fig. 5, where the crack between the poly-silicon gate and the aluminum source is clearly observed. On the other hand, the thin gate-oxide layer appears to be intact, concluding that the field oxide is the weakest part when the device is stressed under short circuit. These results are in agreement with the literature, since cracks

Fig. 4. Focused Ion Beam (FIB) cross-section of three cells at the hot spot location, where one of the cells presents a crack.

have also been observed in the field oxide region in [15]. A more in-depth analysis has been performed on adjacent cells, showing that not only one cell but several ones have cracks on the field oxide region.

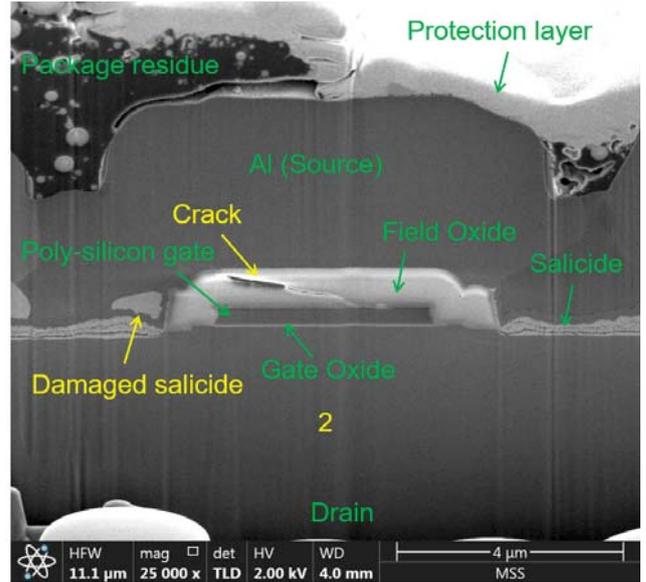
Furthermore, the salicide which is the technology that is used to form the electrical contact between the semiconductor substrate and the source terminal appears severely degraded, as pointed out in Fig. 5. This region is further magnified in Fig. 6, where it can be observed that solid particles accumulate in the aluminium source region between the salicide and the gate oxide. So far, the origin of these particles is not clear and it is not possible to provide the relevant information about the failure mechanism due to the short circuit stress. To better understand whether these particles may come from a process defect or could have originated after the applied short circuit stress, a cross-section of a new 1.2-kV/90-A SiC MOSFET will be presented in the next section.

Fig. 5. Magnified Focused Ion Beam (FIB) cross-section of the damaged cell.

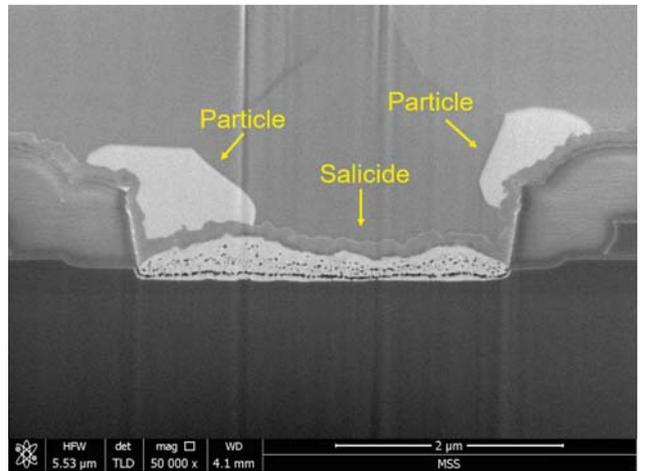
Fig. 6. Magnified Focused Ion Beam (FIB) of the salicide region of the degraded SiC MOSFET.

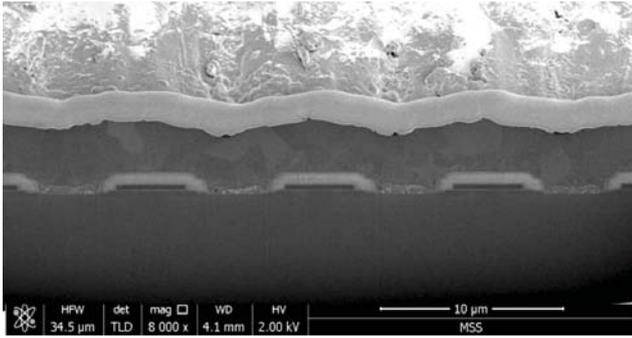
The results can be observed in Fig. 7, where the vertical structure of three cells is presented. It is interesting to compare Figs. 4 and 7, showing that a number of differences can be observed between the new and the degraded device. First, the cracks found in the degraded device between the poly-silicon gate and the aluminium source are not detected in the new device, as it is observed in Fig. 8. Second, the particles seen in the degraded SiC MOSFET near the salicide are not visible for the new device. This indicates that they could have originated as a consequence of the short-circuit stress and not from defects originating from the device process. A more detailed inspection of this region can be observed in Fig. 9. It can be confirmed that the particles cannot be observed and it is also worth to note that the granular structure is significantly altered when compared with the new device. Finally, the shape of the interface between the upper Aluminium layer and

Fig. 7. Focused Ion Beam (FIB) vertical cross-section of a new SiC MOSFET showing three cells.

the passivation layer shows a significant degradation between the non-degraded cell and the degraded one, since this layer appears to be deformed. From these results, it can be inferred that the temperature reached during short circuit provokes the deformation of the cells that could lead to the formation of cracks in the upper oxide region. These deformations

may stress the gate structure and induce the observed cracks between the poly-silicon gate and the aluminium source, which forms a resistive path and as a consequence a gate leakage current appears causing the catastrophic failure of the device.
