Effect of short-circuit stress on the degradation of the SiO₂ dielectric in SiC power MOSFETs

Reigosa, Paula Diaz; Iannuzzo, Francesco; Ceccarelli, Lorenzo

Published in:
Microelectronics Reliability

Publication date:
2018

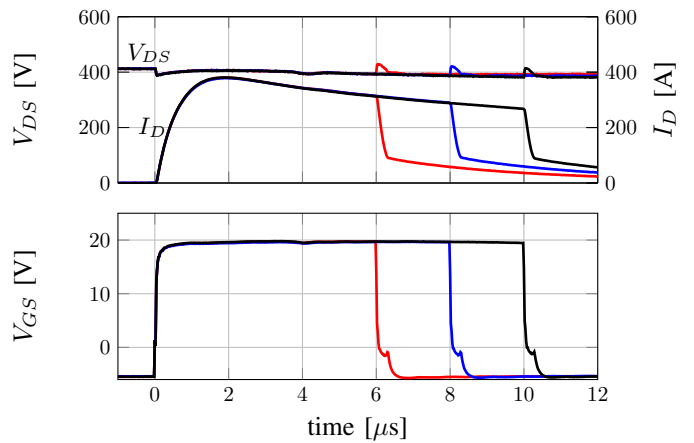
Fig. 3: Short-circuit tests with increasing time of a 1.2-kV/90-A SiC MOSFET: $V_{DC} = 400\text{ V}$ $T_j = 150^\circ\text{C}$.

results at low bias voltage and high temperature do not show any degradation on the gate voltage, and therefore, it can be concluded that the SiC MOSFET is able to survive this condition.

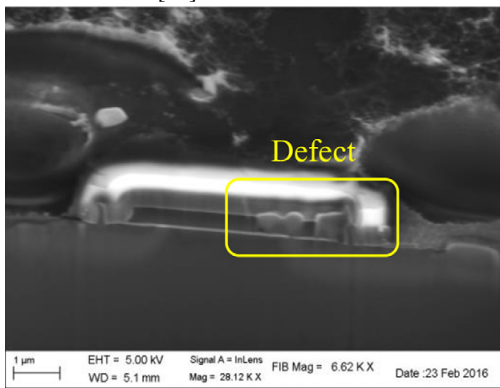
(c) SEM image of the degraded 1.2 kV/ 24 A SiC MOSFET cell showing defects in the poly-silicon gate electrode [4].

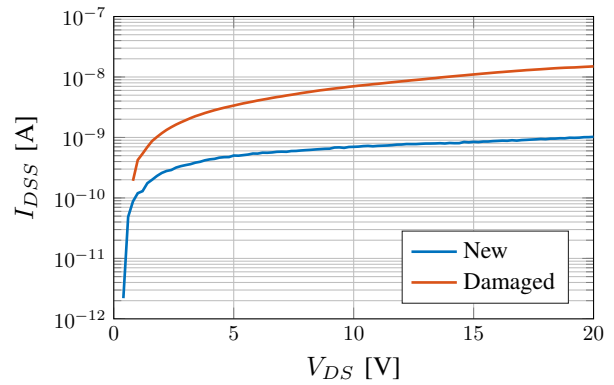
The degradation of the 1.2-kV/ 90-A SiC MOSFET has been attributed to the change in gate leakage current and gate damage due to the formation of cracks in the SiO₂ dielectric. Nevertheless, it is worth to discuss that the drain leakage current significantly increases between the fresh and the damaged device, as observed in Fig. 14, where the typical $I - V$ curve is presented. The aim is now to find out through the physical inspection of the device, whether there are further cracks or defects that allow the drain leakage current to flow from drain to source through a new path.

Fig. 14: Short-circuit tests with increasing time of a new and a degraded 1.2-kV/90-A SiC MOSFET: $V_{DC} = 600$ V $T_j = 150^\circ\text{C}$.
