# The STRYDE limb lengthening nail is susceptible to mechanically assisted crevice corrosion: an analysis of 23 retrieved implants

**Background and purpose** — We noted several adverse events in patients in whom the first version of the STRYDE limb-lengthening nail (NuVasive Specialized Orthopaedics, San Diego, CA) had been implanted. Pain, osteolysis, periosteal reactions, and cortical hypertrophy at the nail junction were noted. Here, we present the analysis of 23 retrieved STRYDE implants.

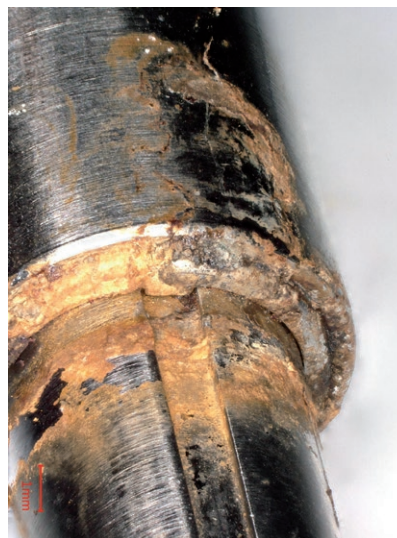
Figure 4. Digital microscopy of the junctional discoloration, i.e., corrosion products.

2 surgeons observed “oozing” of a brown substance from the telescopic nail junction during hardware removal in addition to the observation of junctional discoloration (Figure 4).

Macroscopic inspection and photo documentation revealed discoloration at the telescoping junction in 20/23 implants (Figure 4) and 20/23 had corrosion at the locking screw holes

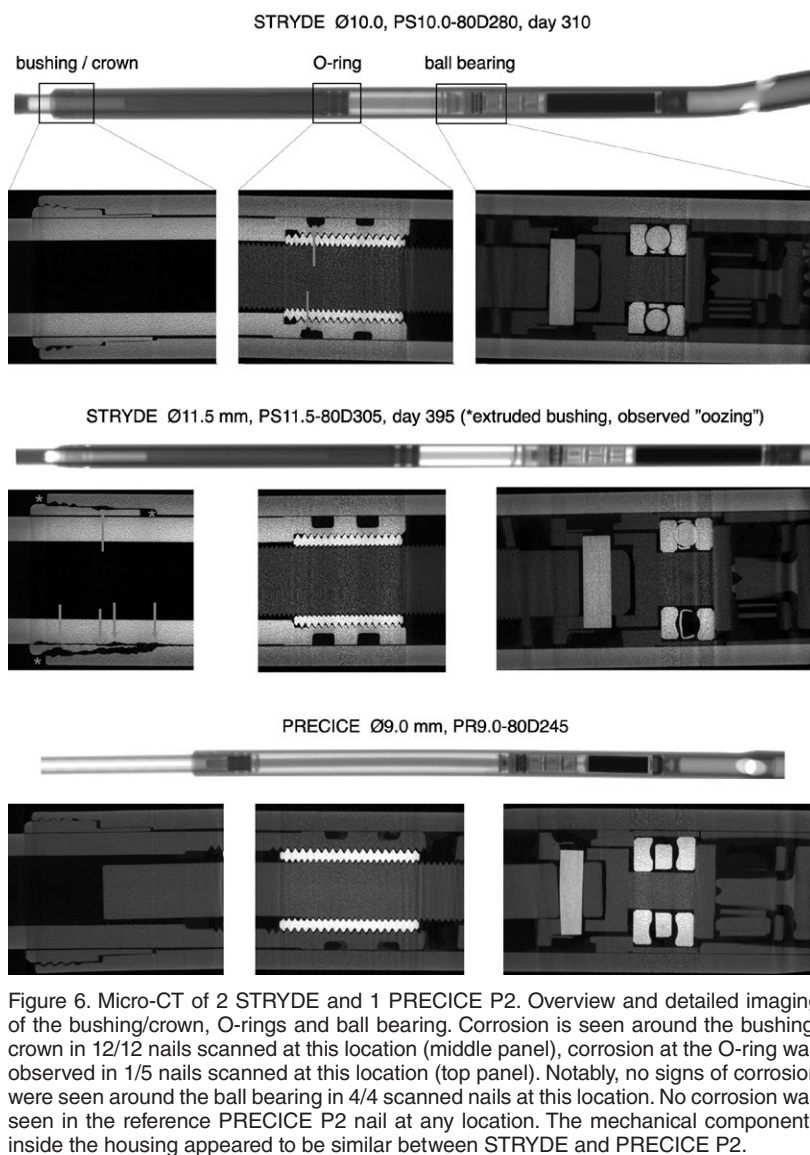
Micro-CT of 12 STRYDE nails documented corrosion attacks at the telescopic junction, primarily at the bushing, but also at the distraction rod and internal components of the nail surrounding the bushing (Figure 6).

Figure 6. Micro-CT of 2 STRYDE and 1 PRECICE P2. Overview and detailed imaging of the bushing/crown, O-rings and ball bearing. Corrosion is seen around the bushing/crown in 12/12 nails scanned at this location (middle panel), corrosion at the O-ring was observed in 1/5 nails scanned at this location (top panel). Notably, no signs of corrosion were seen around the ball bearing in 4/4 scanned nails at this location. No corrosion was seen in the reference PRECICE P2 nail at any location. The mechanical components inside the housing appeared to be similar between STRYDE and PRECICE P2.

mechanical construction; only the bushing seemed to be constructed differently (Figure 6). Close 360° contact between the housing and bushing were observed in PRECICE P2, while none of the 12 STRYDE nails had that feature (Figure 6, lower vs. top panel).

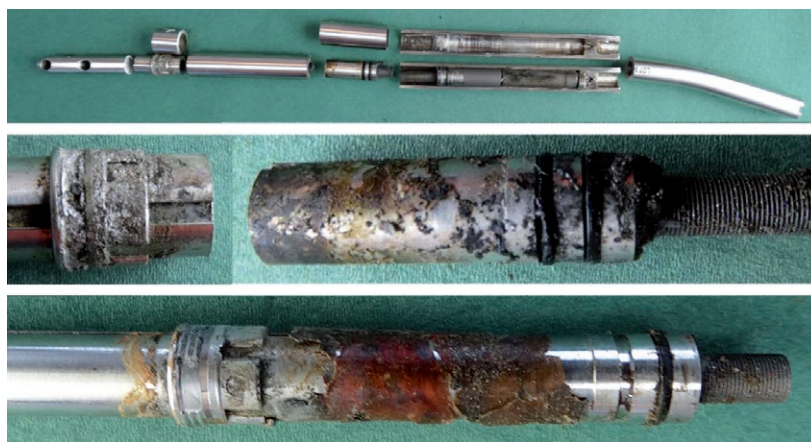
Figure 8. Examples of a sectioned STRYDE (top panel), corroded bushing (middle panel), and presence of biological material on internal components. Biological origin was verified with EDS analysis showing a high oxygen content (bottom panel).

Mechanical sectioning of 5 STRYDE nails, which were selected based on either visual inspection or micro-CT findings, i.e., worst and best cases, showed an internal titanium actuator pin with signs of dry lubricant of a crystalline appearance (Figure 7, see Supplementary data). EDS analysis of the crystalline structure showed high contents of fluorine 35 wt.% and aluminum 24 wt.%. The presence of biologic material within the nail was confirmed by visual inspection and a high oxygen content determined by EDS analysis (Figure 8).

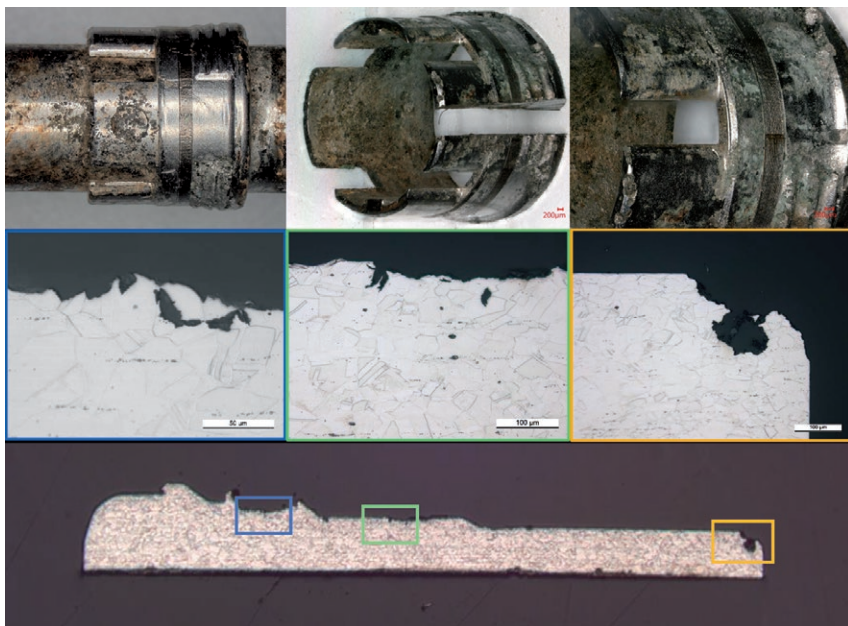
Figure 9. Corrosion attack at the bushing/crown. Digital microscopy (upper panels) and microscopy of the microstructure (middle and lower panels).

Microscopic inspection verified the mechanical damage and local corrosion of the microstructure both at the bushing (Figure 9) and at the screw and screw holes (Figure 10).

A possible explanation for corrosion near the telescopic junction is that corrosion initiates at the interfaces of the bushing where small-amplitude movements can produce disruption of the passive film causing metal degradation and crevice formation. As the environment in the crevice becomes more aggressive it leads to further degradation of the bushing and other parts of the telescopic junction.

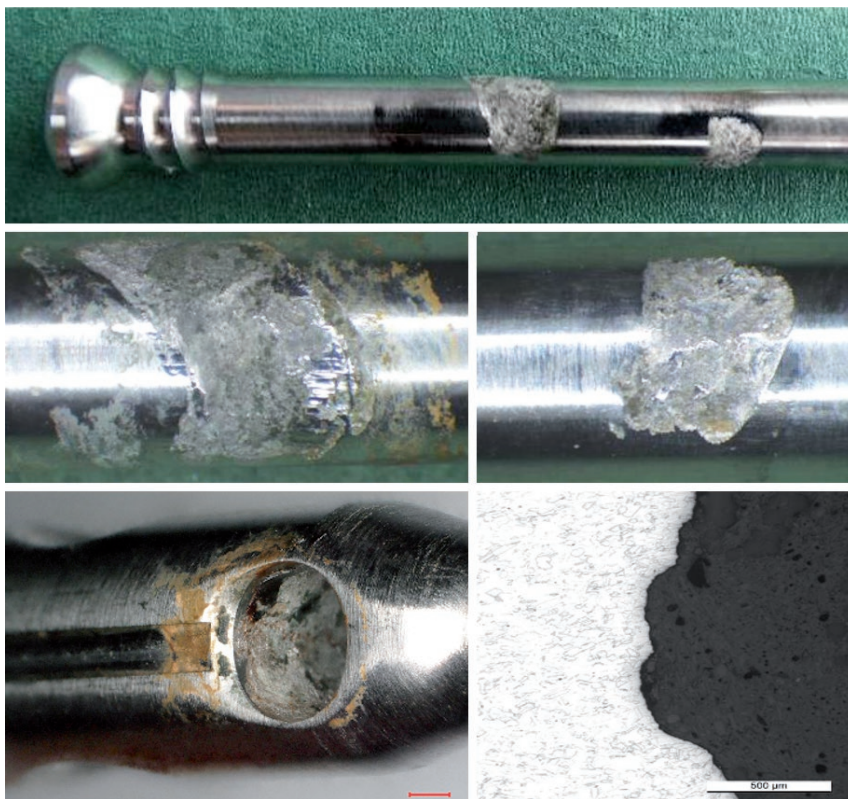
Figure 10. Mechanically assisted crevice corrosion/fretting and crevice corrosion at a locking screw, screw hole including microscopic image of the corrosion-attacked microstructure. For SEM imaging see Figures 12 and 13 in Supplementary data.

Mechanically assisted crevice corrosion may also explain the material degradation inside the screw holes. Weight-bearing may initiate this process by causing small-amplitude movements between the screw and screw hole, initiating fretting. Subsequently, a larger crevice is formed where the distraction rod inside the screw hole is attacked due to increased aggressivity of the environment inside the crevice between screw and screw hole. Moreover, galvanic corrosion could be ruled out, because the housing, bushing, and screw were made from the same metal, i.e., Biodur 108.
