Timber-Frame Walls: Feasible with a Damaged Vapor Barrier?

Ernst Jan de Place Hansen, PhD

Erik Brandt

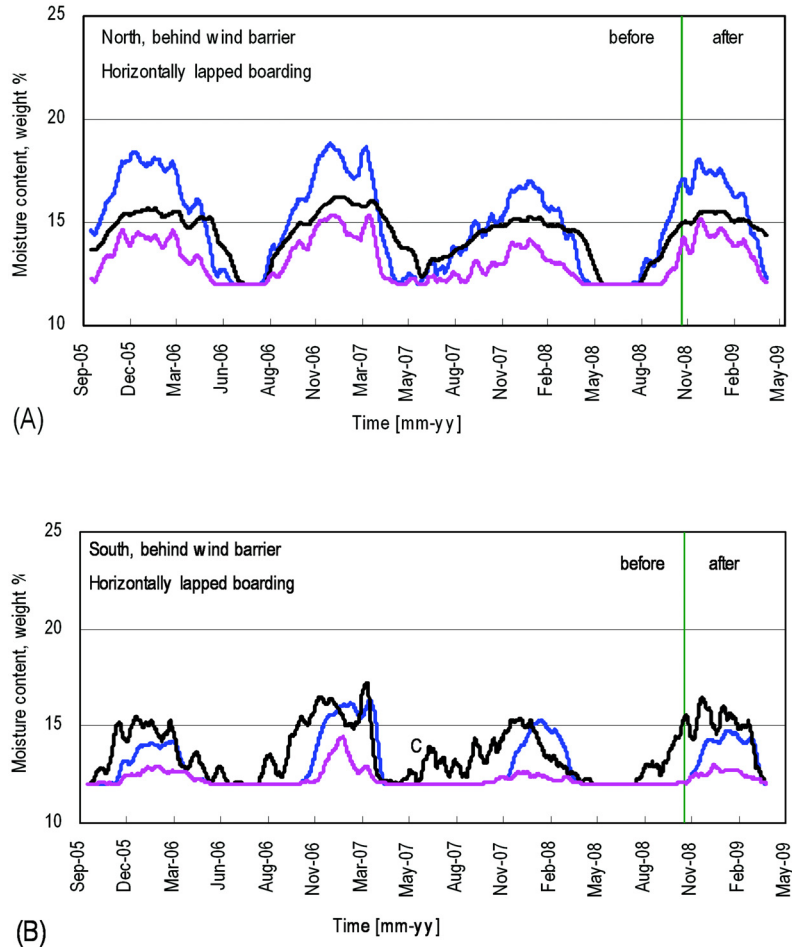
Figure 7 Moisture content (weight %) behind the wind barrier. Façade elements facing (A) north and (B) south. Horizontally lapped boarding. Ventilated cavity (cavity depth: 25 mm, element 1, black), nonventilated cavity (cavity depth: 12 mm, element 4, violet), no cavity (element 11, blue). “Before” and “after” refer to the time when holes were made in the vapor barrier.

The moisture content behind the wind barrier before and after the holes were made in the vapor barrier is shown in Figure 7 and 8. Element 11 (Figure 7) was in principle without a cavity, but because of the type of cladding (horizontally lapped boarding, see Figure 5A) there were small, isolated cavities between the wind barrier and the cladding. Element 10 (Figure 8) was partly ventilated. At the bottom was a 5 mm ventilation opening in the 12 mm deep cavity. In element 13, the type of cladding (vertical weatherboard) left no cavity at all (Figure 8). Element 13 had an intact vapor barrier.

None of the cases where holes were made in the vapor barrier showed a provable effect on the moisture content in the elements (Figures 7 and 8). This indicated that the moisture condition at the wind barrier was only slightly affected by damage to the vapor barrier (at least damage similar to that inflicted in this study). Damage that enables convection through the elements would probably have a more pronounced effect. In that case, one could question whether elements should include a ventilated cavity. Further studies are needed to explore this.

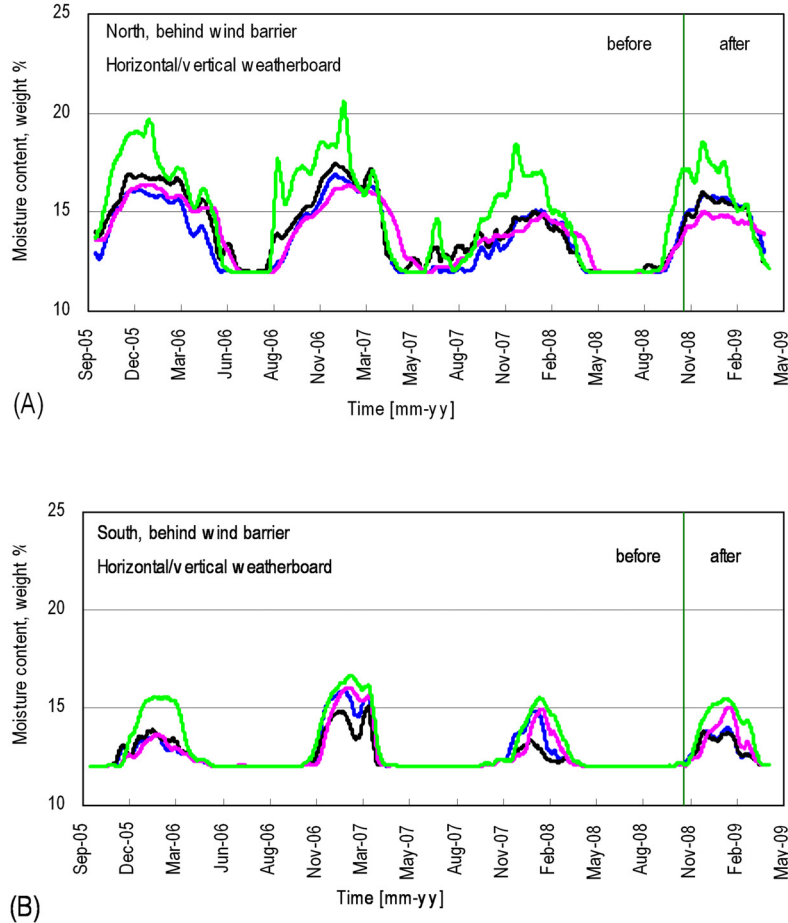
Figure 8 Moisture content (weight %) behind the wind barrier, façade elements facing (A) north and (B) south. Ventilated cavity (element 2, black), nonventilated cavity (element 6, violet), partly ventilated cavity (element 10, blue), no cavity (element 13, green). Horizontal weatherboard (elements 2, 6, and 10; cavity depth: 12 mm) and vertical weatherboard (element 13) as cladding. “Before” and “after” refer to the time when holes were made in the vapor barrier (not element 13).

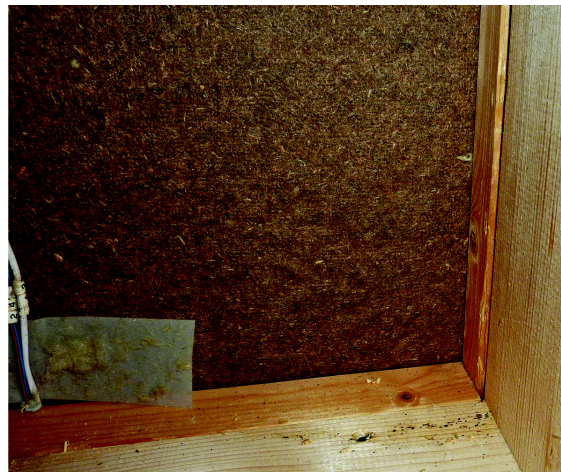
Figures 9 and 11 show the wind barrier at elements 14 and 8 after removing the inner cladding, vapor barrier, and thermal

In general, inspection of elements with an intact vapor barrier showed a moisture content behind or in the wind barrier below the critical level, although the moisture content in the

Figure 9 Inner side of the wind barrier after four years of exposure: element 14, facing north (vertical weatherboard, no cavity, wind barrier: asphalt-impregnated wood fiberboard).

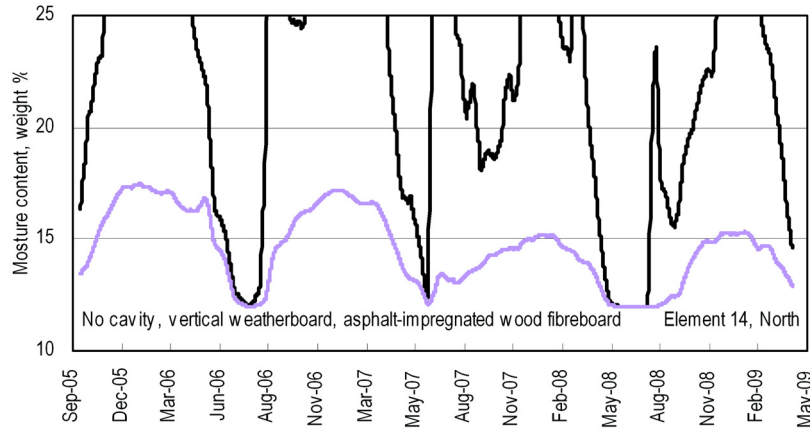
Figure 10 Moisture content (weight %) in element 14, facing north, in the cladding (black), and behind the wind barrier (violet).

cladding was sometimes quite high (see Figure 10). In some cases, this might lead to problems (e.g., in combination with freeze/thaw). In element 8, however, the moisture content in the wind barrier and in the timber studs was very high (see Figures 11 and 12). Element 8 was placed at the corner of the test building, and the moisture was explained by poor workmanship on the outer part of the element, which in combination with a leaky drainpipe made it possible for moisture to enter from the side of the element (Figure 13).

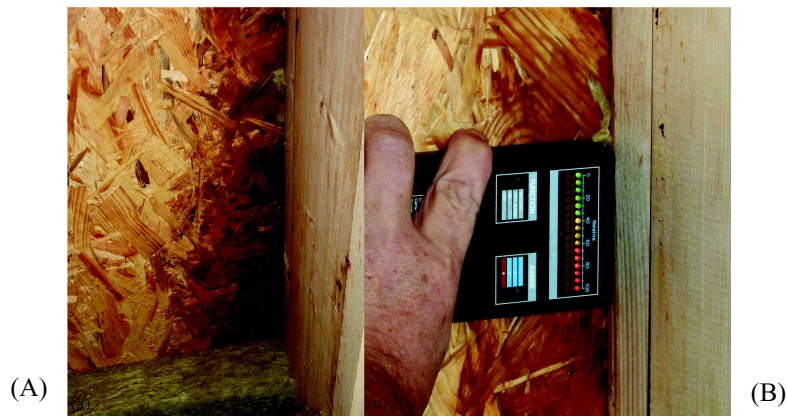
Figure 11 Element 8 facing north (horizontal weatherboard, nonventilated cavity, oriented strand board as wind barrier). (A) Wet part of the wind barrier seen from inside and (B) display on the handheld moisture meter indicating critical moisture content (i.e., all indicator lamps are on, including the red ones).

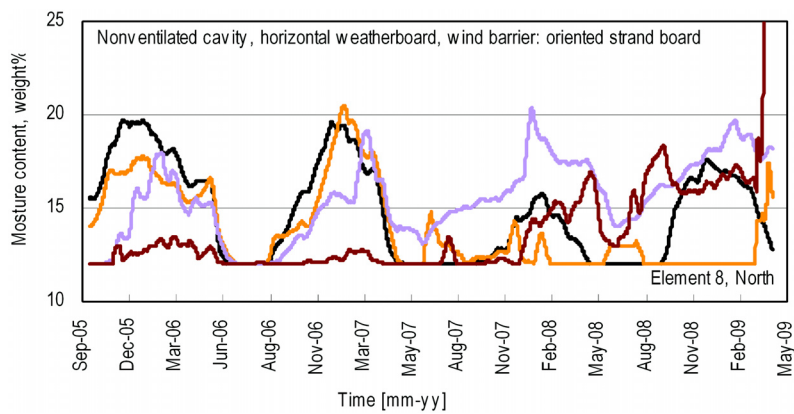
Figure 12 Moisture content (weight %) in element 8 facing north. Moisture content in cladding (black), in the cavity (orange), behind the wind barrier (violet), and in the timber studs (brown). Note the sharp increase of moisture content in the timber studs at the end of the period.

The tests carried out in this study showed that the different types of timber-frame walls in general behaved well when they were exposed to a humid indoor climate (22°C, 60% RH) at the indoor side, although they were vulnerable to defects due to poor workmanship (see Figures 12 and 13). Future work should include exposure of full-scale elements to a typical

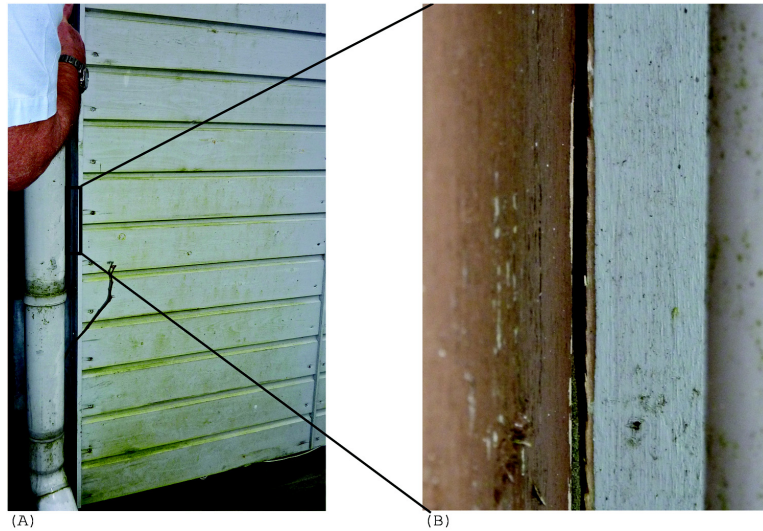
Figure 13 (A) Detail of northeastern corner of the test building with element 8 and its adjacent leaky drainpipe. (B) Close-up of the assembly between the test building and element 8, seen from the side. November 2009 after four years of exposure.

Note the amount of algae on the cladding and compare with the condition five months earlier (Figure 14). This is a clear example of how fast the appearance of the surface can change. It also demonstrates how vulnerable this kind of construction is to poor detailing and workmanship, even when the element includes a cavity.

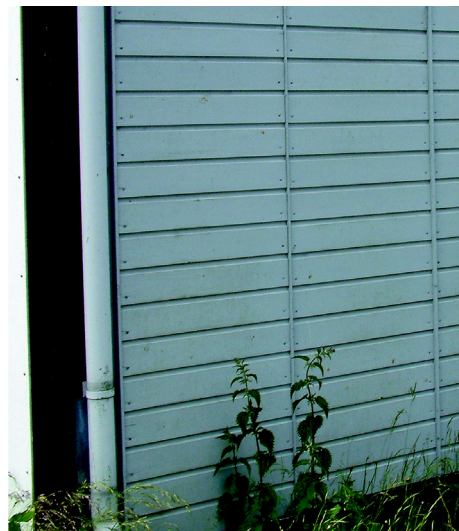
Figure 14 Section of north façade of test building, June 2009. Element 8 is to the left, next to the drainpipe. Algae are not visible on the cladding.
