## **Refurbishing roof systems and roof terraces on a major residential building complex**

## **Refurbishing Roof Systems and Roof Terraces on a Major Residential Building Complex**

**Tommy Bunch-Nielsen, Danish Roofing Advisory Board  
Erik Brandt, Danish Building Research Institute  
Denmark**

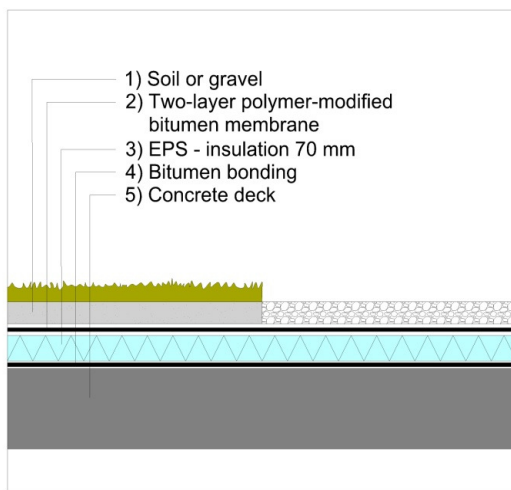
Figure 2: Original vegetative and ballasted roof systems

On the vegetative roof systems, the problem was roots penetrating the roofing materials because they were not root-resistant.

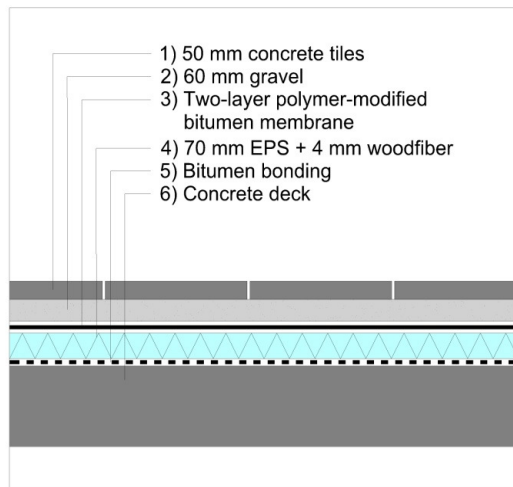
Figure 3: Original roof terraces

The slope of the roof systems and terraces was close to zero, and there was standing water on most roof systems and terraces, though it was hidden under concrete tiles, ballast and vegetation.

One of the surveys' conclusions was that the flashings' height was too low, so water could run over the flashings on the roof terraces.

The flashings themselves also were a problem as frost during the winter made the water in the built-up roof system turn into a solid ice cake that expanded and caused pressure on the roofing materials in the flashings, leading to severe cracks.

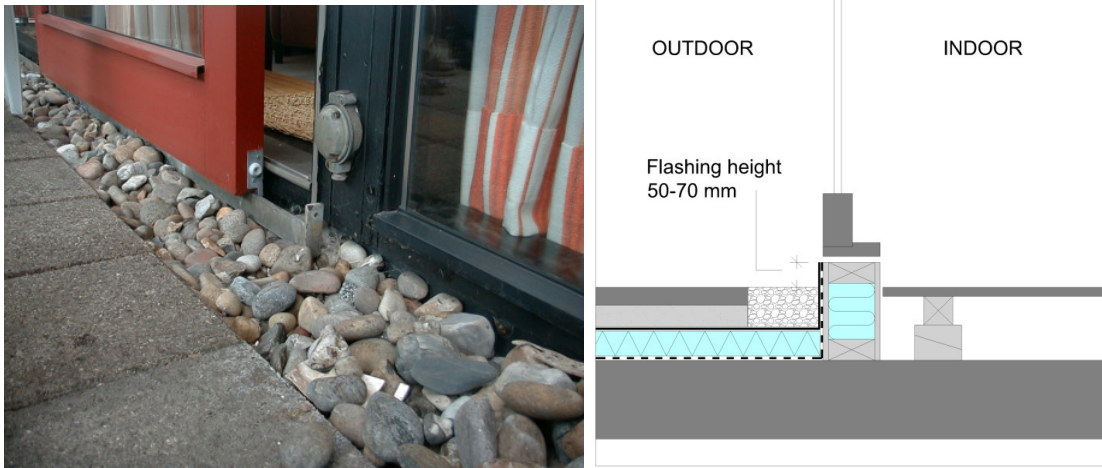
No changes were made to the flashings' height because it would involve changing the windows, doors and wooden facades between the apartments and terraces. Each terrace has two 6 m long façades facing the terrace, and the costs were considered to be too high, even taking into account that it was possible to obtain a 15-year warranty.

Figure 6: Example of flashings between terrace and apartment

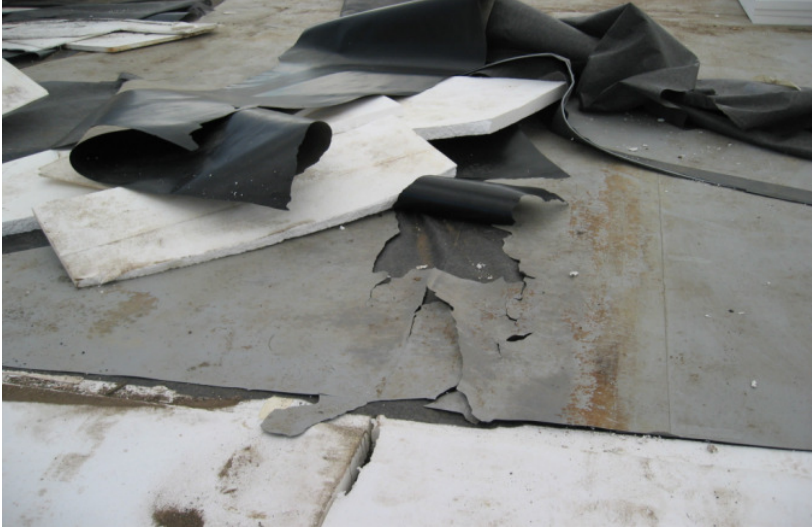
Figure 7: The loss of plasticizers was critical because it caused the membrane to shrink and become brittle.

The biological environment in the soil (bacteria and mold) on top of the membrane probably was the reason for the loss of plasticizers; the plasticizer content fell from 35 percent to 5 percent in 10-12 years. The loss of plasticizer to the EPS insulation was avoided by a separation layer of glass felt.

When the plasticizer content is below 20 percent, the product becomes brittle and cracks readily will occur if people walk on the roofs. The loss of plasticizers also causes the membrane to shrink, which leads to tension in the membrane and creates problems with the flashings, which are pulled off the underlayment.

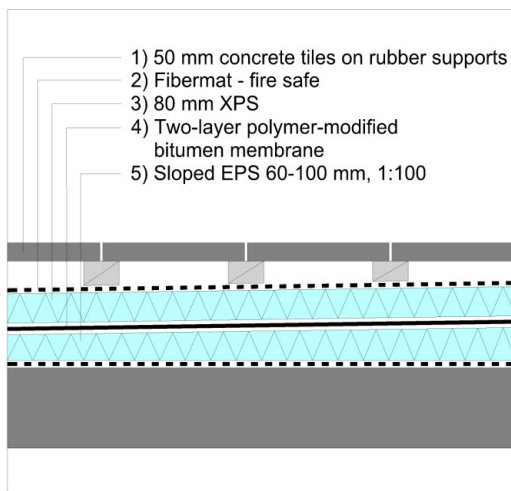
Figure 8: New roof construction of terraces after the second renovation. The roof membrane is protected between two layers of insulation, and water drainage is facilitated by using rubber supports for concrete pavers instead of gravel.

The most difficult part was increasing the height of the up stands. After much consideration, it was decided all light facades would be replaced with new facades, new doors and new windows that were 200 mm shorter, making it possible to create new 200-mm higher up stands.

Furthermore, it was deemed important to ensure water readily could get away from the up stands and, therefore, the concrete pavers were placed on footings instead of in gravel as before. The roof's slope also was improved, and the design was changed to a duo roof system (partly inverted roof system) to keep the membrane frost-free during the winter. When using a partly inverted roof system design, the slope can be reduced to 1:100 instead of the normal (in Denmark) 1:40.

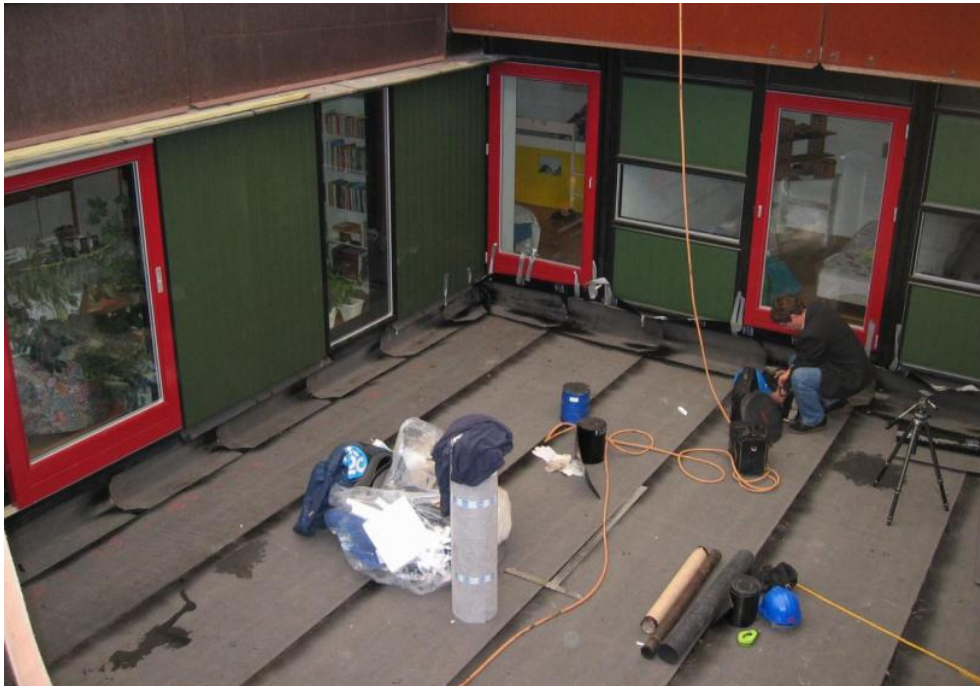
Figure 9: The membrane is installed in a roof terrace after replacing the two facades to create higher up stands.

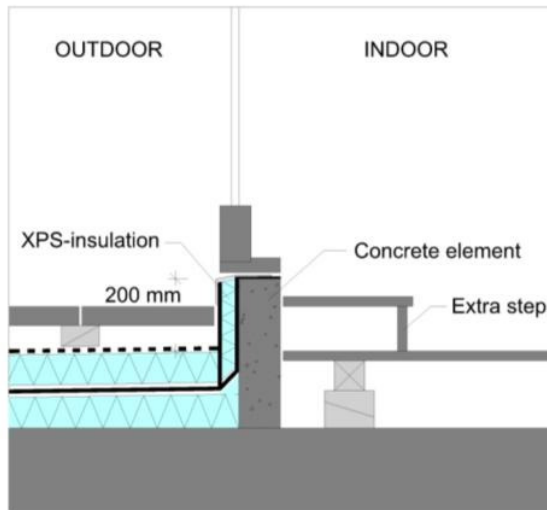
Figure 10: The new 200-mm higher up stands. The up stands are protected from mechanical damage by an external XPS insulation with a render facing.

The up stand design was improved by using concrete elements with external insulation instead of wood parts. The flashings thereby were protected from mechanical damage by extruded polystyrene (XPS) insulation with a mortar surface. As an extra safety precaution, gutters were cut in the front of the terrace so water could run out if the drainage system failed.

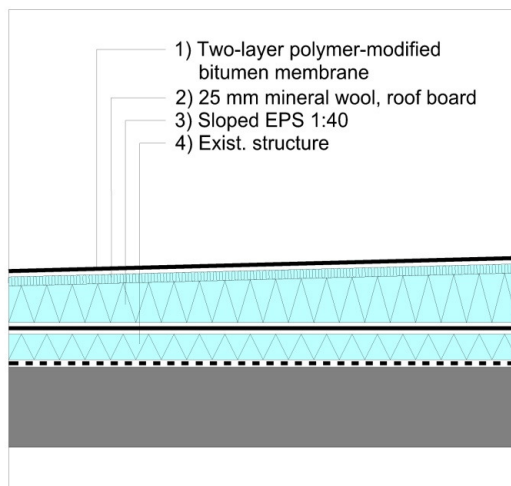
Figure 11: Warm roof system instead of vegetative or ballasted roof systems. The original roof membrane is maintained, the insulation and slope are improved, and the new roof membrane is fully visible.

The slope was increased to 1:40 (25 mm/1 meter) using a tapered insulation corresponding to the standard for warm roof systems.

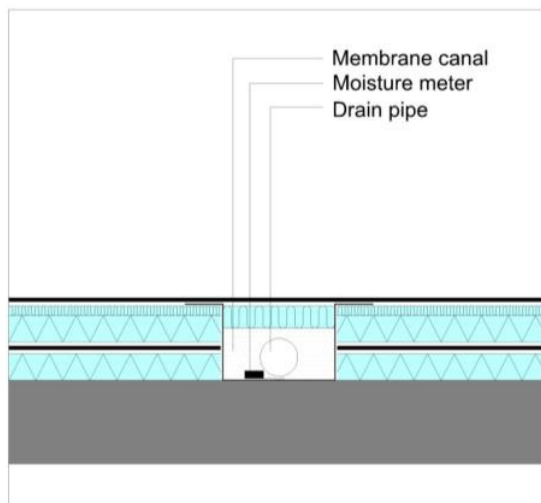
Figure 12: Drainage pipe built into the insulation in a special canal made from the roof membrane

The distance between the outlets of the original roof systems were up to 20 meters apart, and new outlets had to be installed to avoid insulation that was too thick. It was not possible to install a new drainage system in the building, so drainage pipes were installed in the insulation to connect the new outlets to the old drainage system. A siphon system was used to make horizontal pipes possible.

This system often is used but is not considered to have the same safety as normal systems with visible pipes. Therefore, the pipes were installed in a special canal of polymer-modified bitumen roofing materials. The canal is equipped with moisture sensors, allowing it to be checked for water from leaks in the pipes. There are more than 350 moisture sensors installed, and each of them is checked once per year. After the first seven years, it has proved to be working because only five small leaks have been discovered.

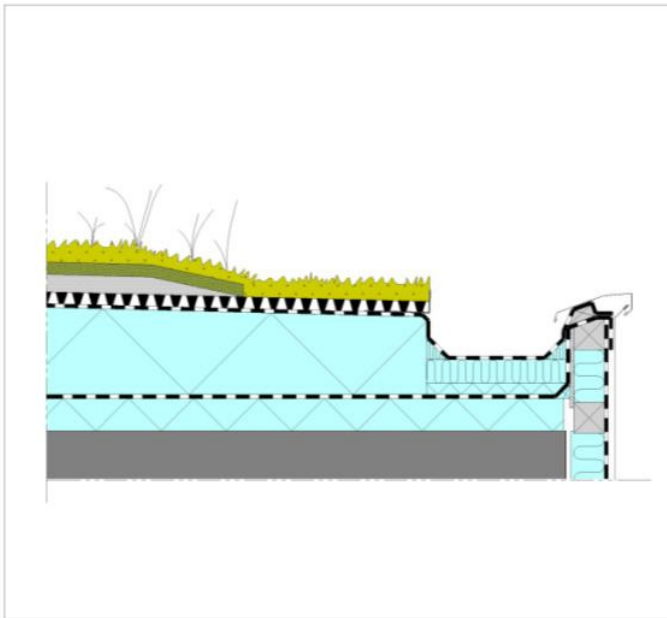
Figure 13: A vegetative roof system designed with sedum in the outer part and grass in the inner part. The gutter is kept free of vegetation.

To keep the vegetative part away from the flashings and gutters, a roof system with a combination of three roof types was used as shown in Figure 13.
