Electric field mapping inside metallized film capacitors

61st Reliability and Maintainability Symposium (RAMS), 26-29 Jan. 2015, Palm Harbor

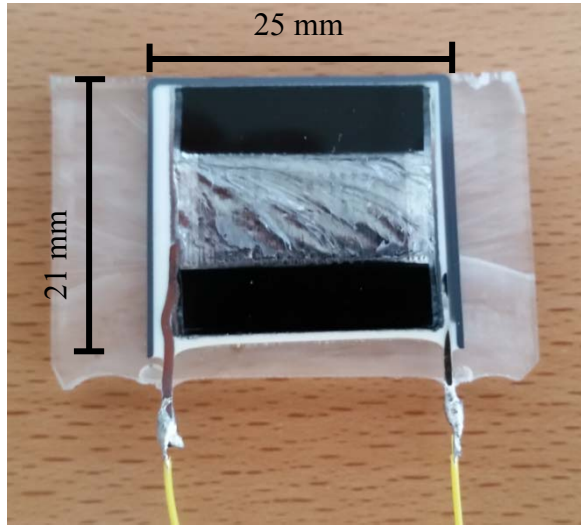
Figure 1: Micro-sectioned film capacitor prepared for KPFM analysis. The yellow wires are soldered onto the connectors.

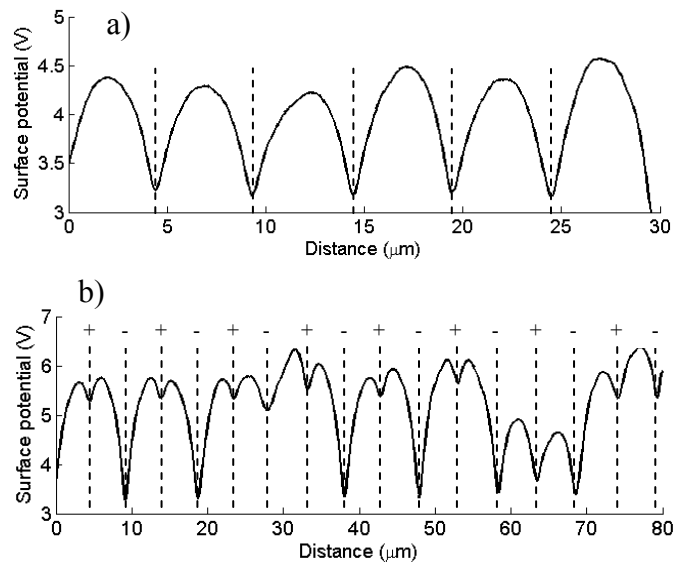
Measurements were also performed on the degraded capacitors and the results are shown in figure 4. The measurements on the grounded capacitor in figure 4a demonstrate a similarly periodic structure as on the reference capacitor, but with a periodicity of $5\ \mu\text{m}$ corresponding to the dielectric layer thickness in this capacitor.

Figure 4: Cross-section profiles of the surface potential distributions a) on the grounded degraded capacitor and b) on the same capacitor with 5V applied across it. The dashed lines indicate the position of the metallization.

It is seen that the magnitude of the CPD at the metallization sites has increased significantly, from -0.6V on the reference capacitor to $+3.2\text{V}$. This is a clear indication that there has been a change in material, and according to table 1 it

is caused by corrosion of the metallization layers.

The measurement on the biased capacitor, displayed in figure 4b, shows a similar magnitude level of the CPD at the grounded metallization layers. One can also see that most of the metallization layers have contact to the end-spray. However, the metallization layers at $30\ \mu\text{m}$, $65\ \mu\text{m}$, and at $80\ \mu\text{m}$ have lost contact to the end spray, because the measured CPD at these layers are unaffected by the applied potential or ground at the end-spray, which they should be connected to. The metallization layer at $65\ \mu\text{m}$ should be connected to the end-spray with 5V applied, but the measured CPD matches that of the grounded metallization. On the other hand, the CPD measured on the metallization layers at $30\ \mu\text{m}$ and $80\ \mu\text{m}$ corresponds to those measured on the layers with 5V applied, even though they are connected to ground.

The result in figure 4b shows that three out of 16 metallization layers were disconnected from the end-spray. This measurement was performed close to the center of the component. According to Reed et. al. [8] the outer layers are more vulnerable with respect to degradation caused by high humidity. Therefore, measurements similar to those shown in figure 4 were performed roughly $3\ \text{mm}$ closer to the edge. The results are shown in figure 5.

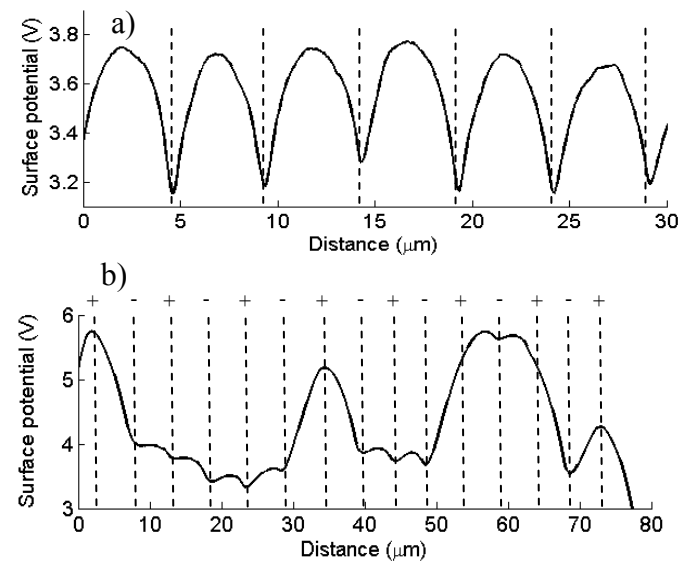
Figure 5: Cross-section profiles of the surface potential distributions measured closer to the edge of the capacitor a) on the grounded degraded capacitor and b) on the same capacitor with 5V applied across it. The dashed lines indicate the expected position of the metallization.

The measurement on the grounded capacitor in figure 5a shows a similar pattern as the one shown in figure 4a. The only difference is that the surface potential variations are smaller. The measurement on the biased capacitor (shown in figure 5b), however, is significantly different from the one shown in figure 4b. It appears that only four out of eight metallization layers preserve contact to the end-spray with the 5V applied. Moreover, at least the metallization layer at $60\ \mu\text{m}$ is not connected to the grounded end-spray as it was supposed to. It could, however, also be caused by missing metallization

layers at 55 μm and 65 μm if compared to figure 4b. At this point it can not be concluded if the rest of the metallization layers are still connected to the ground. It is, however, observed that the surface potential variations at 10-30 μm and 40-50 μm are quite small (around 0.2V), which also could indicate poor connection or lack of connection to the end spray.

Based on the results presented in figures 4 and 5 two conclusions on the failure analysis can be drawn. The metallization layers were corroded and some had lost contact to the end-spray as a result of the accelerated testing. The corrosion level was independent of measurement position on the capacitor, whereas the number of metallization layers without contact to the end-spray increased in the outer layers compared to the layers near the center of the capacitor.
