## **Electric field mapping inside metallized film capacitors**

Nielsen, Dennis Achton; Popok, Vladimir; Pedersen, Kjeld

61st Reliability and Maintainability Symposium (RAMS), 26-29 Jan. 2015, Palm Harbor

# Electric field mapping inside metallized film capacitors

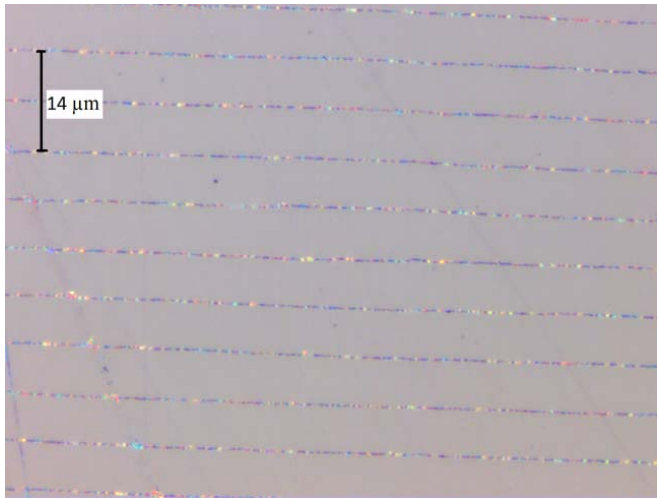
Figure 2: Optical microscope image at 1000X magnification of the micro-sectioned reference capacitor.

The surface roughness was further examined by AFM. From the measurements it was determined that the sample shown in figure 2 had an RMS surface roughness in the range of 20-30 nm, which also demonstrates the quality level of the grinding procedure.

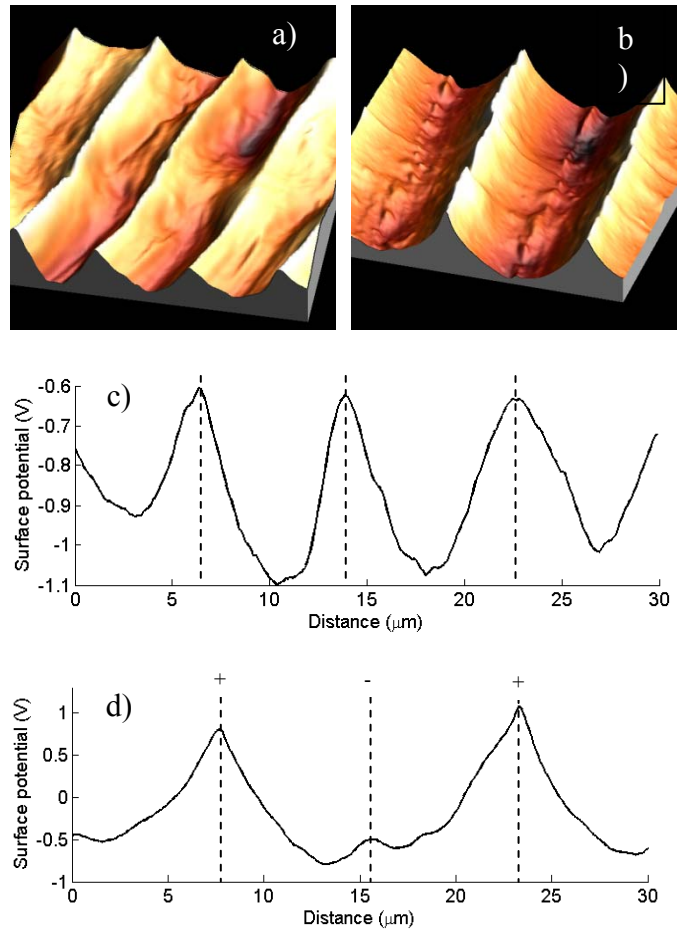
surface potential distribution. The results from the measurements without applied voltage and with 5V DC are shown in figure 3. The measured surface potential distribution on the capacitor with no applied voltage reveals a periodic surface potential profile despite the fact that no electric field should be present in the capacitor structure. This effect is associated with KPFM measurements on metal/dielectric heterostructures and arises due to polarization of the dielectric caused by the electric potential applied to the cantilever. The length of the period is around 7  $\mu\text{m}$ , corresponding to the dielectric film thickness as shown in figure 2. The measured surface potential on the biased capacitor also reveals a periodic surface potential distribution. As expected, the period length is 14  $\mu\text{m}$ , since every second metallization layer had 5V applied and those in between were grounded.

Figure 3: Results from the KPFM measurements on the unstressed film capacitor. a) Surface potential distribution of the capacitor, while grounded and b) while biased. c)-d) Cross-section profiles obtained from the surface potential measurements presented in panels a) and b), respectively. The dashed lines indicate the position of the metallization. The plus and minus signs indicate whether the metallization layers are connected to the biased or grounded end-spray, respectively.

The surface potential on the metallization sites, corresponding to the CPD between the cantilever and metallization, was measured on the grounded and biased capacitor to be  $-0.61\text{V}$  and  $-0.50\text{V}$ , respectively. This means that the metallization is not corroded on the reference capacitor. The magnitude of the CPD does not correspond to the expected CPD, which would be around  $-1\text{V}$ , according to table 1. This could also be explained by the point spread function of the cantilever, but also the fact that the work function varies with crystallinity and crystal direction in the surface [19]. It is also affected by the presence of a thin water adsorbate layer on the surface and possible contaminations from the surrounding environment, since the measurements were carried out in ambient air.

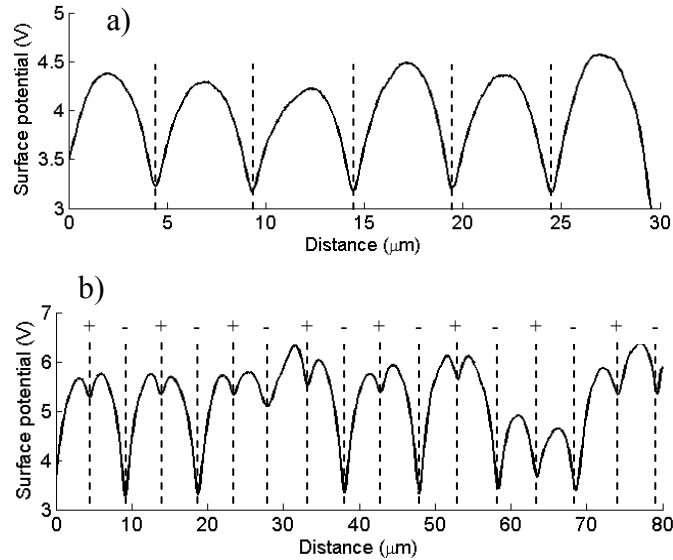
Measurements were also performed on the degraded capacitors and the results are shown in figure 4. The measurements on the grounded capacitor in figure 4a demonstrate a similarly periodic structure as on the reference capacitor, but with a periodicity of  $5\ \mu\text{m}$  corresponding to the dielectric layer thickness in this capacitor.

Figure 4: Cross-section profiles of the surface potential distributions a) on the grounded degraded capacitor and b) on the same capacitor with  $5\text{V}$  applied across it. The dashed lines indicate the position of the metallization.

It is seen that the magnitude of the CPD at the metallization sites has increased significantly, from  $-0.6\text{V}$  on the reference capacitor to  $+3.2\text{V}$ . This is a clear indication that there has been a change in material, and according to table 1 it

is caused by corrosion of the metallization layers.

The measurement on the biased capacitor, displayed in figure 4b, shows a similar magnitude level of the CPD at the grounded metallization layers. One can also see that most of the metallization layers have contact to the end-spray. However, the metallization layers at  $30\ \mu\text{m}$ ,  $65\ \mu\text{m}$ , and at  $80\ \mu\text{m}$  have lost contact to the end spray, because the measured CPD at these layers are unaffected by the applied potential or ground at the end-spray, which they should be connected to. The metallization layer at  $65\ \mu\text{m}$  should be connected to the end-spray with  $5\text{V}$  applied, but the measured CPD matches that of the grounded metallization. On the other hand, the CPD measured on the metallization layers at  $30\ \mu\text{m}$  and  $80\ \mu\text{m}$  corresponds to those measured on the layers with  $5\text{V}$  applied, even though they are connected to ground.

The result in figure 4b shows that three out of 16 metallization layers were disconnected from the end-spray. This measurement was performed close to the center of the component. According to Reed et. al. [8] the outer layers are more vulnerable with respect to degradation caused by high humidity. Therefore, measurements similar to those shown in figure 4 were performed roughly  $3\ \text{mm}$  closer to the edge. The results are shown in figure 5.

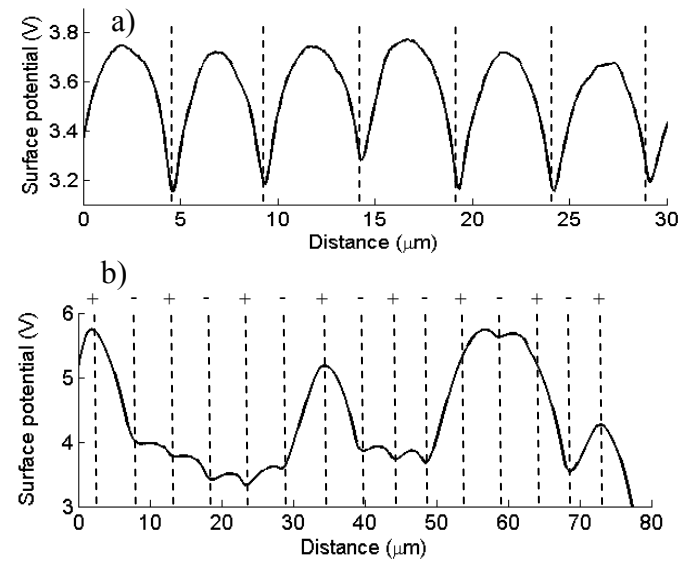
Figure 5: Cross-section profiles of the surface potential distributions measured closer to the edge of the capacitor a) on the grounded degraded capacitor and b) on the same capacitor with  $5\text{V}$  applied across it. The dashed lines indicate the expected position of the metallization.

The measurement on the grounded capacitor in figure 5a shows a similar pattern as the one shown in figure 4a. The only difference is that the surface potential variations are smaller. The measurement on the biased capacitor (shown in figure 5b), however, is significantly different from the one shown in figure 4b. It appears that only four out of eight metallization layers preserve contact to the end-spray with the  $5\text{V}$  applied. Moreover, at least the metallization layer at  $60\ \mu\text{m}$  is not connected to the grounded end-spray as it was supposed to. It could, however, also be caused by missing metallization

layers at 55  $\mu\text{m}$  and 65  $\mu\text{m}$  if compared to figure 4b. At this point it can not be concluded if the rest of the metallization layers are still connected to the ground. It is, however, observed that the surface potential variations at 10-30  $\mu\text{m}$  and 40-50  $\mu\text{m}$  are quite small (around 0.2V), which also could indicate poor connection or lack of connection to the end spray.

Based on the results presented in figures 4 and 5 two conclusions on the failure analysis can be drawn. The metallization layers were corroded and some had lost contact to the end-spray as a result of the accelerated testing. The corrosion level was independent of measurement position on the capacitor, whereas the number of metallization layers without contact to the end-spray increased in the outer layers compared to the layers near the center of the capacitor.
