## Electric field mapping inside metallized film capacitors

61st Reliability and Maintainability Symposium (RAMS), 26-29 Jan. 2015, Palm Harbor

# Electric field mapping inside metallized film capacitors

Key Words: failure mode and effect analysis, film capacitors, micro-sectioning, Kelvin probe force microscopy

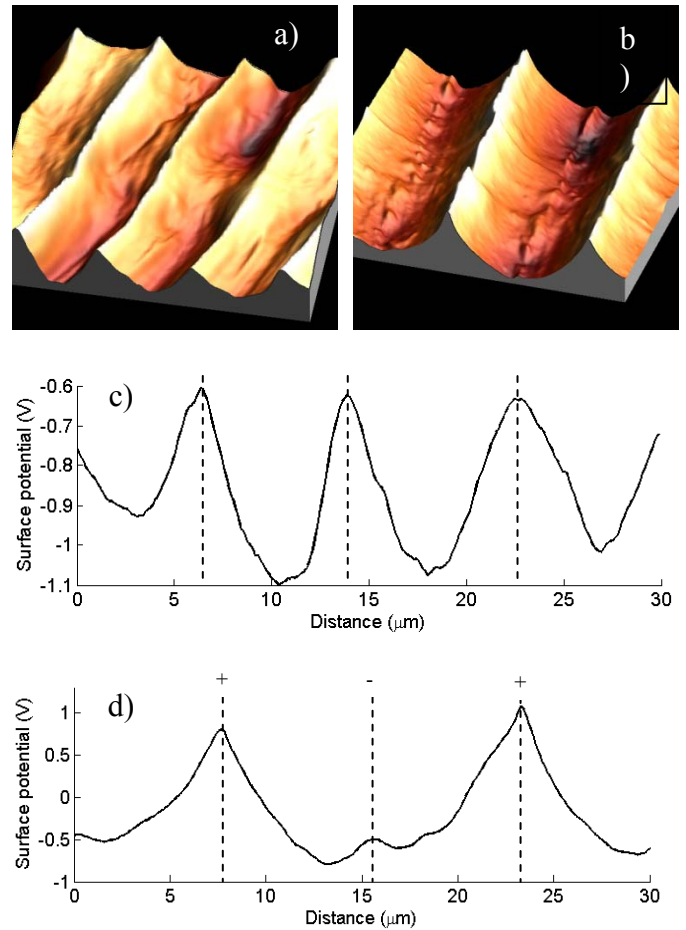
surface potential distribution. The results from the measurements without applied voltage and with 5V DC are shown in figure 3. The measured surface potential distribution on the capacitor with no applied voltage reveals a periodic surface potential profile despite the fact that no electric field should be present in the capacitor structure. This effect is associated with KPFM measurements on metal/dielectric heterostructures and arises due to polarization of the dielectric caused by the electric potential applied to the cantilever. The length of the period is around 7  $\mu\text{m}$ , corresponding to the dielectric film thickness as shown in figure 2. The measured surface potential on the biased capacitor also reveals a periodic surface potential distribution. As expected, the period length is 14  $\mu\text{m}$ , since every second metallization layer had 5V applied and those in between were grounded.

Figure 3: Results from the KPFM measurements on the unstressed film capacitor. a) Surface potential distribution of the capacitor, while grounded and b) while biased. c)-d) Cross-section profiles obtained from the surface potential measurements presented in panels a) and b), respectively. The dashed lines indicate the position of the metallization. The plus and minus signs indicate whether the metallization layers are connected to the biased or grounded end-spray, respectively.

The measured potential difference between alternating metallization layers does, however, not correspond to the 5V that was applied across the capacitor. There are multiple

The surface potential on the metallization sites, corresponding to the CPD between the cantilever and metallization, was measured on the grounded and biased capacitor to be  $-0.61\text{V}$  and  $-0.50\text{V}$ , respectively. This means that the metallization is not corroded on the reference capacitor. The magnitude of the CPD does not correspond to the expected CPD, which would be around  $-1\text{V}$ , according to table 1. This could also be explained by the point spread function of the cantilever, but also the fact that the work function varies with crystallinity and crystal direction in the surface [19]. It is also affected by the presence of a thin water adsorbate layer on the surface and possible contaminations from the surrounding environment, since the measurements were carried out in ambient air.

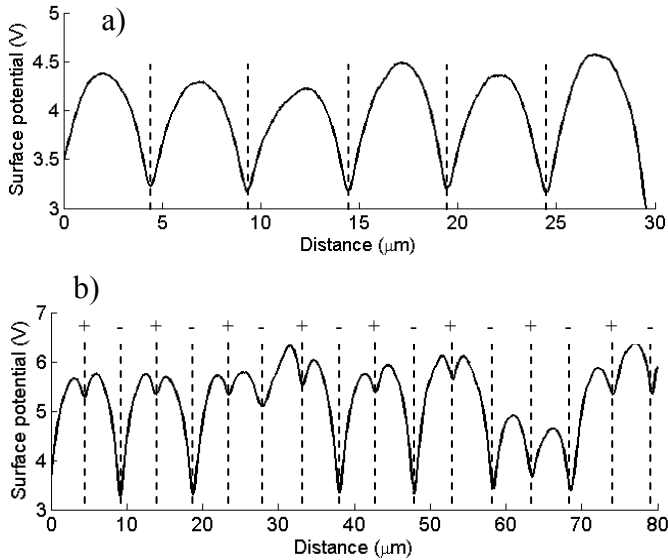
Measurements were also performed on the degraded capacitors and the results are shown in figure 4. The measurements on the grounded capacitor in figure 4a demonstrate a similarly periodic structure as on the reference capacitor, but with a periodicity of  $5\text{ }\mu\text{m}$  corresponding to the dielectric layer thickness in this capacitor.

Figure 4: Cross-section profiles of the surface potential distributions a) on the grounded degraded capacitor and b) on the same capacitor with 5V applied across it. The dashed lines indicate the position of the metallization.

It is seen that the magnitude of the CPD at the metallization sites has increased significantly, from  $-0.6\text{V}$  on the reference capacitor to  $+3.2\text{V}$ . This is a clear indication that there has been a change in material, and according to table 1 it

is caused by corrosion of the metallization layers.

The measurement on the biased capacitor, displayed in figure 4b, shows a similar magnitude level of the CPD at the grounded metallization layers. One can also see that most of the metallization layers have contact to the end-spray. However, the metallization layers at  $30\text{ }\mu\text{m}$ ,  $65\text{ }\mu\text{m}$ , and at  $80\text{ }\mu\text{m}$  have lost contact to the end spray, because the measured CPD at these layers are unaffected by the applied potential or ground at the end-spray, which they should be connected to. The metallization layer at  $65\text{ }\mu\text{m}$  should be connected to the end-spray with 5V applied, but the measured CPD matches that of the grounded metallization. On the other hand, the CPD measured on the metallization layers at  $30\text{ }\mu\text{m}$  and  $80\text{ }\mu\text{m}$  corresponds to those measured on the layers with 5V applied, even though they are connected to ground.

The result in figure 4b shows that three out of 16 metallization layers were disconnected from the end-spray. This measurement was performed close to the center of the component. According to Reed et. al. [8] the outer layers are more vulnerable with respect to degradation caused by high humidity. Therefore, measurements similar to those shown in figure 4 were performed roughly 3 mm closer to the edge. The results are shown in figure 5.

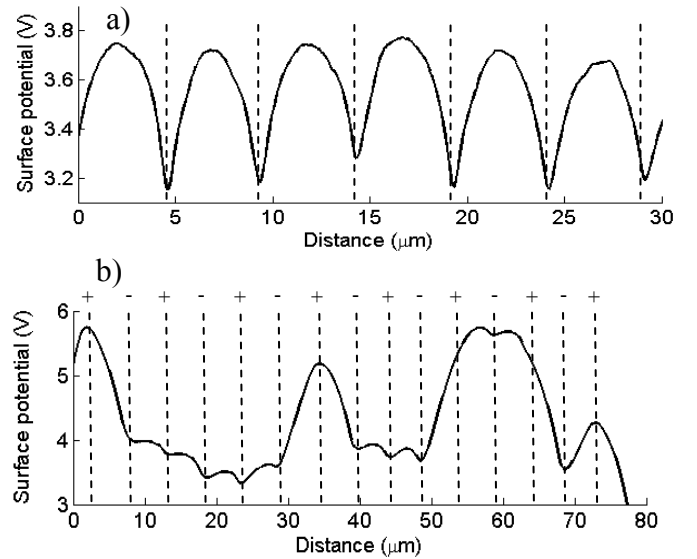
Figure 5: Cross-section profiles of the surface potential distributions measured closer to the edge of the capacitor a) on the grounded degraded capacitor and b) on the same capacitor with 5V applied across it. The dashed lines indicate the expected position of the metallization.

The measurement on the grounded capacitor in figure 5a shows a similar pattern as the one shown in figure 4a. The only difference is that the surface potential variations are smaller. The measurement on the biased capacitor (shown in figure 5b), however, is significantly different from the one shown in figure 4b. It appears that only four out of eight metallization layers preserve contact to the end-spray with the 5V applied. Moreover, at least the metallization layer at  $60\text{ }\mu\text{m}$  is not connected to the grounded end-spray as it was supposed to. It could, however, also be caused by missing metallization

layers at 55  $\mu\text{m}$  and 65  $\mu\text{m}$  if compared to figure 4b. At this point it can not be concluded if the rest of the metallization layers are still connected to the ground. It is, however, observed that the surface potential variations at 10-30  $\mu\text{m}$  and 40-50  $\mu\text{m}$  are quite small (around 0.2V), which also could indicate poor connection or lack of connection to the end spray.

Based on the results presented in figures 4 and 5 two conclusions on the failure analysis can be drawn. The metallization layers were corroded and some had lost contact to the end-spray as a result of the accelerated testing. The corrosion level was independent of measurement position on the capacitor, whereas the number of metallization layers without contact to the end-spray increased in the outer layers compared to the layers near the center of the capacitor.
