## **Distance protection in 150/60 kV transformer 60 kV feeders**

*two real blackout case studies*

# Distance protection in 150/60 kV transformer 60 kV feeders: two real blackout case studies

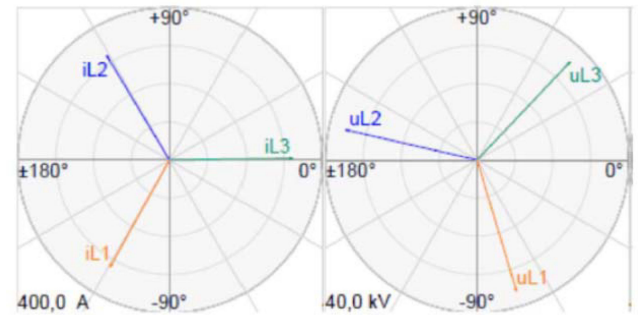
**Fig. 4** KT31 currents (left) and voltages (right) at the instant of trip

Using SIGRA fault record current in L3 at instant of trip was  $I_{L3trip} = 321.6 \text{ A} \angle 1^\circ$  and phase voltage in L3  $U_{L3trip} = 35.54 \text{ kV} \angle 46^\circ$ , see Fig. 4. These are not at all faulty condition values, i.e. current is around one-third of the rated current for the transformer and the voltage is a normal phase voltage. Therefore the first indication is that this is not a faulty condition, but a wrong relay zone setting which has led to the relay tripping for normal load impedance.

This gives rise to measured primary impedance equal to

$$Z_{\text{fault, prim}} = \frac{35,541 \angle 46^\circ}{321.6 \angle 1^\circ} = 110.5 \angle 45^\circ \Omega \quad (3)$$

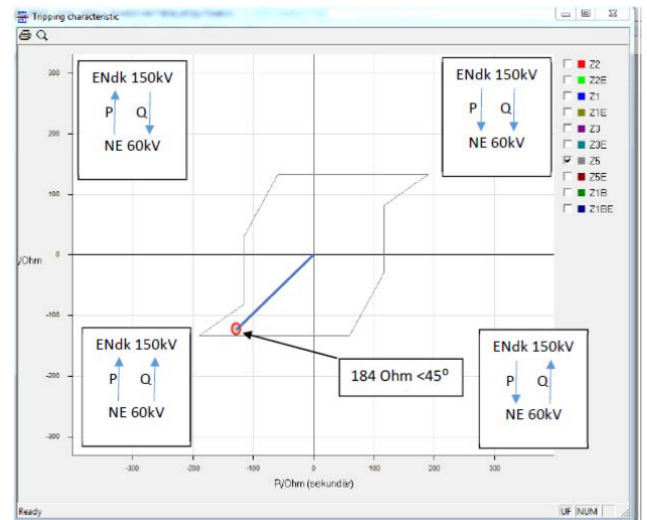
Plotting of the measured impedance in the zone setting graph from DIGSI revealed the cause of the trip, see Fig. 5

As can be seen the intended normal three-phase load (in this case power flow to transmission level due to wind power production in the area) has entered non-directional zone 5 and led to trip. This is caused by a wrong assumption when operating transformers in parallel using the doubled reach (see Section 2.2) to compensate for the underreach caused by the parallel operation. This assumption is actually wrong in two ways as the doubling of the reach should be exactly the opposite, i.e. in half to accommodate the trip of one transformer to be taken over by the second for a shorter period, i.e. the doubling of the load and thereby the half of the load impedance.

Fig. 5 R-X graph shows the measured impedance in secondary values to just enter zone 5 in reverse direction. NE means NordEnergi (distribution 60 kV) and ENdk is TSO (150 kV). The arrows indicate power direction

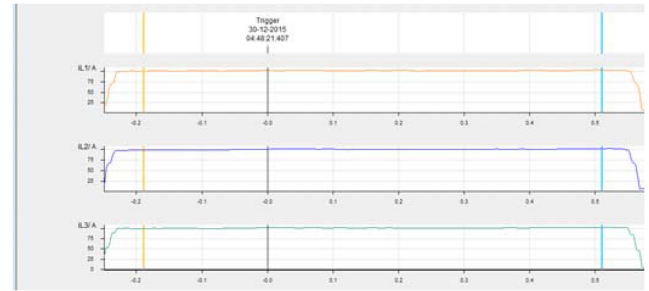
So the transition to backup OC depends from the absence of VT voltage. Address 2913 was set rather low and it is likely that induced noise in the disconnected and non-grounded VT signal cables have led to a voltage at relay voltage terminals not always being below this set value. Furthermore address 1202 (for distance function enabled) was set to 100 A. At the time of the trip the load current was precisely exceeding this value, see Fig. 11.

So by sheer coincidence measured VT voltage fluctuated (due to noise) to a value higher than threshold (2913) disabling backup OC and load current exceeded 100 A (1202) enabling distance leading to a measured impedance virtually zero due to the missing voltage. This caused zone 1 trip with the correct time delay 0.5 s

Fig. 11 Load current around instant of trip for KT31

- Fuse failure measurement supervision must be carefully set and tested to avoid wrong operation due to induced noise voltages. It must not be too sensitive.
