Failure analysis of a degraded 1.2 kV SiC MOSFET after short circuit at high temperature

Proceedings of the IPFA 2018 - 25th International Symposium on the Physical and Failure Analysis of Integrated Circuits

Failure Analysis of a Degraded 1.2 kV SiC MOSFET after Short Circuit at High Temperature

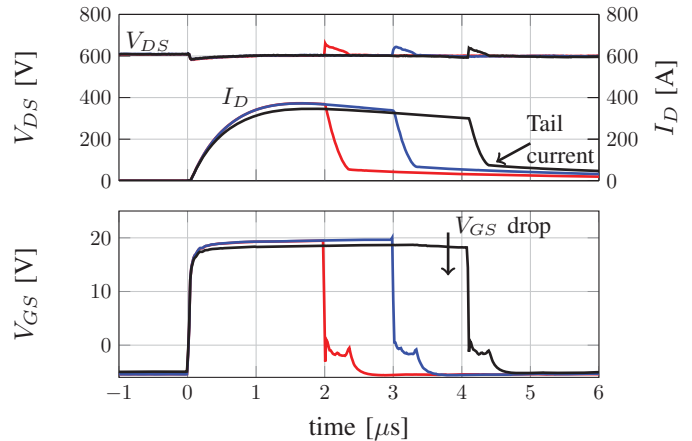
The waveforms of a typical short circuit test can be observed in Fig. 2, where the drain voltage, drain current and gate voltage are shown. The tests have been performed under a high temperature of $T_j = 150^\circ\text{C}$ and bias voltage of 600 V. The drain voltage exhibits negative and positive peaks related to the current variation through the circuit stray inductance. The drain current peak is 380 A and then decreases according to the junction temperature increase, which is a well-known phenomenon related to the positive thermal coefficient of MOSFETs. Furthermore, it is worth to note that two abnormal phenomena take place, which can be recognized as two different failure indicators: (1) the occurrence of a large tail current at turn-off, which is not typical of unipolar devices and it does not occur under normal conditions, and (2) the significant reduction of the on-state gate-source voltage V_{GS} , indicating that a large leakage current is flowing through the gate. The latter failure indicator is only observed when the device is tested with a short-circuit pulse duration of 4 μs . After the last test, the SiC MOSFET shows a permanent damage because the device cannot recover its initial state, but the device is still functional. From these results, one can give a

Fig. 2. Short-circuit tests with increasing time of a 1.2-kV/90-A SiC MOSFET: $V_{DC} = 600 \text{ V}$ $T_j = 150^\circ\text{C}$.

first conclusion that a conductive path between the gate and the source has been formed. The assumption that a new resistive path has been originated will be validated through the physical inspection of the device in the following section.

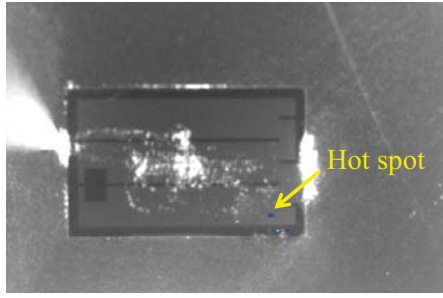
In this section, the electrical behaviour will be correlated with the physical failure analysis of the 1.2-kV/ 90-A SiC MOSFET. To do so, a thermal analysis followed by a Focused Ion Beam (FIB) cut have been performed on the degraded SiC MOSFET in order to find possible damages on the gate oxide. First, the package material has been removed by high-temperature etching, and then, an Indium Gallium Arsenide (InGaAs) infra-red camera has been used to find possible hot spots. The principle is to apply a voltage on the drain terminal, for example up to 150 V, and connect the gate and the source terminals to ground. If the SiC MOSFET has a defect, a leakage current will appear from drain to source or drain to gate, which it can be detected with a very sensitive infrared camera. The infra-red camera can penetrate to the device with a certain depth, so it is possible to observe the chip surface and the structure underneath. The results can be observed in Fig. 3, where two hot spots can be identified. The hot-spot analysed in this paper is the one localized in the active region, which is highlighted in in Fig 3.

Fig. 3. InGaAs infra-red image of the degraded SiC MOSFET.

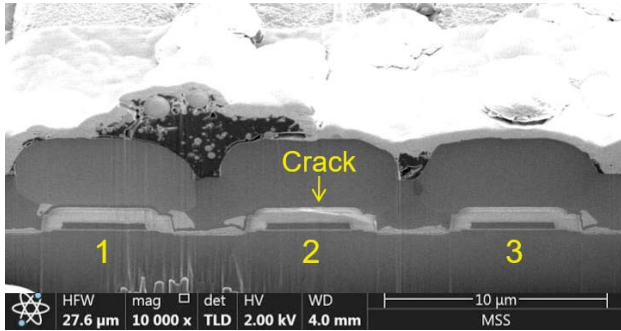
A Focused Ion Beam (FIB) at the hot spot location is used to obtain the vertical cross-section of the SiC MOSFET structure, whose image is revealed in Fig. 4. The image shows the physical structure corresponding to three cells, where one of the cells appears to be cracked on the field-oxide region. This cell in particular is further magnified in Fig. 5, where the crack between the poly-silicon gate and the aluminum source is clearly observed. On the other hand, the thin gate-oxide layer appears to be intact, concluding that the field oxide is the weakest part when the device is stressed under short circuit. These results are in agreement with the literature, since cracks

Fig. 4. Focused Ion Beam (FIB) cross-section of three cells at the hot spot location, where one of the cells presents a crack.

have also been observed in the field oxide region in [15]. A more in-depth analysis has been performed on adjacent cells, showing that not only one cell but several ones have cracks on the field oxide region.

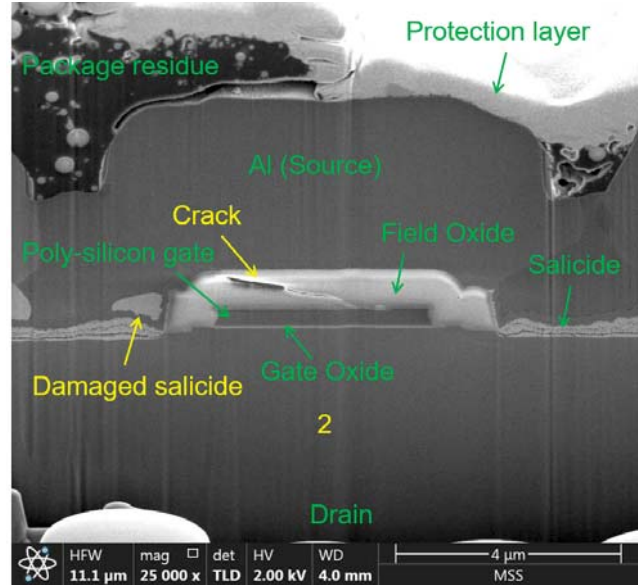
Furthermore, the salicide which is the technology that is used to form the electrical contact between the semiconductor substrate and the source terminal appears severely degraded, as pointed out in Fig. 5. This region is further magnified in Fig. 6, where it can be observed that solid particles accumulate in the aluminium source region between the salicide and the gate oxide. So far, the origin of these particles is not clear and it is not possible to provide the relevant information about the failure mechanism due to the short circuit stress. To better understand whether these particles may come from a process defect or could have originated after the applied short circuit stress, a cross-section of a new 1.2-kV/90-A SiC MOSFET will be presented in the next section.

Fig. 5. Magnified Focused Ion Beam (FIB) cross-section of the damaged cell.

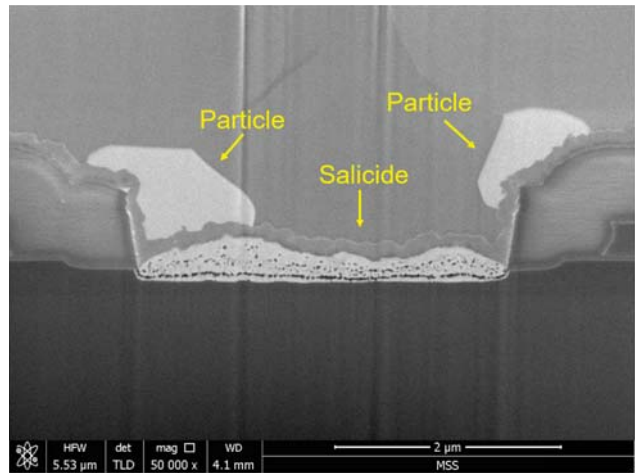
Fig. 6. Magnified Focused Ion Beam (FIB) of the salicide region of the degraded SiC MOSFET.

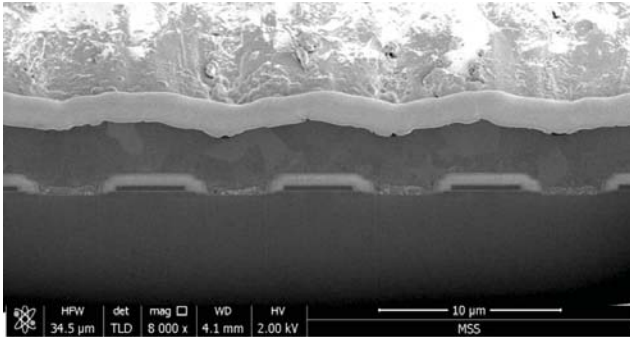
The results can be observed in Fig. 7, where the vertical structure of three cells is presented. It is interesting to compare Figs. 4 and 7, showing that a number of differences can be observed between the new and the degraded device. First, the cracks found in the degraded device between the poly-silicon gate and the aluminium source are not detected in the new device, as it is observed in Fig. 8. Second, the particles seen in the degraded SiC MOSFET near the salicide are not visible for the new device. This indicates that they could have originated as a consequence of the short-circuit stress and not from defects originating from the device process. A more detailed inspection of this region can be observed in Fig. 9. It can be confirmed that the particles cannot be observed and it is also worth to note that the granular structure is significantly altered when compared with the new device. Finally, the shape of the interface between the upper Aluminium layer and

Fig. 7. Focused Ion Beam (FIB) vertical cross-section of a new SiC MOSFET showing three cells.

the passivation layer shows a significant degradation between the non-degraded cell and the degraded one, since this layer appears to be deformed. From these results, it can be inferred that the temperature reached during short circuit provokes the deformation of the cells that could lead to the formation of cracks in the upper oxide region. These deformations

may stress the gate structure and induce the observed cracks between the poly-silicon gate and the aluminium source, which forms a resistive path and as a consequence a gate leakage current appears causing the catastrophic failure of the device.
