Failure analysis of a degraded 1.2 kV SiC MOSFET after short circuit at high temperature

Proceedings of the IPFA 2018 - 25th International Symposium on the Physical and Failure Analysis of Integrated Circuits

Failure Analysis of a Degraded 1.2 kV SiC MOSFET after Short Circuit at High Temperature

Paula Diaz Reigosa, Francesco Iannuzzo, Lorenzo Ceccarelli

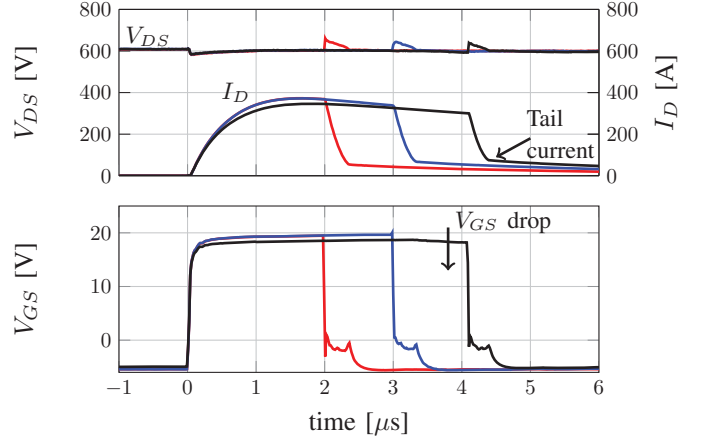
The waveforms of a typical short circuit test can be observed in Fig. 2, where the drain voltage, drain current and gate voltage are shown. The tests have been performed under a high temperature of T_j = 150°C and bias voltage of 600 V. The drain voltage exhibits negative and positive peaks related to the current variation through the circuit stray inductance. The drain current peak is 380 A and then decreases according to the junction temperature increase, which is a well-known phenomenon related to the positive thermal coefficient of MOSFETs. Furthermore, it is worth to note that two abnormal phenomena take place, which can be recognized as two different failure indicators: (1) the occurrence of a large tail current at turn-off, which is not typical of unipolar devices and it does not occur under normal conditions, and (2) the significant reduction of the on-state gate-source voltage V_{GS} , indicating that a large leakage current is flowing through the gate. The latter failure indicator is only observed when the device is tested with a short-circuit pulse duration of 4 μ s. After the last test, the SiC MOSFET shows a permanent damage because the device cannot recover its initial state, but the device is still functional. From these results, one can give a

Fig. 2. Short-circuit tests with increasing time of a 1.2-kV/90-A SiC MOSFET: V_{DC} = 600 V T_j = 150°C.

first conclusion that a conductive path between the gate and the source has been formed. The assumption that a new resistive path has been originated will be validated through the physical inspection of the device in the following section.

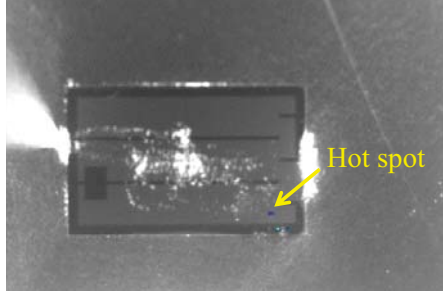
In this section, the electrical behaviour will be correlated with the physical failure analysis of the 1.2-kV/ 90-A SiC MOSFET. To do so, a thermal analysis followed by a Focused Ion Beam (FIB) cut have been performed on the degraded SiC MOSFET in order to find possible damages on the gate oxide. First, the package material has been removed by high-temperature etching, and then, an Indium Gallium Arsenide (InGaAs) infra-red camera has been used to find possible hot spots. The principle is to apply a voltage on the drain terminal, for example up to 150 V, and connect the gate and the source terminals to ground. If the SiC MOSFET has a defect, a leakage current will appear from drain to source or drain to gate, which it can be detected with a very sensitive infrared camera. The infra-red camera can penetrate to the device with a certain depth, so it is possible to observe the chip surface and the structure underneath. The results can be observed in Fig. 3, where two hot spots can be identified. The hot-spot analysed in this paper is the one localized in the active region, which is highlighted in in Fig 3.

Fig. 3. InGaAs infra-red image of the degraded SiC MOSFET.

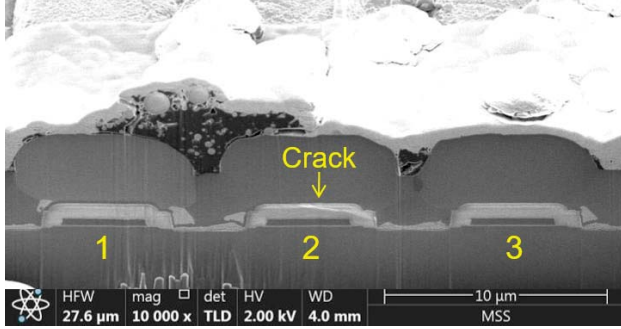
A Focused Ion Beam (FIB) at the hot spot location is used to obtain the vertical cross-section of the SiC MOSFET structure, whose image is revealed in Fig. 4. The image shows the physical structure corresponding to three cells, where one of the cells appears to be cracked on the field-oxide region. This cell in particular is further magnified in Fig. 5, where the crack between the poly-silicon gate and the aluminum source is clearly observed. On the other hand, the thin gate-oxide layer appears to be intact, concluding that the field oxide is the weakest part when the device is stressed under short circuit. These results are in agreement with the literature, since cracks

Fig. 4. Focused Ion Beam (FIB) cross-section of three cells at the hot spot location, where one of the cells presents a crack.

have also been observed in the field oxide region in [15]. A more in-depth analysis has been performed on adjacent cells, showing that not only one cell but several ones have cracks on the field oxide region.

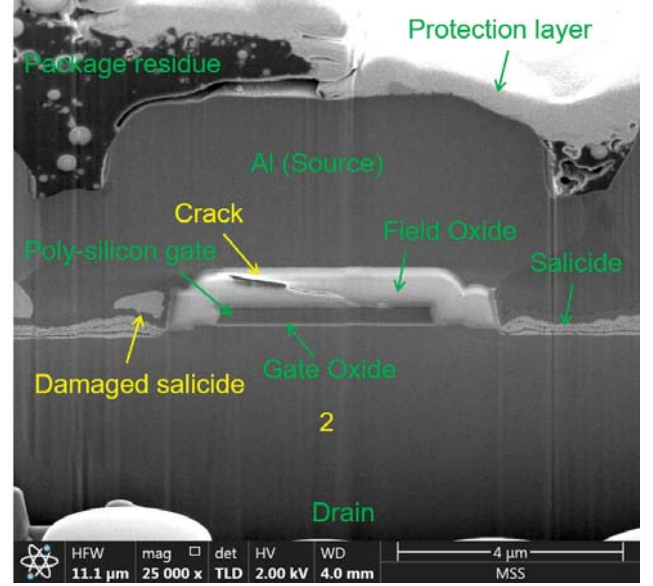
Furthermore, the salicide which is the technology that is used to form the electrical contact between the semiconductor substrate and the source terminal appears severely degraded, as pointed out in Fig. 5. This region is further magnified in Fig. 6, where it can be observed that solid particles accumulate in the aluminum source region between the salicide and the gate oxide. So far, the origin of these particles is not clear and it is not possible to provide the relevant information about the failure mechanism due to the short circuit stress. To better understand whether these particles may come from a process defect or could have originated after the applied short circuit stress, a cross-section of a new 1.2-kV/90-A SiC MOSFET will be presented in the next section.

Fig. 5. Magnified Focused Ion Beam (FIB) cross-section of the damaged cell.

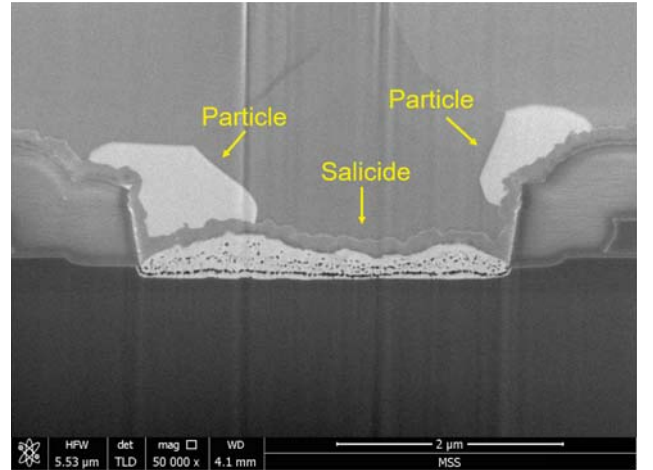
Fig. 6. Magnified Focused Ion Beam (FIB) of the salicide region of the degraded SiC MOSFET.

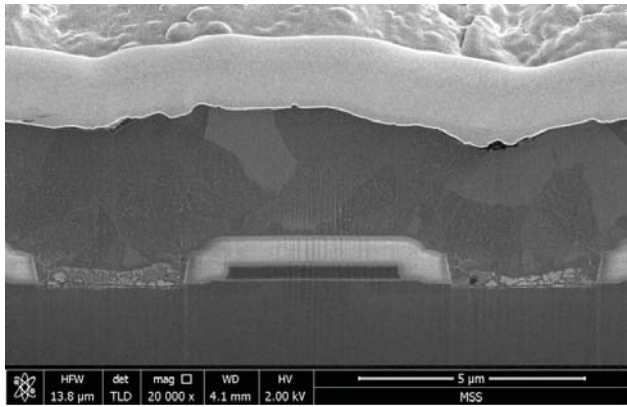
Fig. 8. Zoomed view of the FIB cross-section of a new SiC MOSFET.

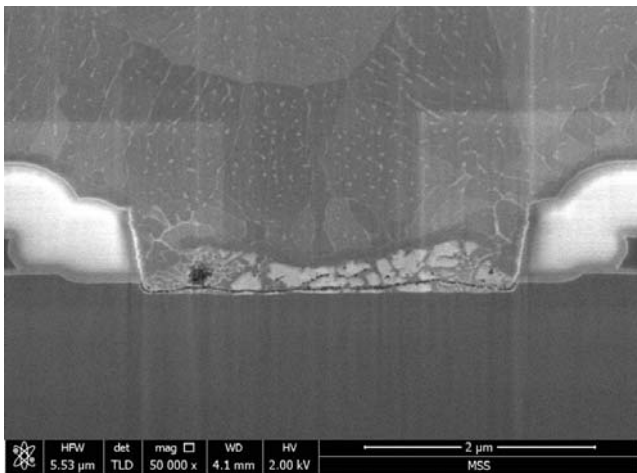
Fig. 9. Magnified Focused Ion Beam (FIB) of the salicide region of a new SiC MOSFET.
