## **Effect of short-circuit stress on the degradation of the SiO<sub>2</sub> dielectric in SiC power MOSFETs**

Reigosa, Paula Diaz; Iannuzzo, Francesco; Ceccarelli, Lorenzo

*Published in:*  
Microelectronics Reliability

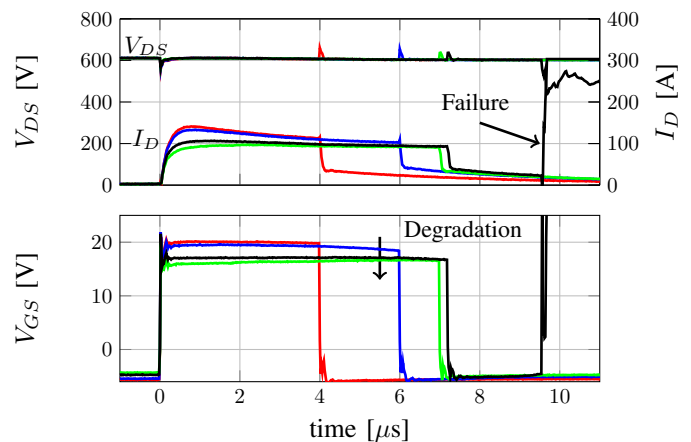
In SiC MOSFETs, the most common failure mechanism seems to be the gate-oxide breakdown, as the experimental results in Fig. 1 demonstrate so. Two degradation mechanisms are typically observed: (1) gate-voltage reduction at the end of the short circuit pulse, for example, the short circuit waveforms in Fig. 1 when the device is tested up to 6  $\mu$ s, and (2) permanent gate-voltage reduction, for example, the short

Fig. 1: Short-circuit tests with increasing time of a 1.2-kV/36-A SiC MOSFET:  $V_{DC} = 600$  V  $T_j = 150^\circ\text{C}$ .

circuit waveforms in Fig. 1 when the device is tested up to 7  $\mu$ s. Therefore, it is worth to note that the failure indicator is the on-state gate-source voltage reduction due to the increase in the gate leakage current, which eventually causes a permanent gate damage and ends up in a gate-oxide breakdown failure. This failure mode has been attributed to the high temperature and high electric field withstood across the thin gate oxide [7], [15], [16], combined with the much higher defect density of SiC MOSFET structures (i.e., substrate defects, particles and metallic contaminations). Recently, it has been discussed that robust short-circuit devices can be designed if the thickness of the oxide is increased or the cell pitch is increased, while on the other hand, the on-state resistance becomes compromised leading to greater power losses [17], [18]. Despite of this trade-off curve, cracks across the thin gate-oxide have not been reported in the literature, as discussed in [19], therefore this assumption needs to be further validated.

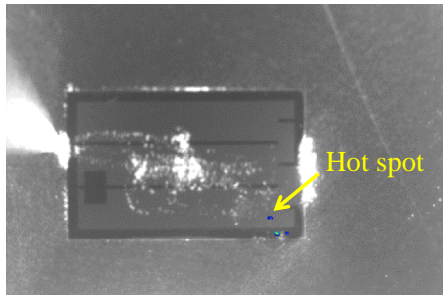
After the last short circuit test under bias voltage of 600 V and initial junction temperature  $T_j = 150^\circ\text{C}$ , where we have observed a clear damage on the gate side (Fig. 5), a physical failure analysis on the 1.2-kV/ 90-A SiC MOSFET has been performed. First, the package material has been removed by high-temperature etching, and then, an Indium Gallium Arsenide (InGaAs) infra-red camera has been used to find possible hot spots. The principle is to apply a voltage on the drain terminal and connect the gate and the source terminals to ground. If the SiC MOSFET has a damage, a leakage current will appear from drain to source or drain to gate, which can be detected with a very sensitive infra-red camera. The results can be observed in Fig. 7, where a hot spot in the device active area is revealed. The location of the hot-spot is highlighted in Fig. 7.

Fig. 7: InGaAs infra-red image of the degraded 1.2-kV/ 90-A SiC MOSFET under short circuit.

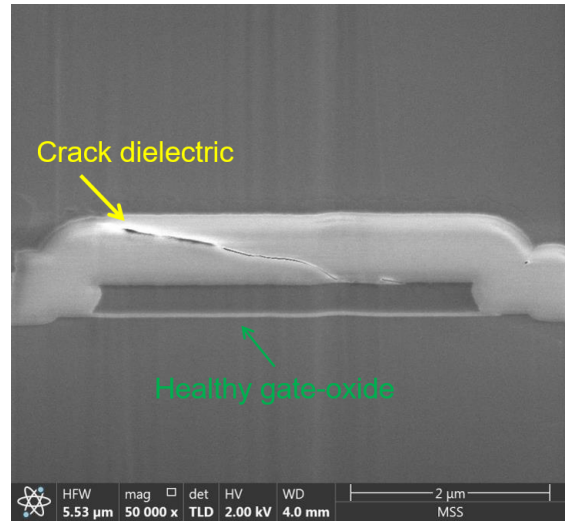
Fig. 10: Image of the gate-oxide region.

formed after the short circuit stress. Furthermore, Fig. 10 shows a magnified image where the gate-oxide layer appears to be intact in this cell. This observation demonstrates that the high electric field and high temperature sustained across the thin gate-oxide was not the root cause of the gate damage. A more in-depth analysis has been performed on adjacent cells, showing that not only one cell but several ones have cracks on the inter-level dielectric (between poly-silicon gate and aluminium source).

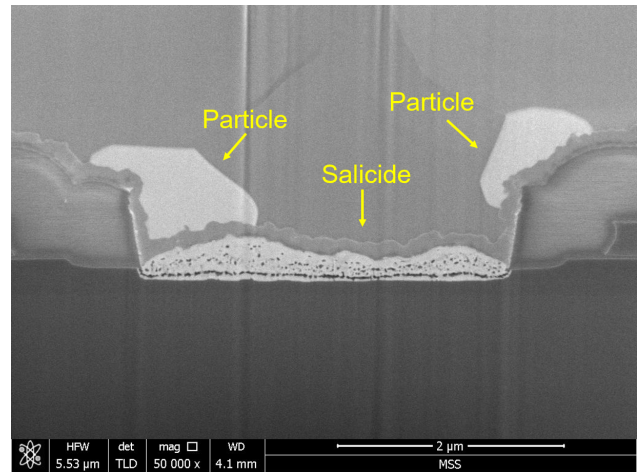
Fig. 11: Magnified Focused Ion Beam (FIB) of the salicide region of the degraded SiC MOSFET.

The salicide which is the technology that is used to form the electrical contact between the semiconductor substrate and the source terminal appears to be severely degraded, which can be observed in Fig. 11. First, the source contact thickness is not homogeneous and second, particles can be observed near the salicide which are not seen for the new device. This indicates that they could have originated as a consequence of the short-circuit stress and not from device process defects. Although a material analysis has not been performed on the particle itself,

it can be said that the material must be a metal because of the image light color.

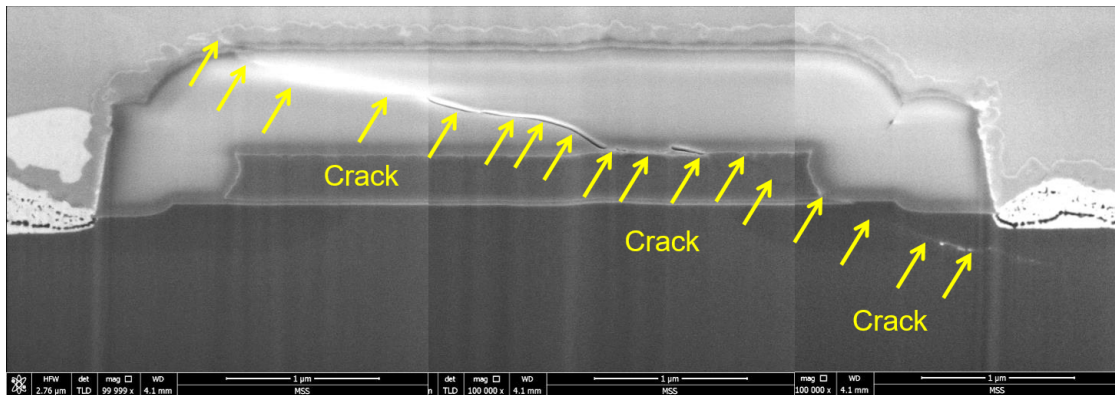
Fig. 12: Focused Ion Beam (FIB) microsection showing a crack between the source metallization and the SiC substrate.

The damaged SiC MOSFET die has been further analysed with the aim of finding defects that could explain the drain leakage current increase. A FIB micro-section has been performed at different locations in the vicinity of the hot spot. In Fig. 12, it can be recognized that the crack between the poly-silicon gate and the aluminum source has propagated towards the SiC substrate through the poly-silicon gate and gate-oxide probably in the third dimension and therefore not clearly visible in Fig. 12. This crack allows for a conductive path between the drain and source generating a drain leakage increase consequently.

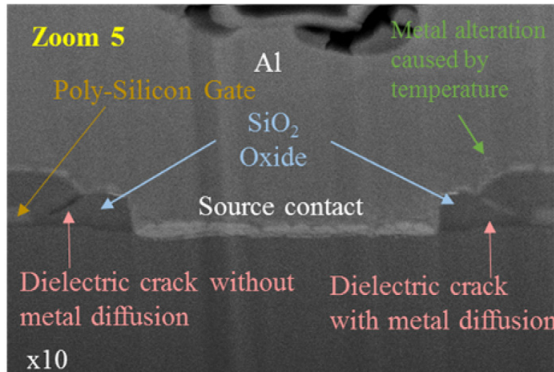
(a) Scanning Electron Microscope (SEM) image showing cracks in the dielectric around the poly-silicon gate electrode of a 1.2 kV/ 36 A SiC MOSFET [20].

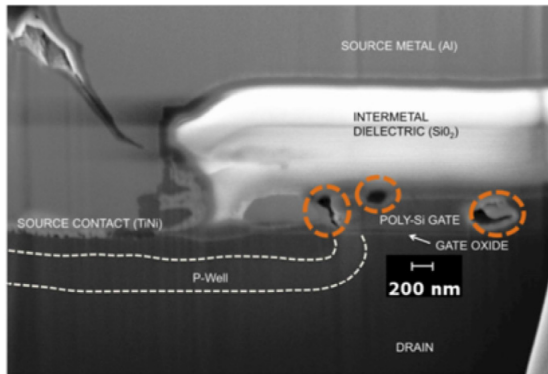
(b) SEM image showing defects in the poly-silicon gate electrode of a 1.2 kV SiC MOSFET [21].

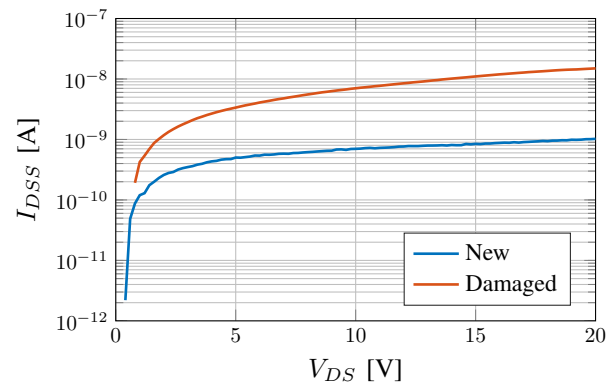
The degradation of the 1.2-kV/ 90-A SiC MOSFET has been attributed to the change in gate leakage current and gate damage due to the formation of cracks in the SiO<sub>2</sub> dielectric. Nevertheless, it is worth to discuss that the drain leakage current significantly increases between the fresh and the damaged device, as observed in Fig. 14, where the typical  $I - V$  curve is presented. The aim is now to find out through the physical inspection of the device, whether there are further cracks or defects that allow the drain leakage current to flow from drain to source through a new path.

Fig. 14: Short-circuit tests with increasing time of a new and a degraded 1.2-kV/90-A SiC MOSFET:  $V_{DC} = 600$  V  $T_j = 150^\circ\text{C}$ .
