Effect of short-circuit stress on the degradation of the SiO₂ dielectric in SiC power MOSFETs

Reigosa, Paula Diaz; Iannuzzo, Francesco; Ceccarelli, Lorenzo

Published in:
Microelectronics Reliability

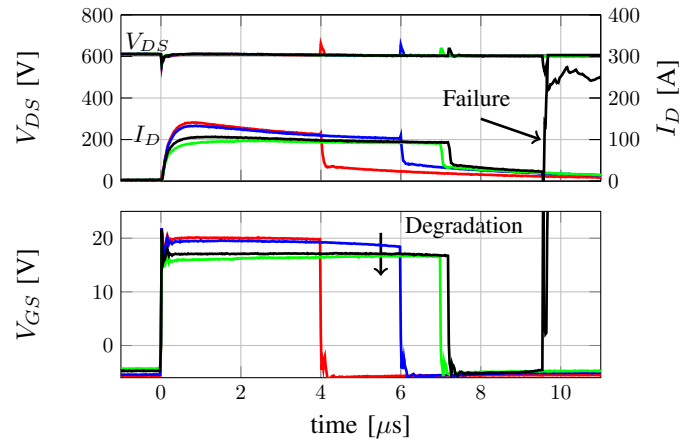
In SiC MOSFETs, the most common failure mechanism seems to be the gate-oxide breakdown, as the experimental results in Fig. 1 demonstrate so. Two degradation mechanisms are typically observed: (1) gate-voltage reduction at the end of the short circuit pulse, for example, the short circuit waveforms in Fig. 1 when the device is tested up to 6 μ s, and (2) permanent gate-voltage reduction, for example, the short

Fig. 1: Short-circuit tests with increasing time of a 1.2-kV/36-A SiC MOSFET: $V_{DC} = 600$ V $T_j = 150^\circ\text{C}$.

circuit waveforms in Fig. 1 when the device is tested up to 7 μ s. Therefore, it is worth to note that the failure indicator is the on-state gate-source voltage reduction due to the increase in the gate leakage current, which eventually causes a permanent gate damage and ends up in a gate-oxide breakdown failure. This failure mode has been attributed to the high temperature and high electric field withstood across the thin gate oxide [7], [15], [16], combined with the much higher defect density of SiC MOSFET structures (i.e., substrate defects, particles and metallic contaminations). Recently, it has been discussed that robust short-circuit devices can be designed if the thickness of the oxide is increased or the cell pitch is increased, while on the other hand, the on-state resistance becomes compromised leading to greater power losses [17], [18]. Despite of this trade-off curve, cracks across the thin gate-oxide have not been reported in the literature, as discussed in [19], therefore this assumption needs to be further validated.

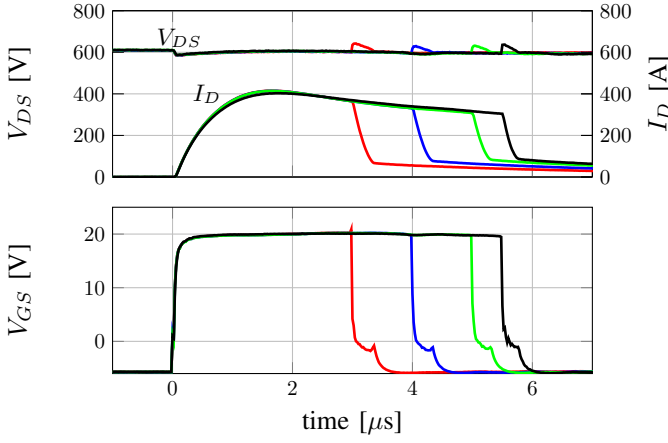
Finally, it is also worth to note that the gate voltage shows a voltage decay with increasing short circuit pulses. In Fig. 4, the V_{GS} reduces from 19.8 V to 19.4 V when the applied short circuit pulse is increased from $3\ \mu\text{s}$ to $5.5\ \mu\text{s}$ at $T_j = 25^\circ\text{C}$. This leads to a $\Delta V_{GS} = 0.36\text{ V}$, which means that the gate leakage current is only 36 mA, and therefore, the device

Fig. 4: Short-circuit tests with increasing time of a 1.2-kV/90-A SiC MOSFET: $V_{DC} = 600$ V $T_j = 25^\circ\text{C}$.

is not permanently degraded as in the previous case when the short circuit test was performed at higher temperature ($T_j = 150^\circ\text{C}$).

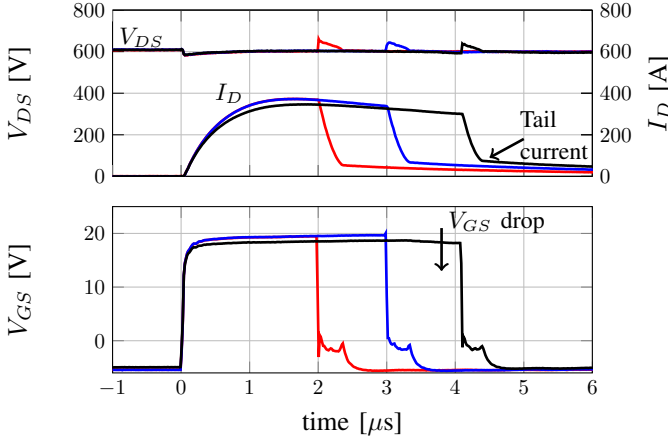
Fig. 4 shows the short-circuit voltage and current waveforms of the 1.2-kV/ 90-A SiC MOSFET for a bias voltage of 600 V and initial junction temperature $T_j = 25^\circ\text{C}$. Furthermore, Fig. 5 shows the same waveforms for a bias voltage of 600 V and $T_j = 150^\circ\text{C}$. In this work it has been assumed a 600 V application to be the nominal. The results at high temperature and nominal voltage show a significant reduction of the gate-source voltage V_{GS} , while the results at room temperature do not show such a degradation. In Fig. 5, the V_{GS} reduces from 19.7 V to 18.7 V while the short circuit pulse has been increased from $3\ \mu\text{s}$ to $4\ \mu\text{s}$. This leads to a $\Delta V_{GS} = 1\text{ V}$, which means that the gate current increases 100 mA ($R_g = 10\ \Omega$). The gate leakage current for a fresh device is in the nA-level, and then gradually increases with the short circuit pulse duration up to 100 mA, which is considered as the critical point. The gate leakage current now flows through a new path between gate and source, which demonstrates that the gate electrode is no longer isolated.

After the last test, the damage on the gate side is permanent but the device is still able to turn-on/turn-off. With the aim of performing a physical structural analysis of the device, the short-circuit experiments are stopped before observing a gate breakdown failure, as pointed out in Fig. 1. Thanks to the physical analysis, the assumption that a new resistive path has been originated will be validated.

Fig. 5: Short-circuit tests with increasing time of a 1.2-kV/90-A SiC MOSFET: $V_{DC} = 600$ V $T_j = 150^\circ\text{C}$.

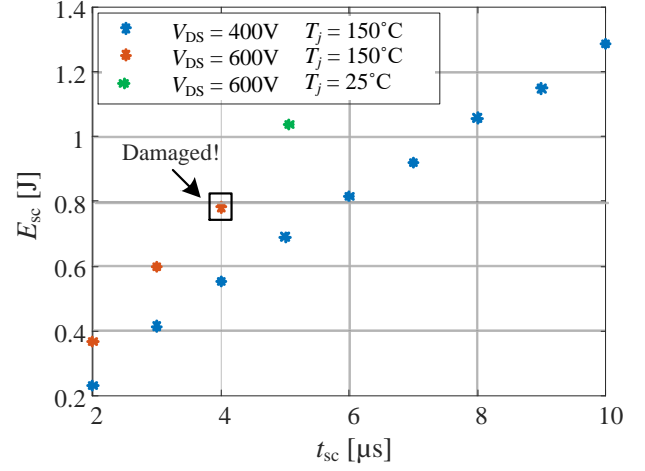
The calculated short-circuit energies from the short circuit current and drain-source voltage waveforms have been plotted in Fig. 6. The short-circuit energy causing a permanent damage on the SiC MOSFET is 0.8 J, which can be considered as the critical energy when the device is tested at $T_j = 150^\circ\text{C}$ and $V_{DC} = 600$ V. Furthermore, the calculated short-circuit energy for a bias voltage of 600 V and $T_j = 25^\circ\text{C}$ is about 1.14 J, which is above the one that lead to a permanent degradation in the previous case. The calculated short-circuit energies when the device is tested under a bias voltage of 400 V and $T_j = 150^\circ\text{C}$ show that the value is also above the one leading to the permanent damage of the device, even though the initial junction temperature was the same ($T_j = 150^\circ\text{C}$). These results prove that in planar SiC MOSFETs, the gate reliability

is not only related to the critical energy, but bias voltage plays a significant role, too.

Fig. 6: Calculated short-circuit energy for two bias voltage ($V_{DC} = 400$ V and 600 V) and initial junction temperatures ($T_j = 25^\circ\text{C}$ and 150°C).

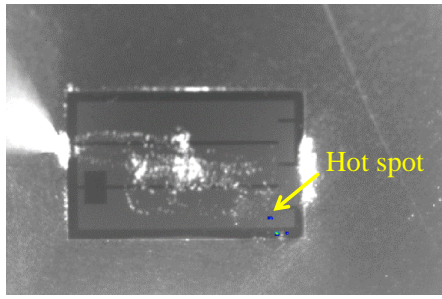
After the last short circuit test under bias voltage of 600 V and initial junction temperature $T_j = 150^\circ\text{C}$, where we have observed a clear damage on the gate side (Fig. 5), a physical failure analysis on the 1.2-kV/ 90-A SiC MOSFET has been performed. First, the package material has been removed by high-temperature etching, and then, an Indium Gallium Arsenide (InGaAs) infra-red camera has been used to find possible hot spots. The principle is to apply a voltage on the drain terminal and connect the gate and the source terminals to ground. If the SiC MOSFET has a damage, a leakage current will appear from drain to source or drain to gate, which can be detected with a very sensitive infra-red camera. The results can be observed in Fig. 7, where a hot spot in the device active area is revealed. The location of the hot-spot is highlighted in Fig. 7.

Fig. 7: InGaAs infra-red image of the degraded 1.2-kV/ 90-A SiC MOSFET under short circuit.

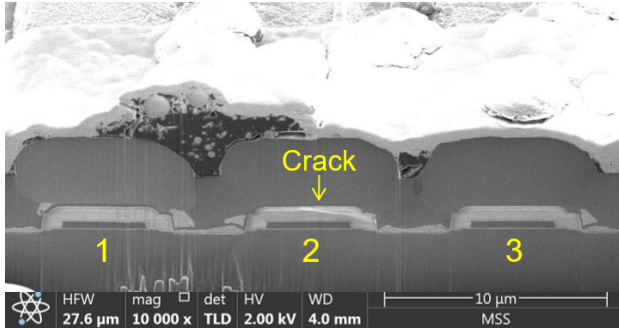
A Focused Ion Beam (FIB) micro-section at the hot spot location is applied to find possible damages on the gate oxide. Fig. 8 reveals the image of the FIB cut, where the vertical structure corresponding to three cells is observed. It is worth to note that one of the cells appears to be cracked, therefore, this particular cell is further magnified in Fig. 9. It is interesting to compare the image between the new (Fig. 2) and the degraded SiC MOSFET (Fig. 9), which proves that three major degradations have been found:

Fig. 8: Focused Ion Beam (FIB) cross-section of three cells at the hot spot location, where one of the cells presents a crack.

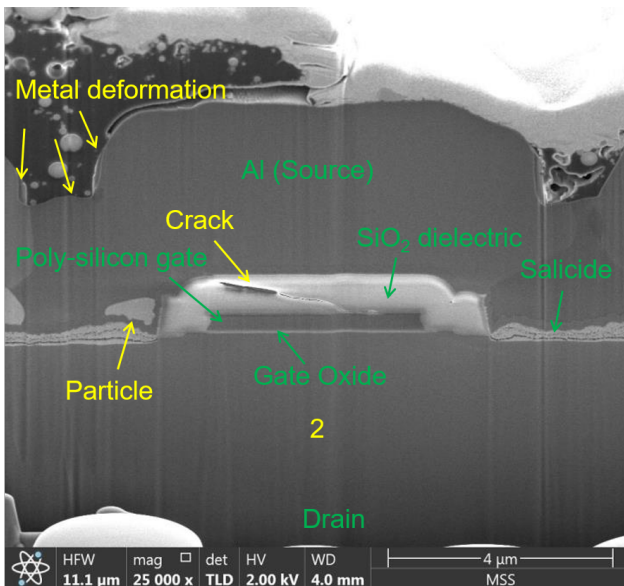
- 1) A crack in the dielectric between the poly-silicon gate and the aluminium source.
- 2) Metal particles accumulated near the source contact (salicide).

3) Alterations in the top surface of the aluminium source.

Each of the three degradations are analysed in more detail in the following. First, the cracks found in the degraded device between the poly-silicon gate and the aluminium source cannot be found for the new device, which proves that have been

Fig. 9: Magnified Focused Ion Beam (FIB) cross-section of the damaged cell.

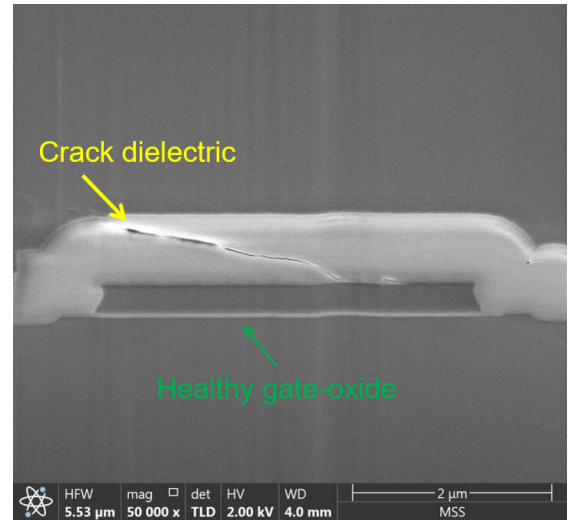
Fig. 10: Image of the gate-oxide region.

formed after the short circuit stress. Furthermore, Fig. 10 shows a magnified image where the gate-oxide layer appears to be intact in this cell. This observation demonstrates that the high electric field and high temperature sustained across the thin gate-oxide was not the root cause of the gate damage. A more in-depth analysis has been performed on adjacent cells, showing that not only one cell but several ones have cracks on the inter-level dielectric (between poly-silicon gate and aluminium source).

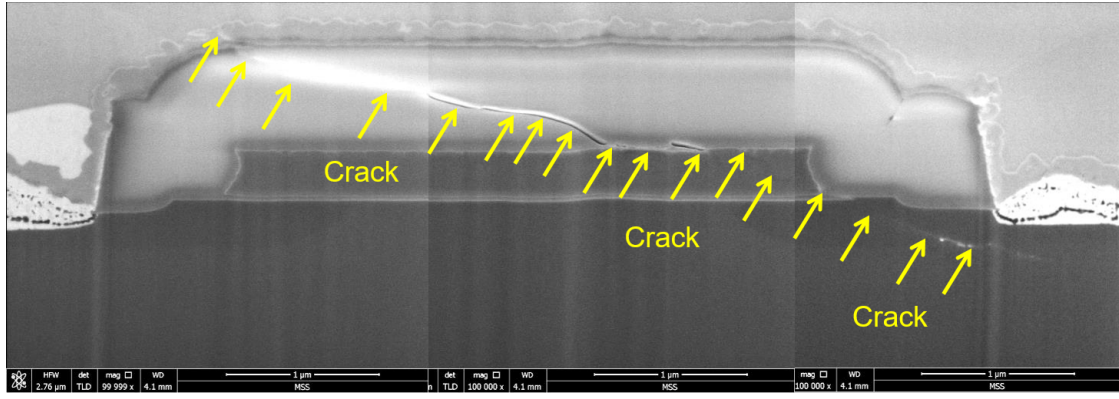
Fig. 12: Focused Ion Beam (FIB) microsection showing a crack between the source metallization and the SiC substrate.

The damaged SiC MOSFET die has been further analysed with the aim of finding defects that could explain the drain leakage current increase. A FIB micro-section has been performed at different locations in the vicinity of the hot spot. In Fig. 12, it can be recognized that the crack between the poly-silicon gate and the aluminum source has propagated towards the SiC substrate through the poly-silicon gate and gate-oxide probably in the third dimension and therefore not clearly visible in Fig. 12. This crack allows for a conductive path between the drain and source generating a drain leakage increase consequently.

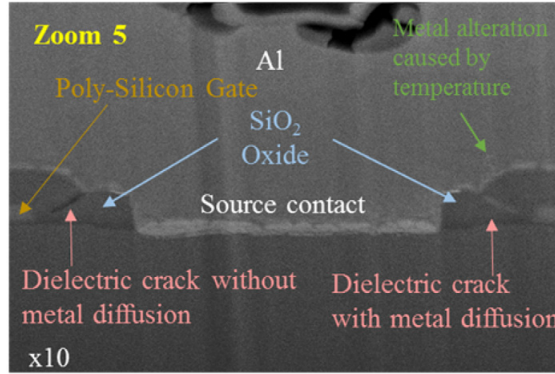
(a) Scanning Electron Microscope (SEM) image showing cracks in the dielectric around the poly-silicon gate electrode of a 1.2 kV/ 36 A SiC MOSFET [20].

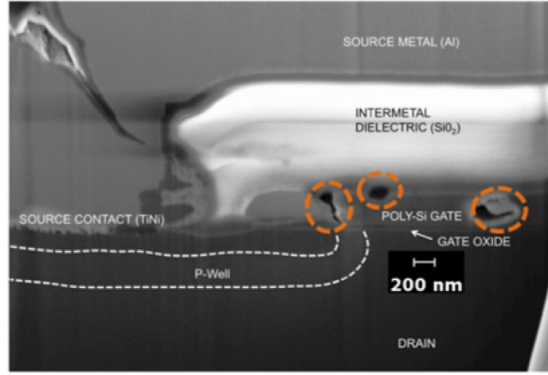
(b) SEM image showing defects in the poly-silicon gate electrode of a 1.2 kV SiC MOSFET [21].

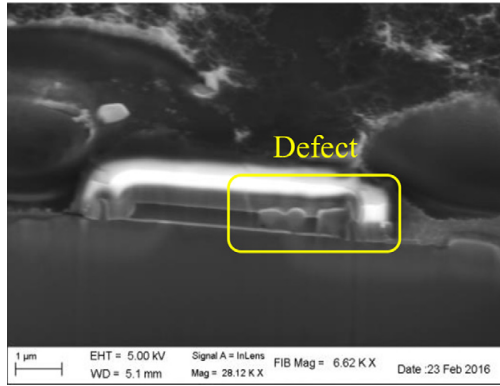
(c) SEM image of the degraded 1.2 kV/ 24 A SiC MOSFET cell showing defects in the poly-silicon gate electrode [4].

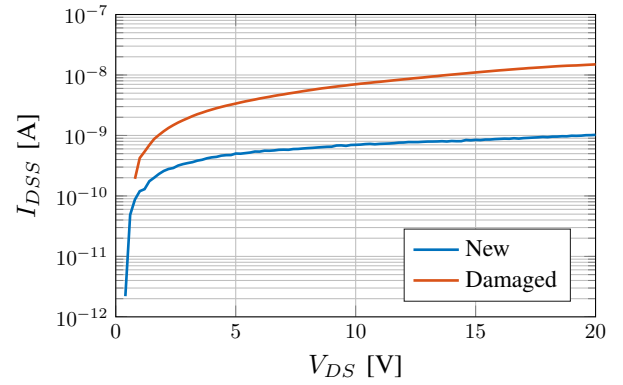
The degradation of the 1.2-kV/ 90-A SiC MOSFET has been attributed to the change in gate leakage current and gate damage due to the formation of cracks in the SiO₂ dielectric. Nevertheless, it is worth to discuss that the drain leakage current significantly increases between the fresh and the damaged device, as observed in Fig. 14, where the typical $I - V$ curve is presented. The aim is now to find out through the physical inspection of the device, whether there are further cracks or defects that allow the drain leakage current to flow from drain to source through a new path.

Fig. 14: Short-circuit tests with increasing time of a new and a degraded 1.2-kV/90-A SiC MOSFET: $V_{DC} = 600$ V $T_j = 150^\circ\text{C}$.
