*Published in:*  
Microelectronics Reliability

# Effect of Short-Circuit Stress on the Degradation of the SiO<sub>2</sub> Dielectric in SiC power MOSFETs

## Abstract

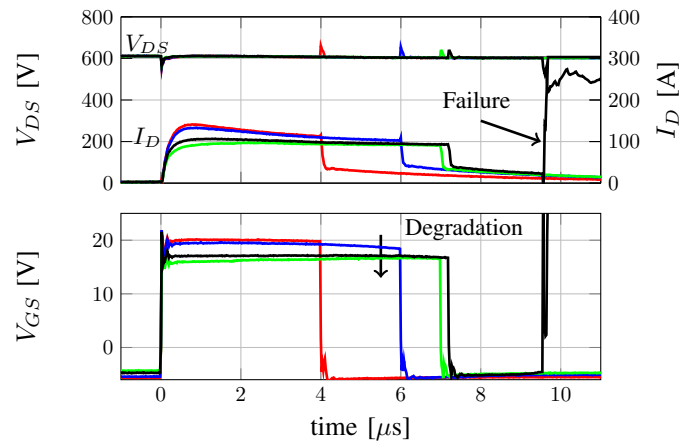
In SiC MOSFETs, the most common failure mechanism seems to be the gate-oxide breakdown, as the experimental results in Fig. 1 demonstrate so. Two degradation mechanisms are typically observed: (1) gate-voltage reduction at the end of the short circuit pulse, for example, the short circuit waveforms in Fig. 1 when the device is tested up to 6  $\mu$ s, and (2) permanent gate-voltage reduction, for example, the short

Fig. 1: Short-circuit tests with increasing time of a 1.2-kV/36-A SiC MOSFET:  $V_{DC} = 600$  V  $T_j = 150^\circ\text{C}$ .

circuit waveforms in Fig. 1 when the device is tested up to 7  $\mu$ s. Therefore, it is worth to note that the failure indicator is the on-state gate-source voltage reduction due to the increase in the gate leakage current, which eventually causes a permanent gate damage and ends up in a gate-oxide breakdown failure. This failure mode has been attributed to the high temperature and high electric field withstood across the thin gate oxide [7], [15], [16], combined with the much higher defect density of SiC MOSFET structures (i.e., substrate defects, particles and metallic contaminations). Recently, it has been discussed that robust short-circuit devices can be designed if the thickness of the oxide is increased or the cell pitch is increased, while on the other hand, the on-state resistance becomes compromised leading to greater power losses [17], [18]. Despite of this trade-off curve, cracks across the thin gate-oxide have not been reported in the literature, as discussed in [19], therefore this assumption needs to be further validated.

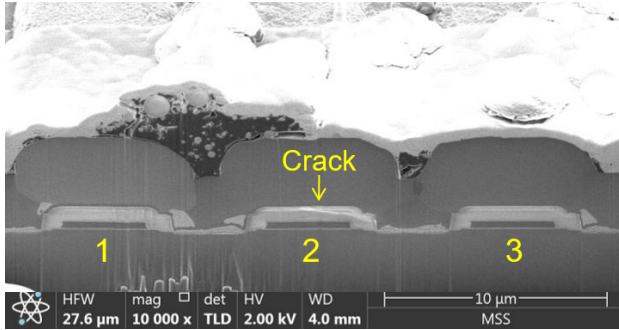
A Focused Ion Beam (FIB) micro-section at the hot spot location is applied to find possible damages on the gate oxide. Fig. 8 reveals the image of the FIB cut, where the vertical structure corresponding to three cells is observed. It is worth to note that one of the cells appears to be cracked, therefore, this particular cell is further magnified in Fig. 9. It is interesting to compare the image between the new (Fig. 2) and the degraded SiC MOSFET (Fig. 9), which proves that three major degradations have been found:

Fig. 8: Focused Ion Beam (FIB) cross-section of three cells at the hot spot location, where one of the cells presents a crack.

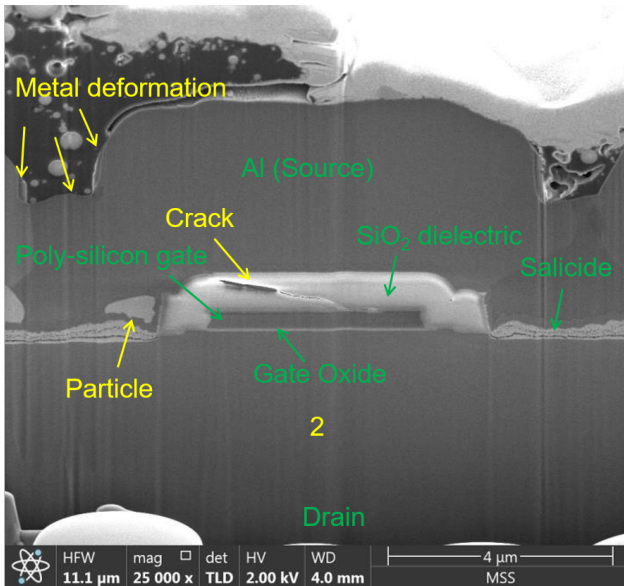
- 1) A crack in the dielectric between the poly-silicon gate and the aluminium source.
- 2) Metal particles accumulated near the source contact (salicide).

3) Alterations in the top surface of the aluminium source.

Each of the three degradations are analysed in more detail in the following. First, the cracks found in the degraded device between the poly-silicon gate and the aluminium source cannot be found for the new device, which proves that have been

Fig. 9: Magnified Focused Ion Beam (FIB) cross-section of the damaged cell.

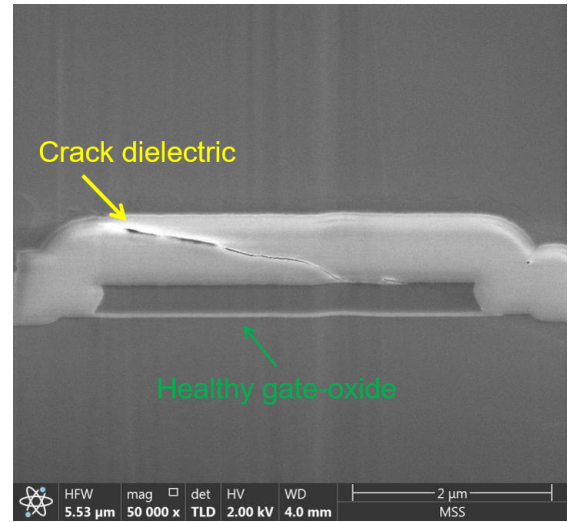
Fig. 10: Image of the gate-oxide region.

formed after the short circuit stress. Furthermore, Fig. 10 shows a magnified image where the gate-oxide layer appears to be intact in this cell. This observation demonstrates that the high electric field and high temperature sustained across the thin gate-oxide was not the root cause of the gate damage. A more in-depth analysis has been performed on adjacent cells, showing that not only one cell but several ones have cracks on the inter-level dielectric (between poly-silicon gate and aluminium source).
