Comprehensive energy renovation of two Danish heritage buildings within IEA SHC Task 59

Rose, Jørgen; Thomsen, Kirsten Engelund

Comprehensive Energy Renovation of Two Danish Heritage Buildings within IEA SHC Task 59

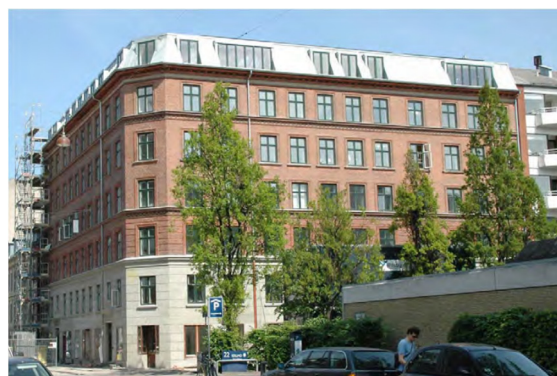
Figure 1. Façade of Ryesgade 30 after renovation, including new roof and penthouse apartments. Ground floor has commercial premises.

Ryesgade 30, a Copenhagen apartment building with a preservation-worthy period brick façade which featured internal insulation of facades and external insulation of the gable, new energy efficient windows, central mechanical ventilation with heat recovery, roof insulation and a roof-installed photovoltaic system, and established new attractive penthouse apartments with roof terraces overlooking Copenhagen. Due to the building's status as worthy of preservation, the renovation could not change the appearance of the facade. However, the municipality accepted that windows were replaced with new and energy efficient replicas of the old windows. A test apartment had demonstrated that this solution was the cheapest and most energy efficient.

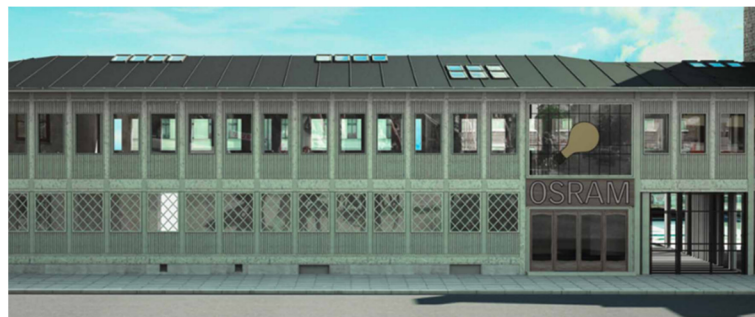
**Figure 3.** Façade facing the main street after renovation.

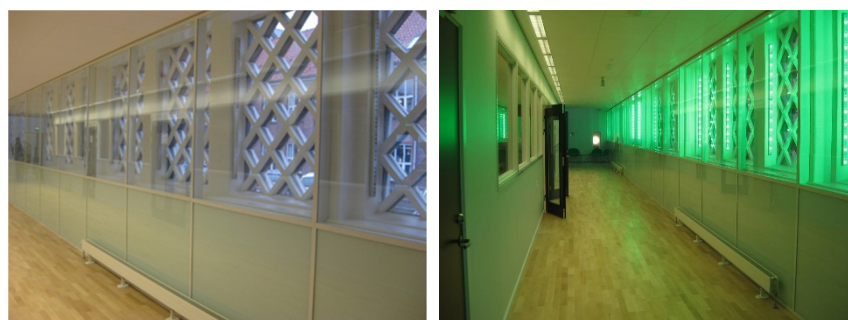
**Figure 4.** Façade facing inside after renovation. LEDs, off (left) and on (right).

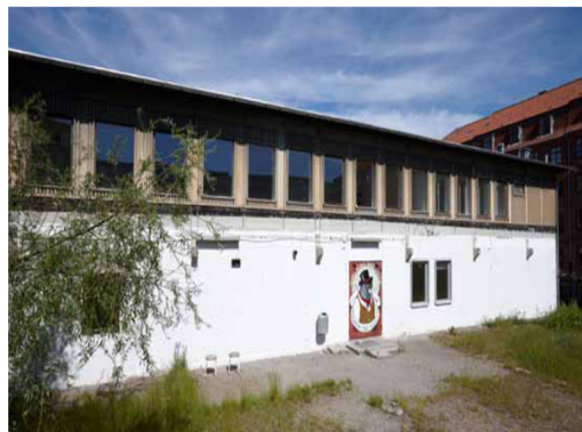
Figure 5. Façade facing the garden before renovation. The façade was originally the division between the office area (existing) and the factory area (which was torn down many years ago). The façade is not protected.

The walls were a mix of prefabricated concrete elements, concrete columns and uninsulated brick walls, and 380 mm insulation was added on the inside. The lower part of the back façade was insulated on the outside (see Figures 5 and 6).

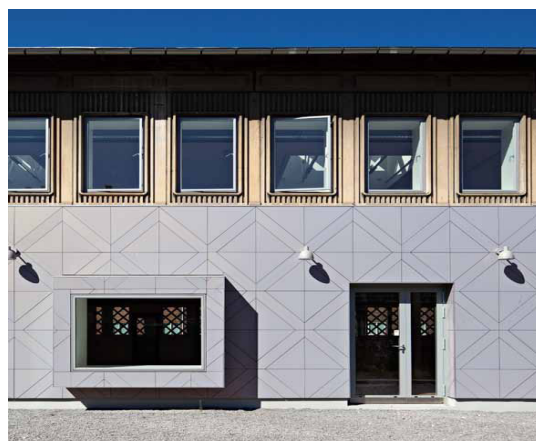
Figure 6. Façade facing the garden after renovation.

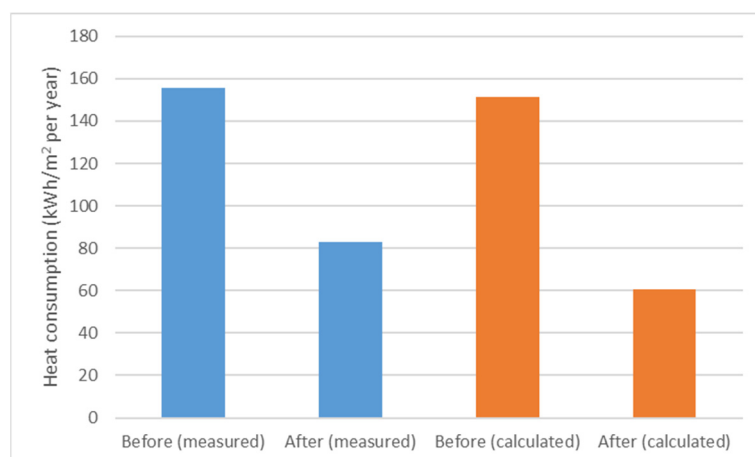
One of the main reasons for not achieving the expected savings in heat consumption was the fact that the indoor temperature after the renovation was significantly higher than what is usually used in these types of calculations. The temperature was measured during the heating season of 2013–2014 in blocks A and B (20 different sensors in total), and the result showed an average indoor temperature of 22.5 °C.

Figure 7. Measured and calculated heat consumption before and after renovation of Ryesgade 30.

Another possible explanation for the difference between measured and calculated heat consumption is the infiltration and ventilation of the building. In the calculations, it was assumed that the heat recovery rate was 85% in average and that the infiltration was very low, i.e., 0.05 L/s per m². Parametric calculations with the calculation model show that, in particular, an underestimation of the infiltration rate can influence the heat consumption, and because the opening of windows and doors is part of the infiltration, this parameter is heavily dependent on user behaviour.

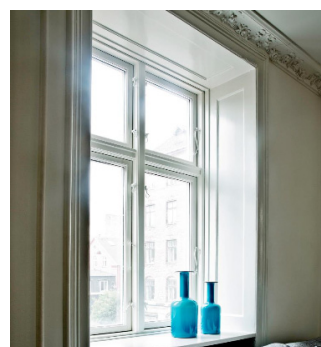
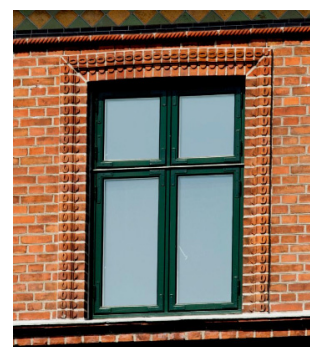
Regarding the windows, four different solutions were tested. The windows were ready for replacement, but the municipality wanted to preserve the windows for reasons of principle. The solution with a coupled frame, however, met resistance from tenants who did not want windows that opened inward because the solution is cumbersome and limits the use of the windowsill. Furthermore, this solution also proved problematic because the existing window frames had significant moisture damage.

Figure 9. New windows from the inside (left) and from the outside (right). Source: Leif Rönby.

The fourth solution was a complete replacement of the window with a replica of the original. This was a 1 + 2 solution with two energy glasses (inner and outer panes) and energy panes with “warm” pane edge and krypton filling.

Based on this information, it was concluded that solution 4 was the cheapest, while at the same time being highly energy efficient. The solution was also very user friendly, i.e., all the glass was fitted in one frame, and they had been manufactured to replicate, from the outside, the originals. Project participants presented these findings to the municipality who gave permission to replace the windows of the building. The new windows are shown in Figure 9.

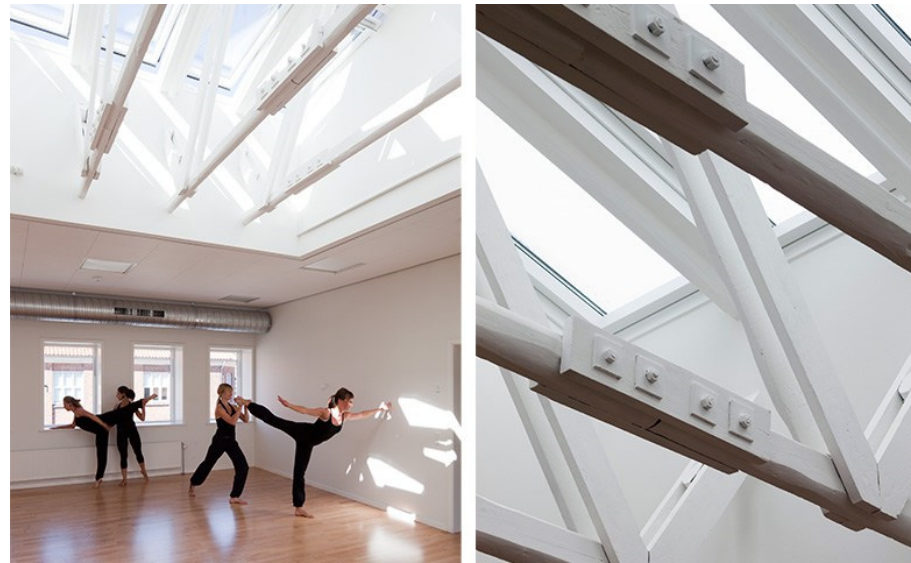
The comparison of results shows the positive effects of adding roof windows on the daylight conditions of the first floor. The roof windows deliver high levels of daylight in the centre part of the main room, as well as in the meeting rooms at the end of the building. The use of roof windows also contributes to raising the daylight levels on the lower floor via a new opening in the existing structural floor situated below the skylights in the hallway, as shown in Figure 16.

Figure 16. The roof lights provide a significant amount of daylight to the first floor in the building.
