Hydraulic Response of the Wave Energy Converter Wave Dragon in Nissum Bredning

*Determination of Hydraulic Response of the Wave Energy Converter
Wave Dragon placed in Nissum Bredning*

Jens Peter Kofoed & Peter Frigaard, Aalborg University

December, 2004

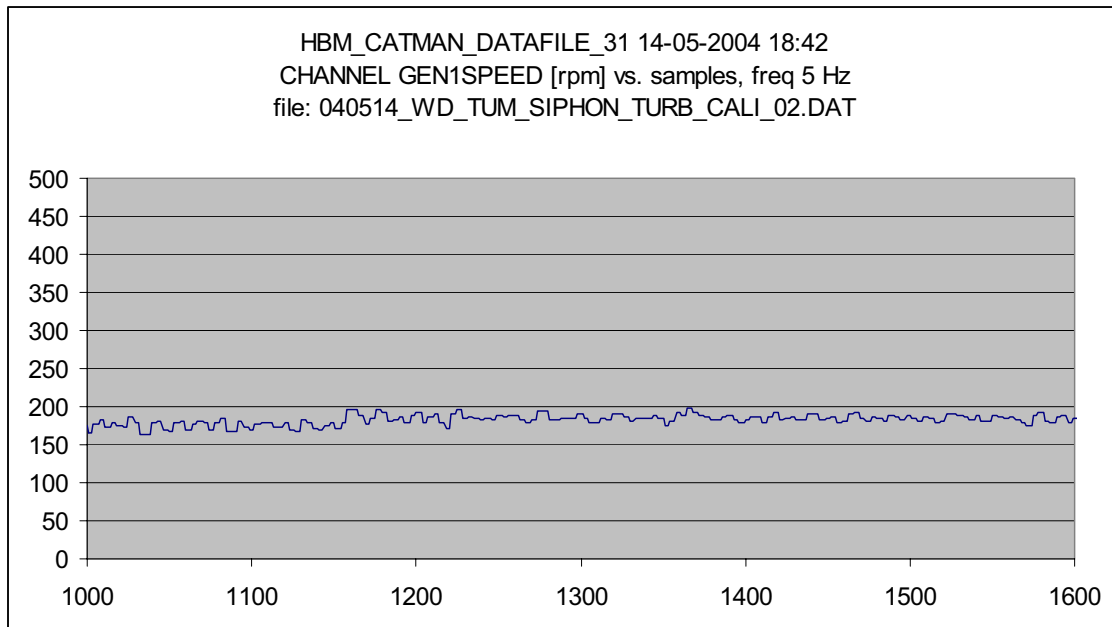
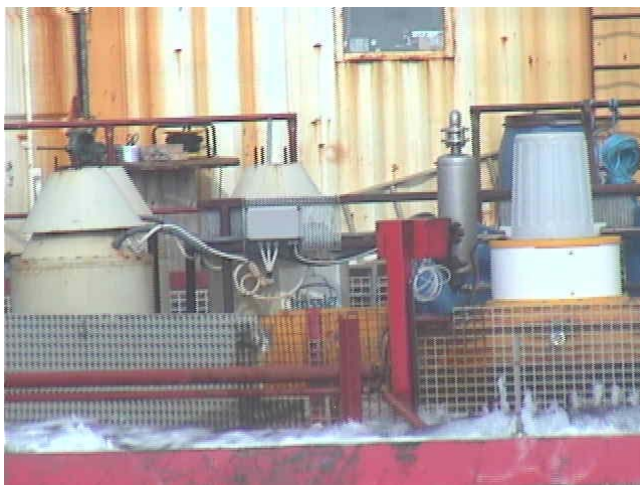
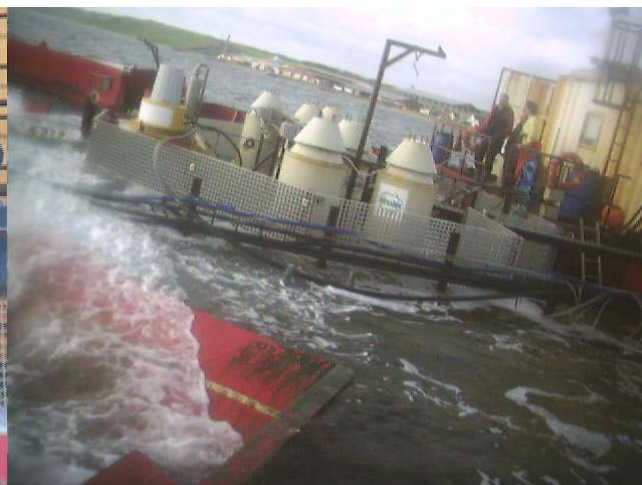
Figure 3.4. Turbine calibration by TUM after restoration of TURB 1.

The change in the turbine speed oscillations are pronounced from figure 3.4 to 3.5 and 3.6. The period of the oscillations are not far from the wave periods, for what reason it seems fair to say that the oscillations are tricked by the changing turbine head due to waves propagating under the platform. West Control was at WD-NB in July 2004 to change some burned IGBT's (transistors) and at this time the EEPROMS containing the West Control programming of the inverters was also replaced. A change in the programming might be responsible for the increased sensitivity to oscillations in the turbine head. This item is currently being investigated.

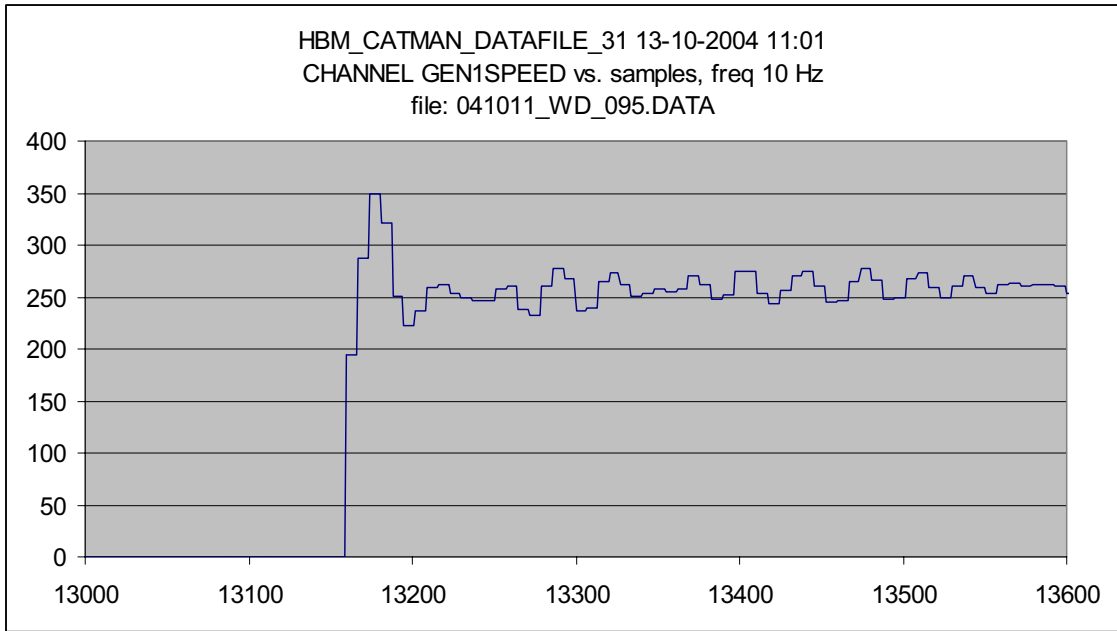
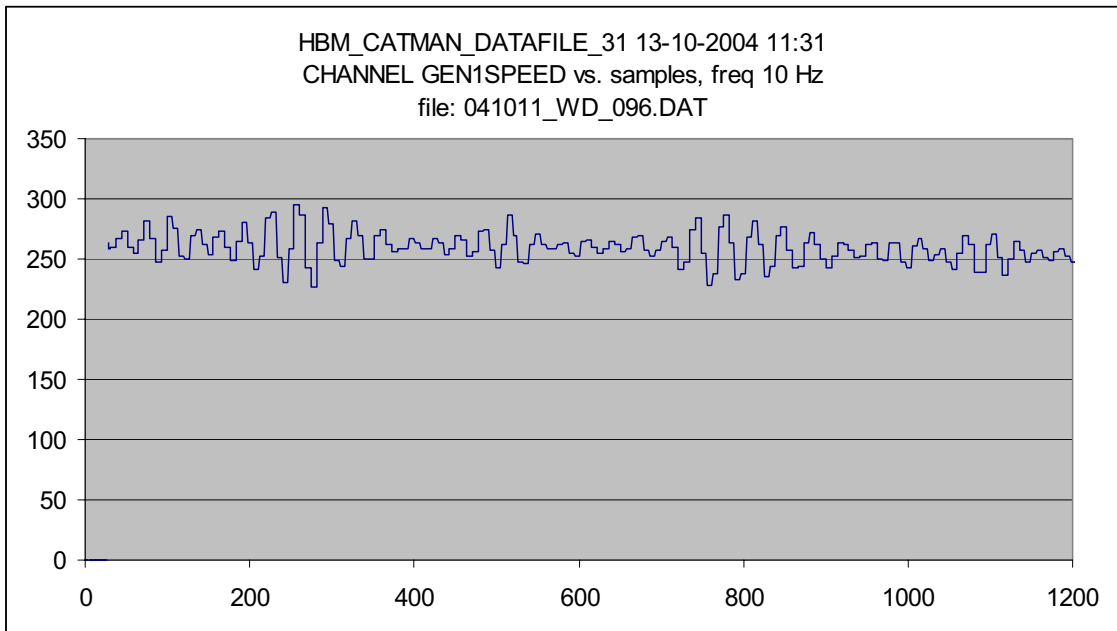
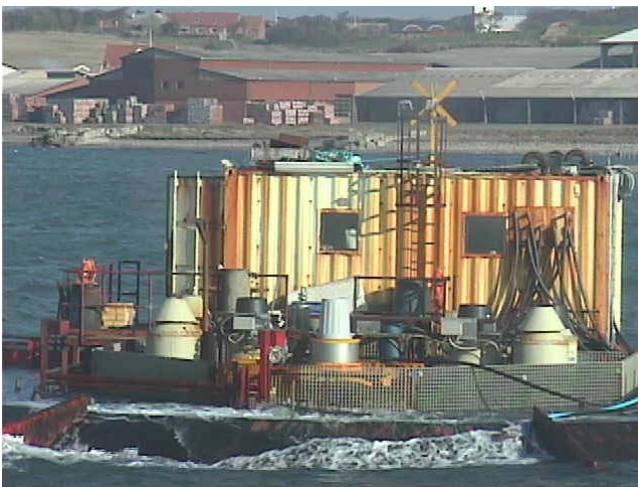
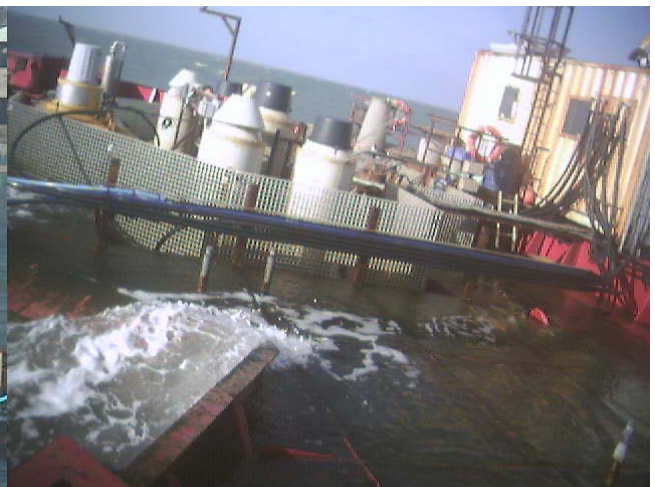
Figure 3.5. Turbine testing by TUM after restoration of TURB 2 and 4.

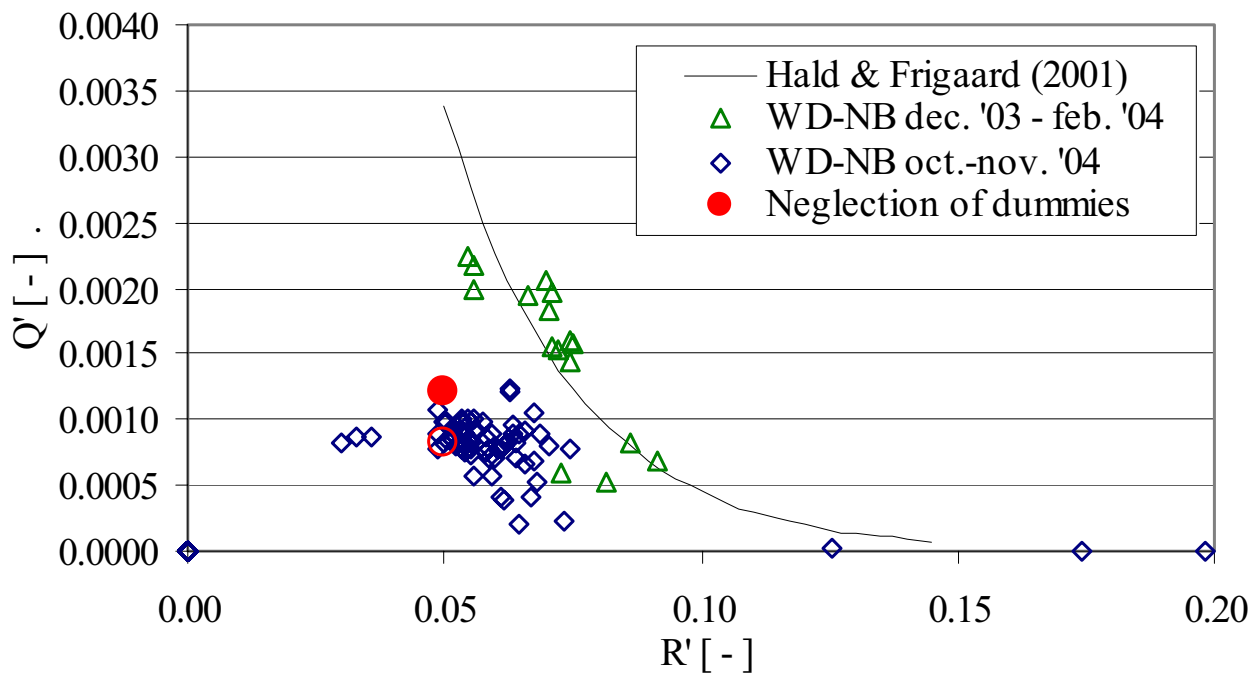
- Bias in estimation of wave conditions. As mentioned in chapter 2 the presence of the mooring caisson and reflections from the WD structure towards the wave measuring point is not taken into account in the wave analyses. This will tend to result in slight overestimation of wave height, i.e. biasing the overtopping data points to fall below the prediction line.

Figure 4.1. Non-dimensional overtopping rate as a function of the non-dimensional crest freeboard compared to lab. results and previous measurements at WD-NB. The effect of neglecting the dummy turbines exemplified in a single point based on observations in the SCADA system (all three dummies open 20 % of the time).

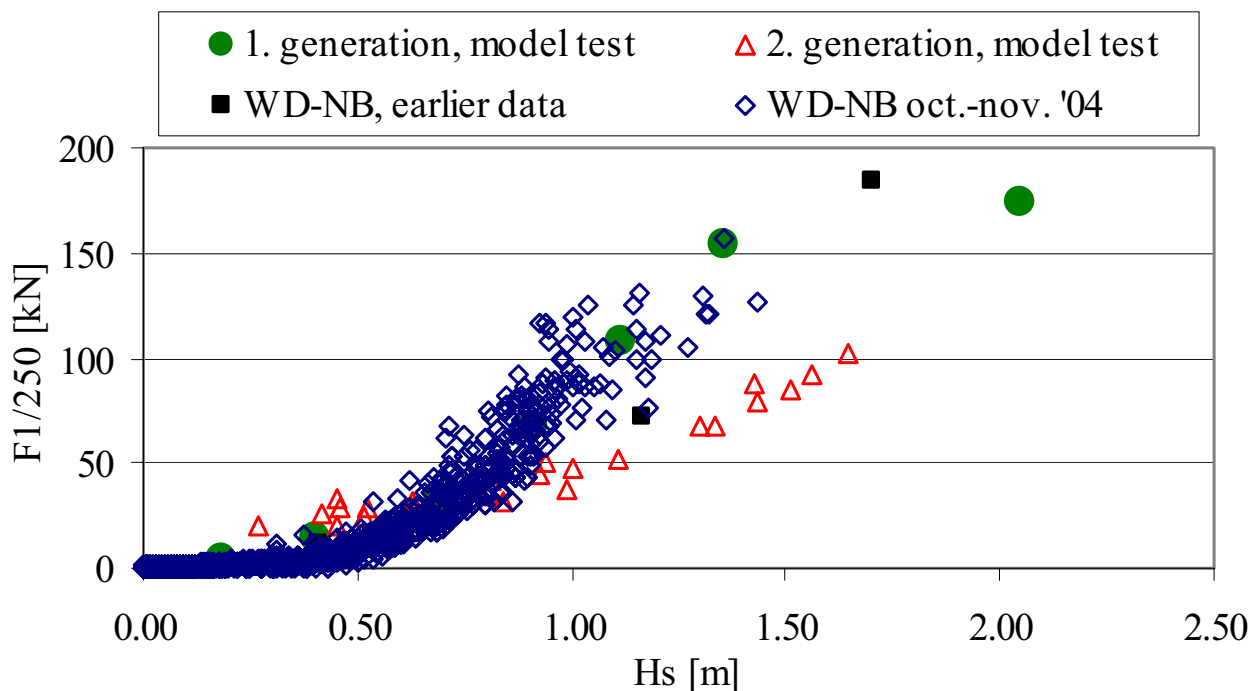
Figure 5.1. Mooring force in main mooring line attached to mooring pile in terms of $F_{1/250}$ (average of the 1/250 largest force peaks). The ‘WD-NB, earlier data’ is data observed at the SCADA system, ie. not really statistical data, but merely max points observed at the indicated single wave height.

From this figure it seems that the stiffness of the mooring system is too large – more like the situation as in the 1. generation model tests than in the 2.

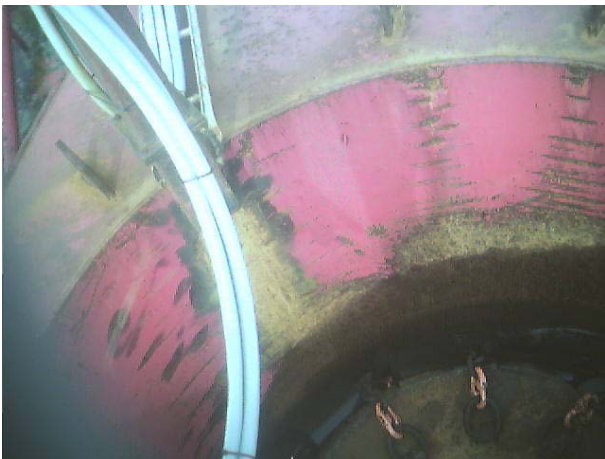
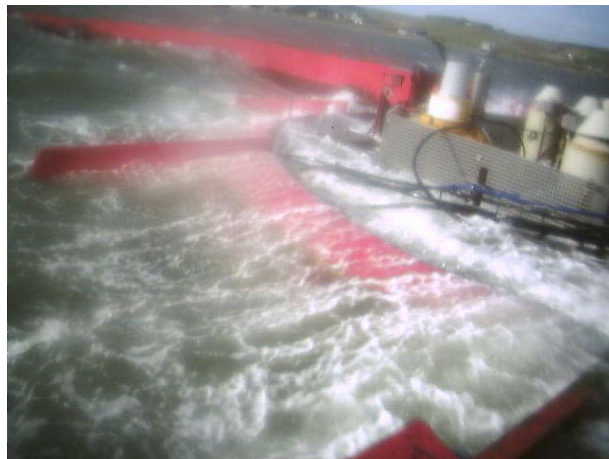
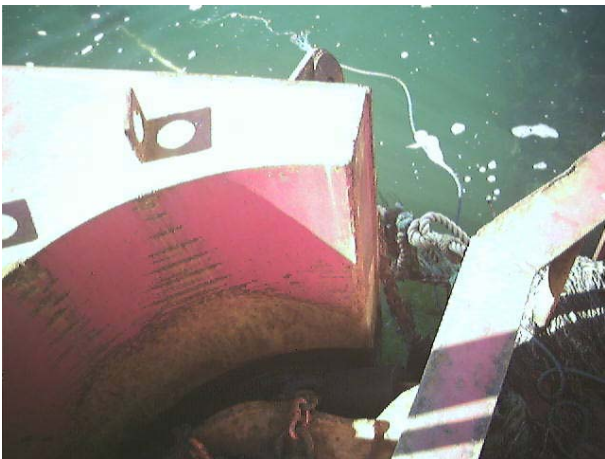
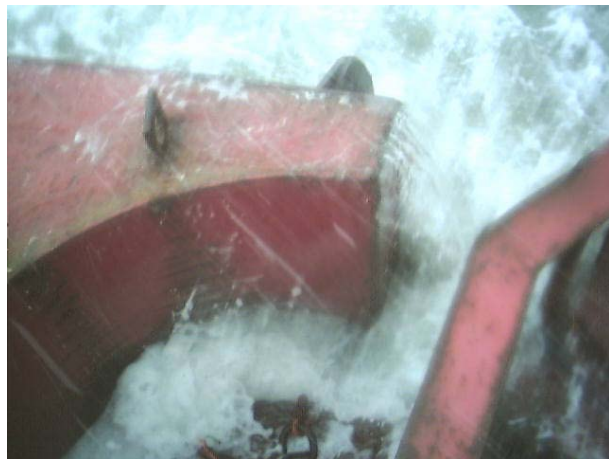
Before repair of the port side fender arrangement planned in the autumn 2003 was carried out, heavy weather caused dislocation of the port reflector and consequently damage/puncture of the port side shoulder. This led to flooding of a large buoyancy chamber. Further description is given in appendix A, date 03.10.08-09.

Figure 7.1. Pictures captured by WebCam2 on the port shoulder.

Furthermore, the fenders and the chains holding them have continuously had problems. Both parts of the chains and fenders have been replaced in an attempt to maintain the connection. However, A durable long-term solution has not been found, and the layout of the connection most probably needs to be completely redesigned in order to obtain a solution that is applicable to a full-size structure.

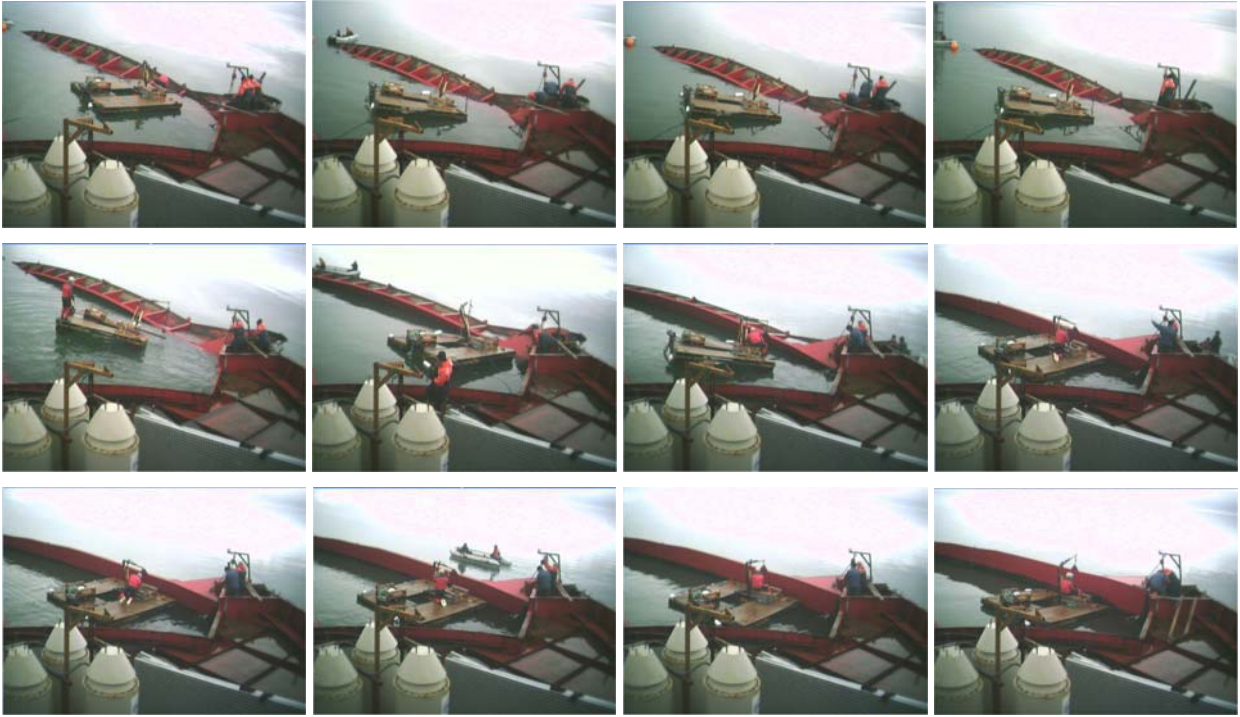
Between Christmas and New Year 2003 the starboard reflector was dislocated due failure of back rope between back of reflector and back corner of platform. The reflector was reinstalled the following day with calm weather, see figure 7.2.

Figure 7.2. Reinstallation of starboard reflector after dislocation, occurring between Christmas and New Year 2003.

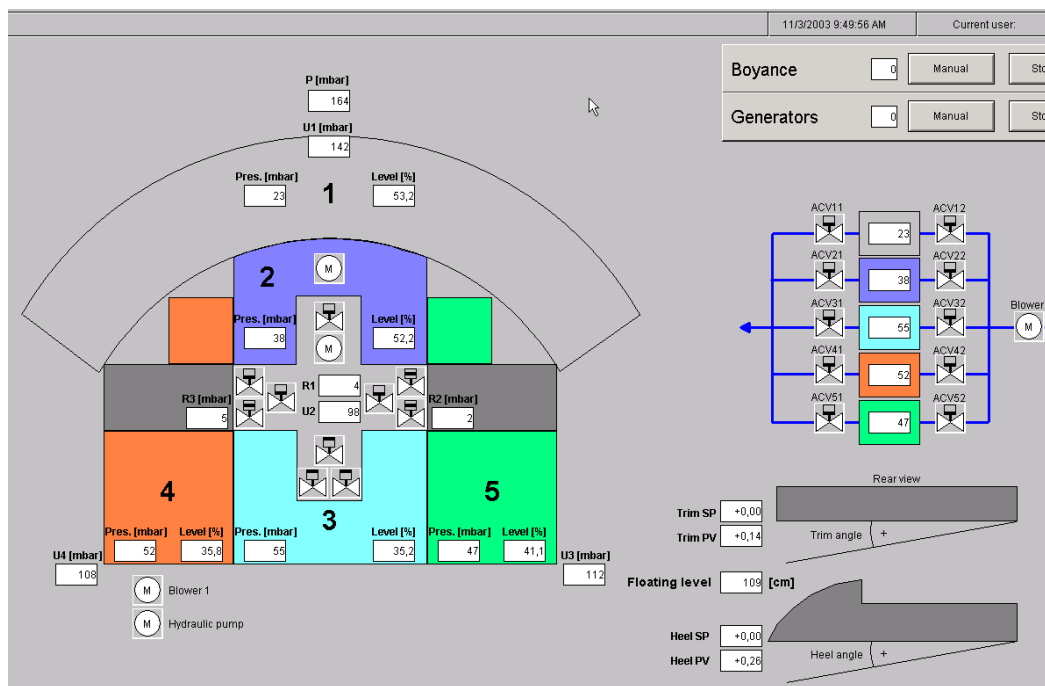
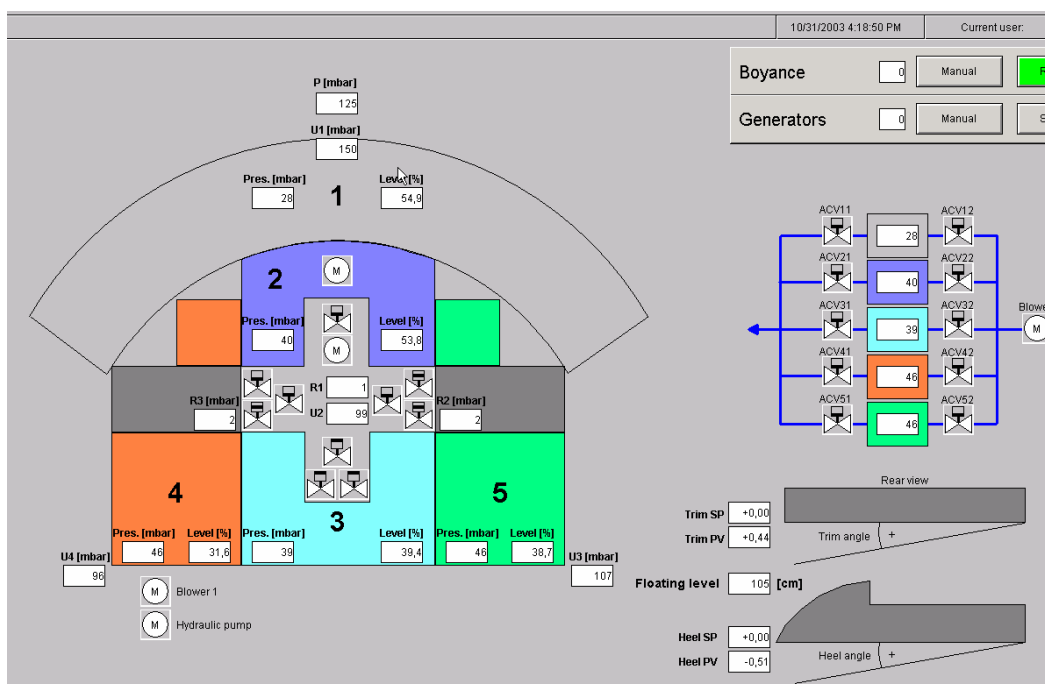
Automatikken har ikke været i drift i perioden mellem ovenstående screen dumps – d.v.s. i 65½ timer. Der har i perioden været bølgehøjder op til 0,7 m significant. Ved periodens start var ballastkamrene på dækket kun delvis fyldt, og der var væsentlig mere ballast i højre side.

Det fremgår, at platformen i perioden er krænget $0,77^\circ$ bagover (Heel), hvilket kan tilskrives fyldning af ballastkamrene på dækket. Samtidig ses det, at platformen har rettet sig $0,3^\circ$ op i tværetningen (Trim). Trykket i luftkamrene er ændret i god overensstemmelse hermed, d.v.s. luftmængderne i kamrene 1, 2, 3 og 5 er stort set konstante. Imidlertid viser tryk-/level indikeringen, at der er tilført en vis luftmængde til kammer 3 - luftmængden er øget ca. 9%. Denne lufttilførsel kan kun stamme fra luft, der rives med i vandstrømmen gennem dummy turbinerne. Ved forholdsvis store opskylsmængder, som der her må have været tale om (på trods af, at flydehøjden har været 50% større end den største registrerede søtilstand) er der så stor inert i vand-/luftblandingen, at noget af luften bevæger sig under skottene omkring dummyturbine-sektionen og op i kammer 3.

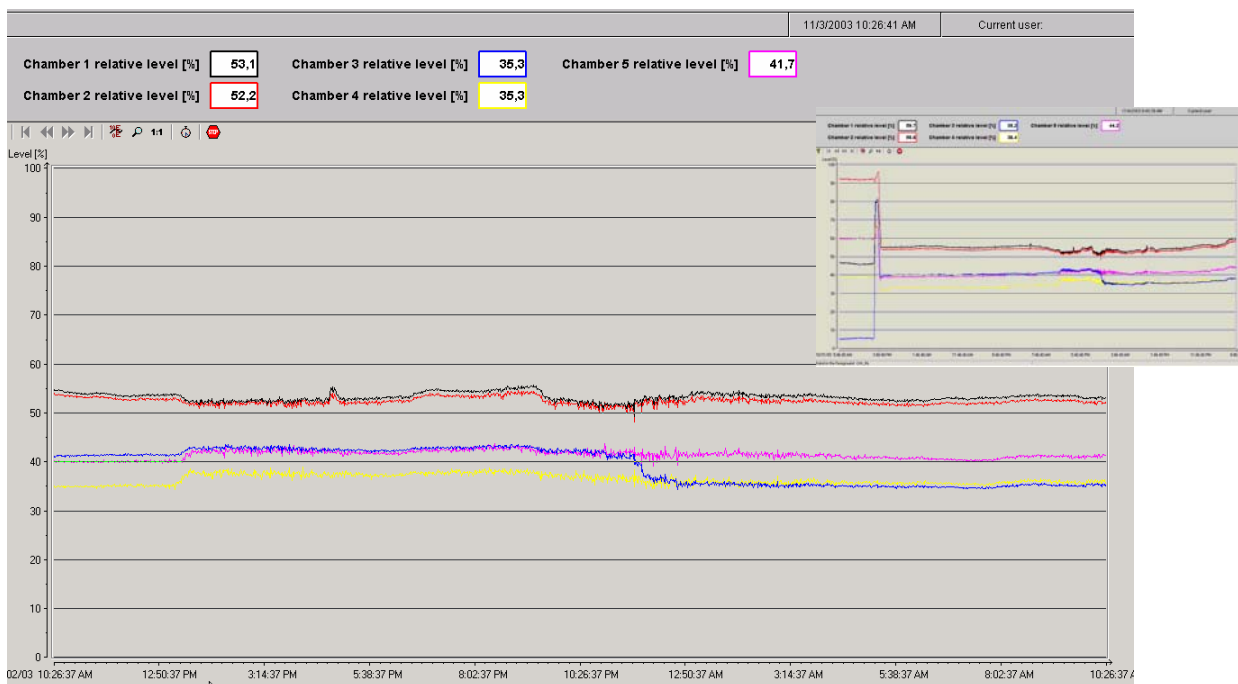
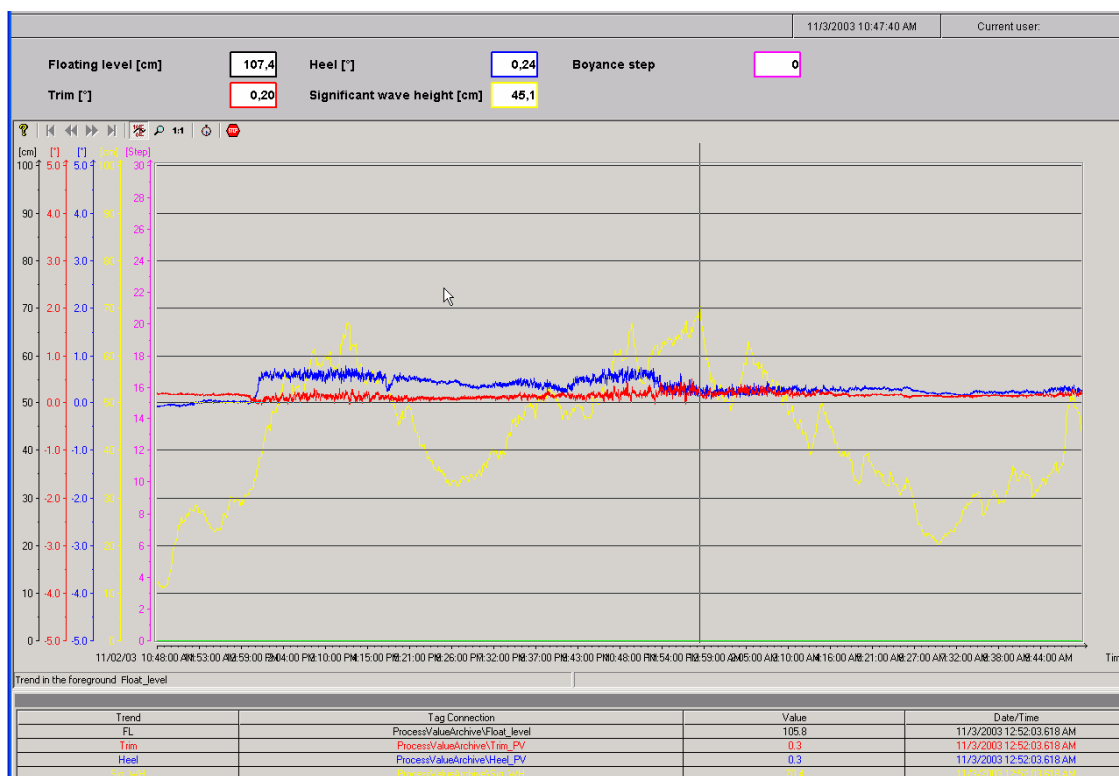
Det fremgår tydeligt af ovenstående skærm-dumps, at der ved den aktuelle flydehøjde bliver et så stort opskyl, når bølgehøjden overstiger ca. 0,3 m, at ballastkamrene fyldes og WD krænger lidt bagover. Denne krængning er en tilsigtet effekt af fyldningen af ballastkamrene/reservoiret og skyldes, at tyngdepunktet af vandet i reservoiret er placeret længere bagud end platformens tyngdepunkt. Det fremgår ligeledes, at den ovenfor omtalte tilførsel af luft til kammer 3 sker på et tidspunkt, hvor bølgehøjden er større end 0,6 m. I løbet af en halv time falder vandstanden i kammer 3 betydeligt, mens vandstanden og dermed luftmængden er næsten konstant i de øvrige kamre. Over en længere periode – her vist 4 døgn på det indsatte formindskede diagram – forsvinder ca. 10% af luftmængden i alle kamre bortset fra kammer 3. Denne reduktion svarer kun til halvdelen af iltindholdet i den friske luft. Det er således sandsynligt, at tabet af luft skyldes at en væsentlig del af ilten i luften forsvinder fra kamrene dels på grund af forrådnelsesprocesser dels på grund af korrosion af stålpladerne. Der bør foretages en iltmåling i kamrene for at få en bedre viden om dette forhold.

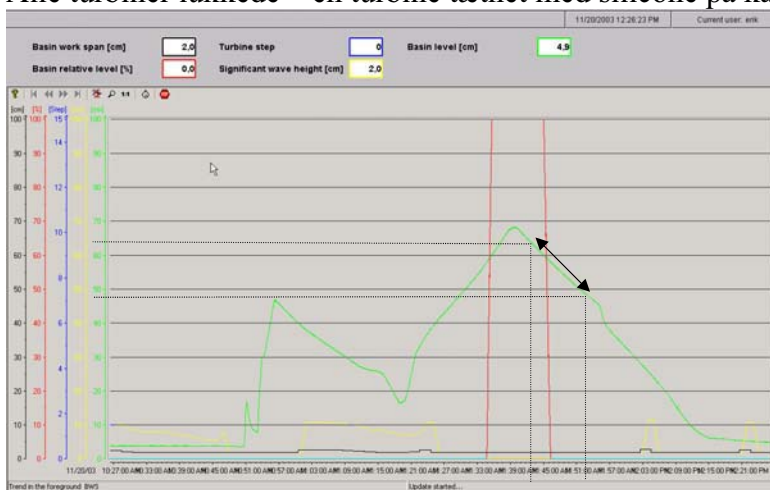
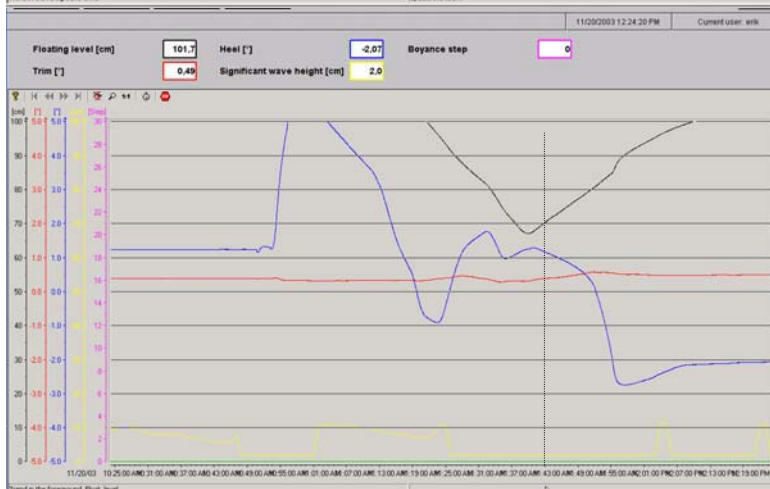
På 10 minutter (11:43 til 11:53) ses vandspejlet at falde med stort set konstant hastighed fra et niveau på 64 cm til 47,5 cm, d.v.s. 16,5 cm.

Idet netto bassinarealet er beregnet til at være $165,5 - 6 = 159,5 \text{ m}^2$ bliver læk tabet $2,63 \text{ m}^3$ svarende til 44 l/s eller en mistet elproduktion på ca. 300 W ved højt flydeniveau.

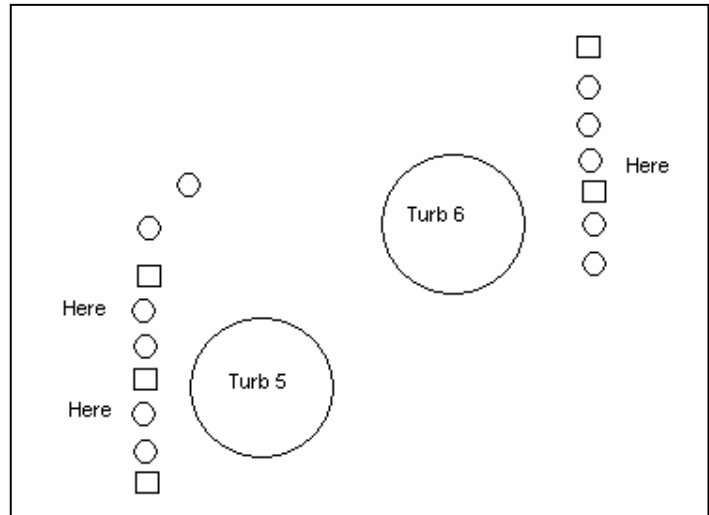
Tried to fill holes in the bottom of the turbine area, but had trouble making the filling stick in the holes. There was too much water in the turbine area. It is necessary to remove all the water from turbine area to be able to fill holes, but the wind was too strong to do so. Tree holes were filled as illustrated:
