## **Fire resistance of extruded hollow-core slabs**

*Published in:*  
Journal of Structural Fire Engineering

# Fire resistance of extruded hollow-core slabs

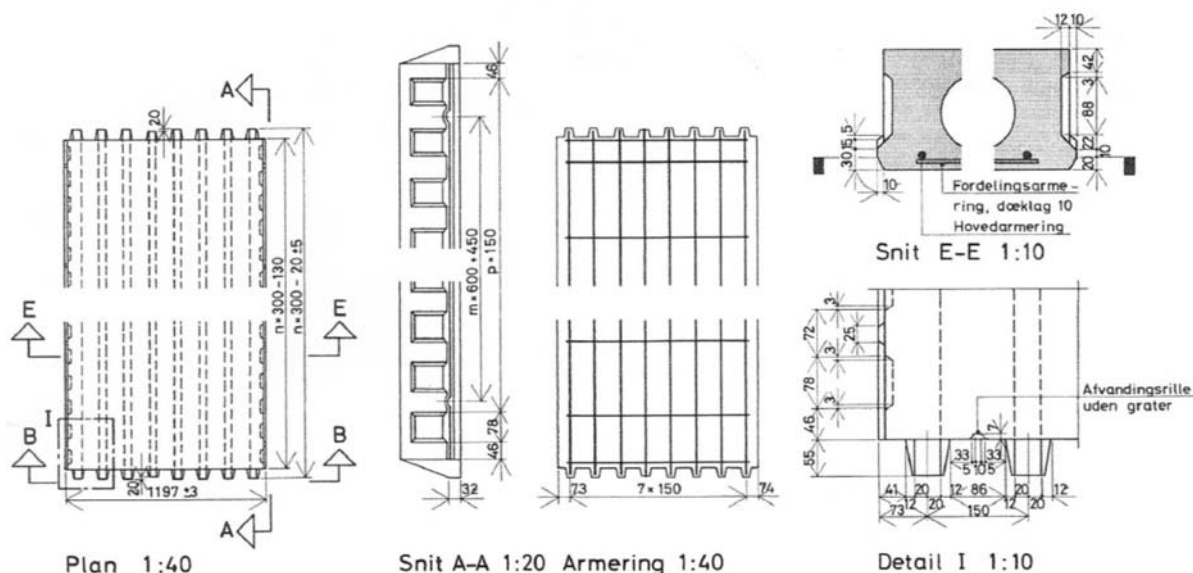
Figure 1. A classic hollow-core slab with slack main reinforcement and transverse reinforcement in the bottom flange [1].

Their geometry and reinforcement are seen on Figure 1 from Nissen [1].

They had slack deformed bars as main reinforcement in the longitudinal direction and slack transverse reinforcement in the bottom flange. This means that the bottom flange under the holes was reinforced across the element, improving the ability to keep the bottom flange in place and transferring horizontal shear.

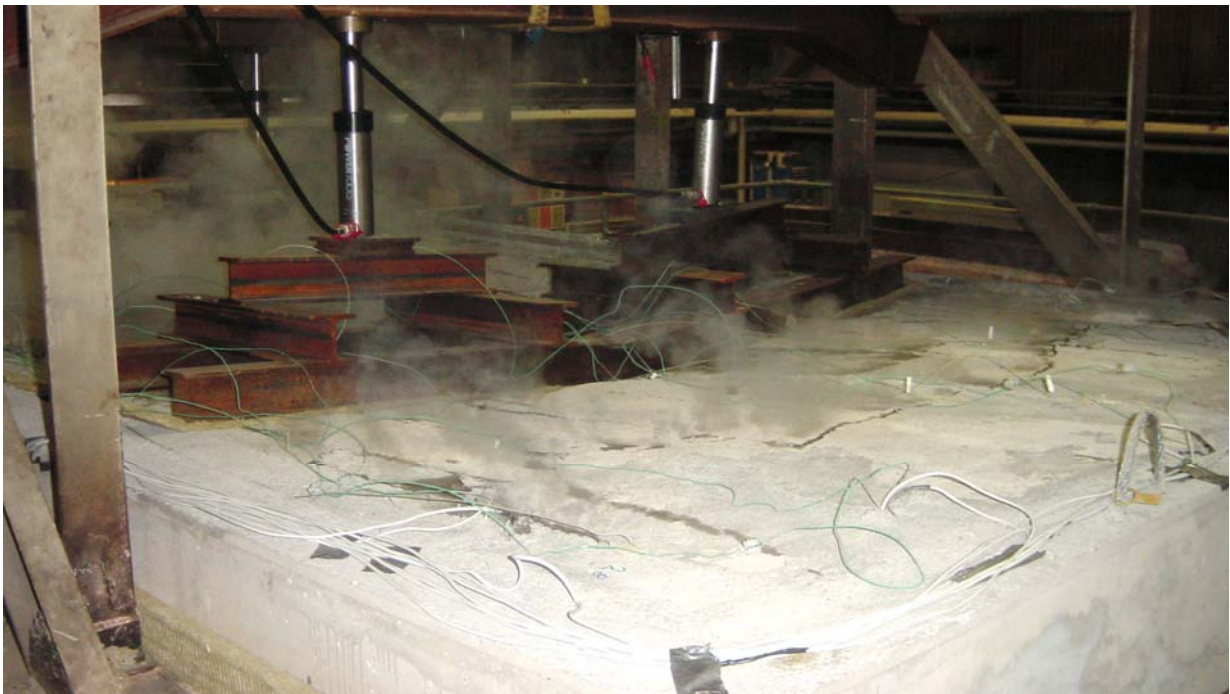
Figure 7. Cracks in top flange after approx. 15 min. Photo K. Hertz.

The midspan deflections are given in Figure 6. Substantial cracks were developed in top and bottom of the slab elements after 15 minutes (Figure 7), and the ISO 834 standard fire duration was assessed to be 25 minutes at this accredited test.

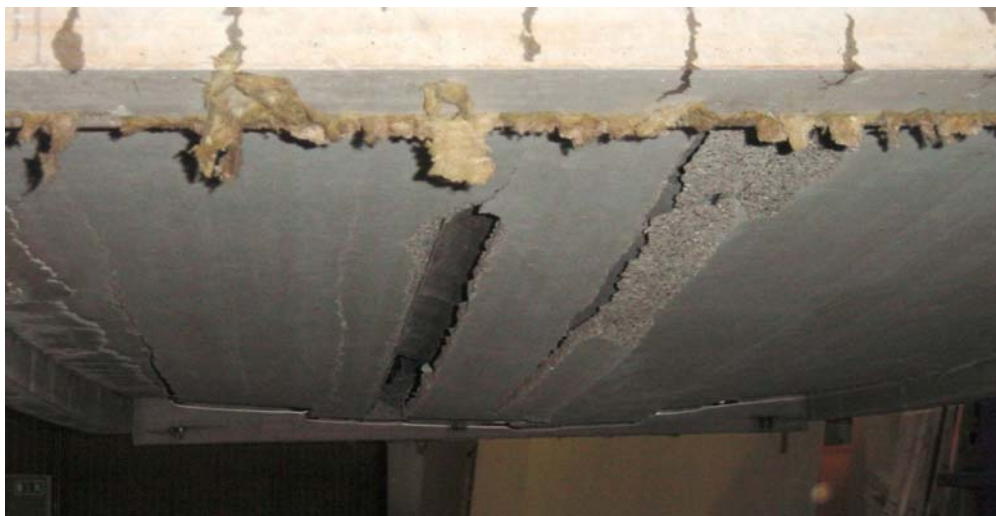
Figure 8. Damages after 25 minutes. Photo K. Hertz.

Lifting the element off the oven, it was seen that the bottom flange was partly fallen down and large cracks were developed to the other channels (Figure 8). No sign of shear failure was seen and the deflection indicated that the failure mode may have been bending. But as explained in the following, the failure modes of shear, anchorage, bending, and de-lamination may be results of the same deterioration of the slab.

Cracks appear along the decks under the channels after 10-15 minutes fire exposure and often the bottom flanges falls down, as shown for example in Figure 8.
