Experimental setup description and raw data from the micro-climate measurement campaign of the outdoor air temperature around an office building in Denmark during summer

Technical Report No. 313

April 2023

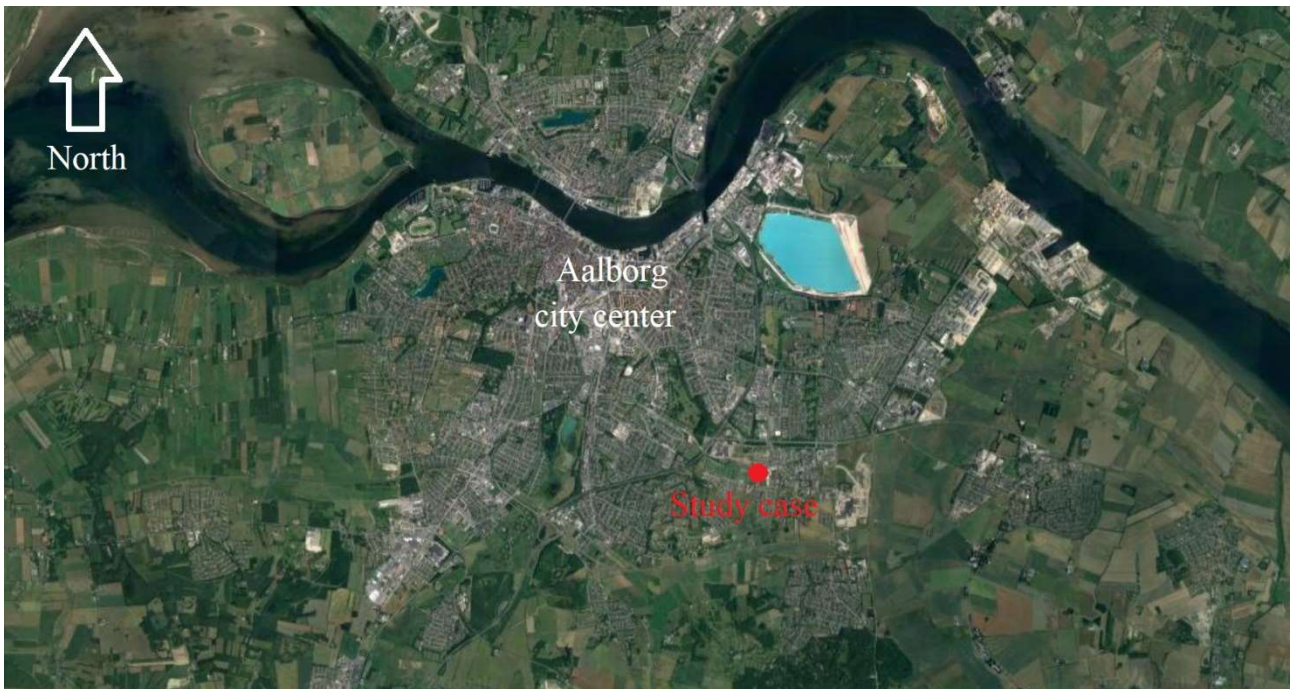
Figure 1: Location of the study case building in the Aalborg urban area.

This study case building (denominated in the rest of the report as “AAU-TMV”) is located at Thomas Manns Vej 23, 9220 Aalborg Øst, Denmark. The building belongs to a university campus situated on the SouthEast edge of the urban area of the city of Aalborg in the north of Denmark (see *Figure 1*).

Aalborg urban area is not a densely-populated city (population density in the municipality area: 178 habitants/km²) surrounded by open flatland agricultural fields. Aalborg is situated in the north of Denmark, in the north of the Jutland peninsula. Aalborg city center is roughly 30 km away from the Kattegat (the sea between the Baltic Sea and the North Sea) in the east and 30 km away from the North Sea in the west. This region is very windy with dominant winds coming from the west.

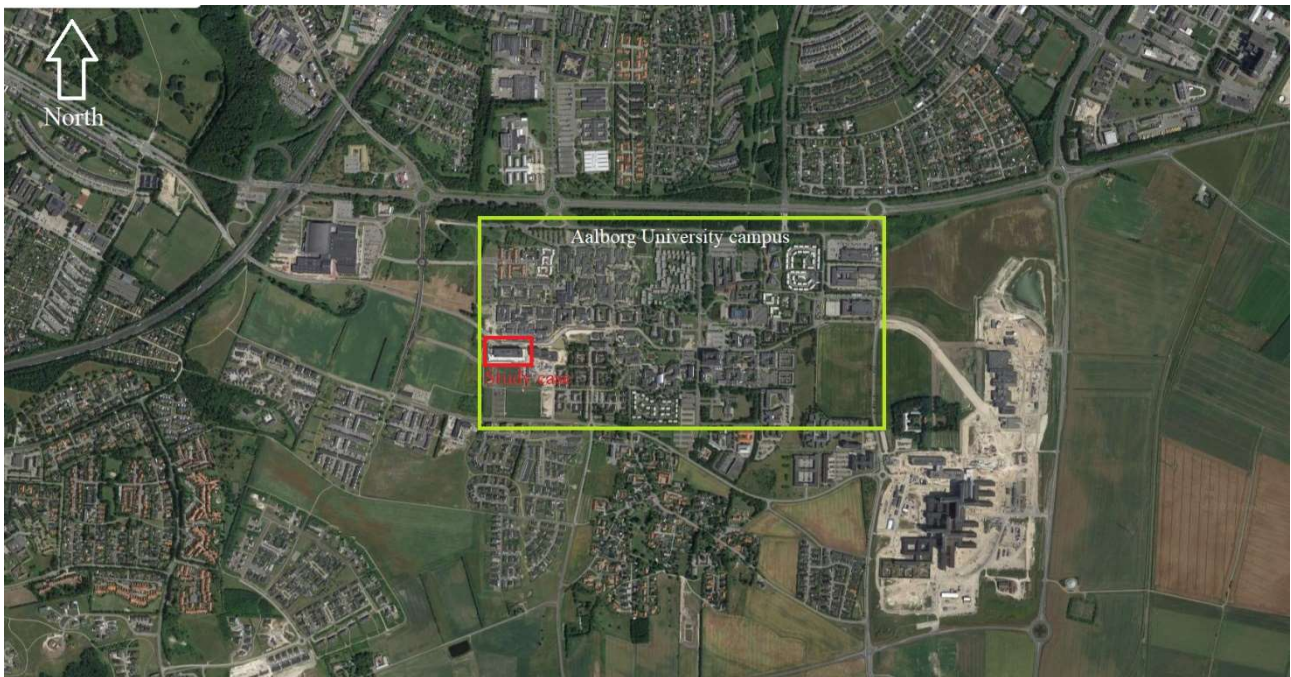
Figure 2: Location of the study case building on the Aalborg University campus.

The study case building is located at the western edge of the Aalborg University campus (see Figure 2).

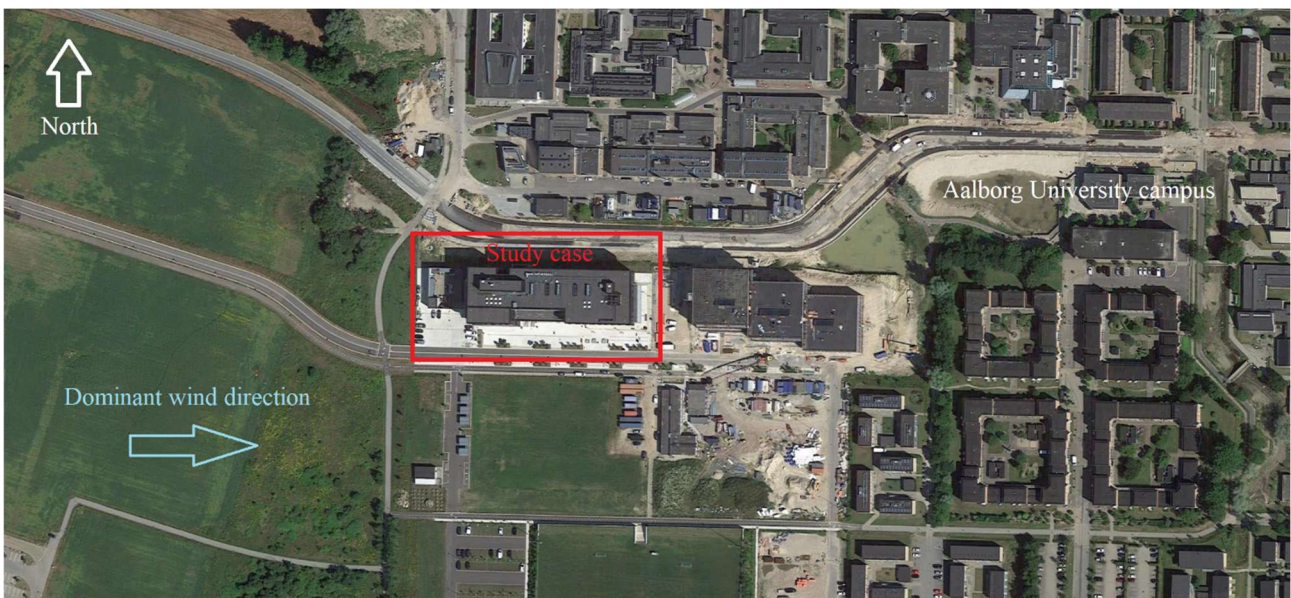
Figure 3: Aerial view of the AAU-TMV building in its surrounding environment on the Aalborg University main campus.

The study case building is surrounded by low-rise (2-3 floors) office buildings to the north, medium-rise office buildings to the east (5 floors) and flatland open fields to the south and west (see Figure 3).

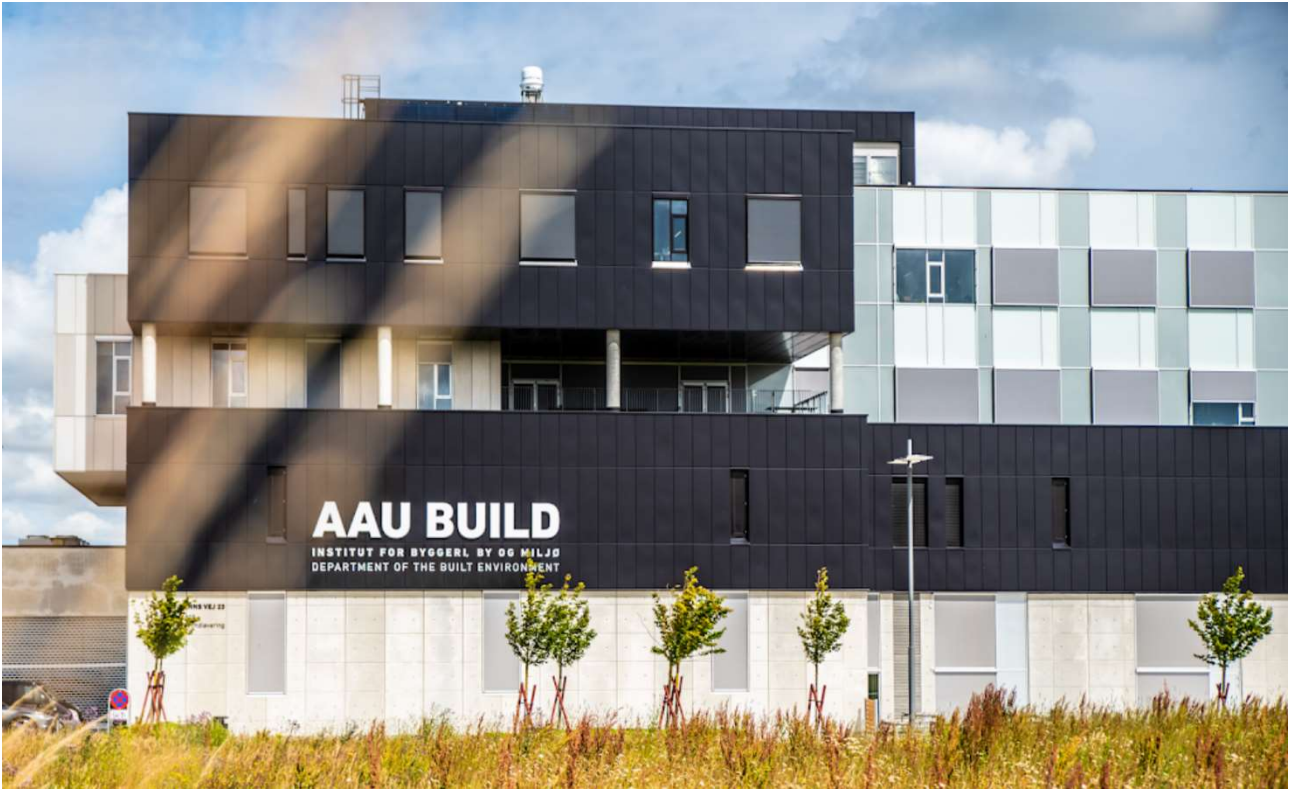
Figure 4: View of the South facade of the AAU-TMV building (credit to Aalborg University).

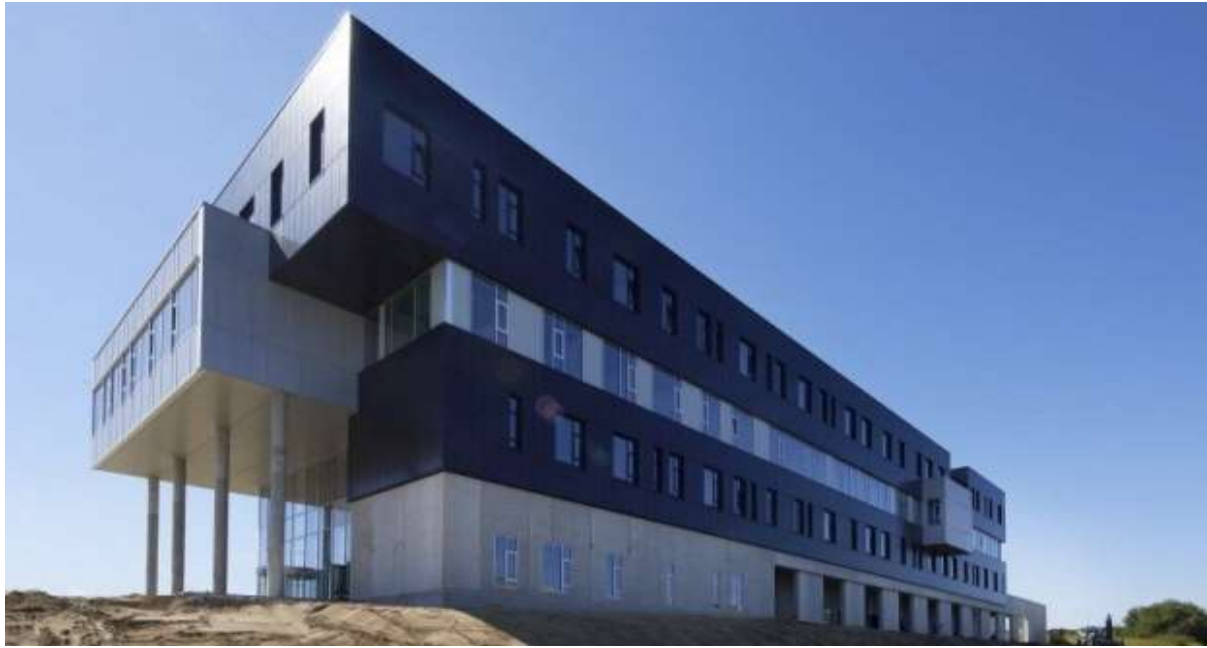
Figure 6: View of the North facade of the AAU-TMV building.

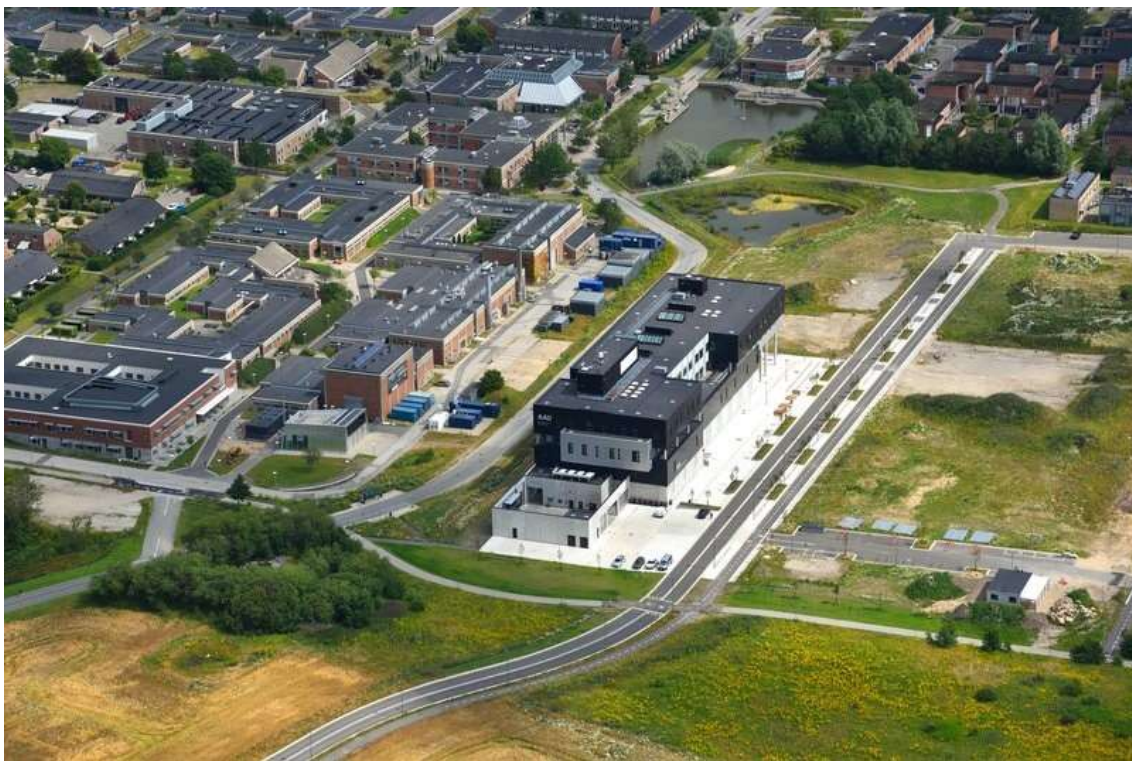
Figure 7: Aerial view of the AAU-TMV building in its surrounding environment on the Aalborg University main campus. The South façade, the West façade and the roof of the building are visible. In 2022, a new building was built on the East side of the AAU-TMV building (upper right corner of the AAU-TMV building in the picture) but was not visible yet in that aerial view. This new building on the East side of the AAU-TMV building was completed and opened on October 2022 (<https://www.aau.dk/grand-opening-e41542>). The measurements on AAU-TMV were carried out in summer 2022, therefore, the external part of the building on the East side was already finished (credit to Aalborg University).

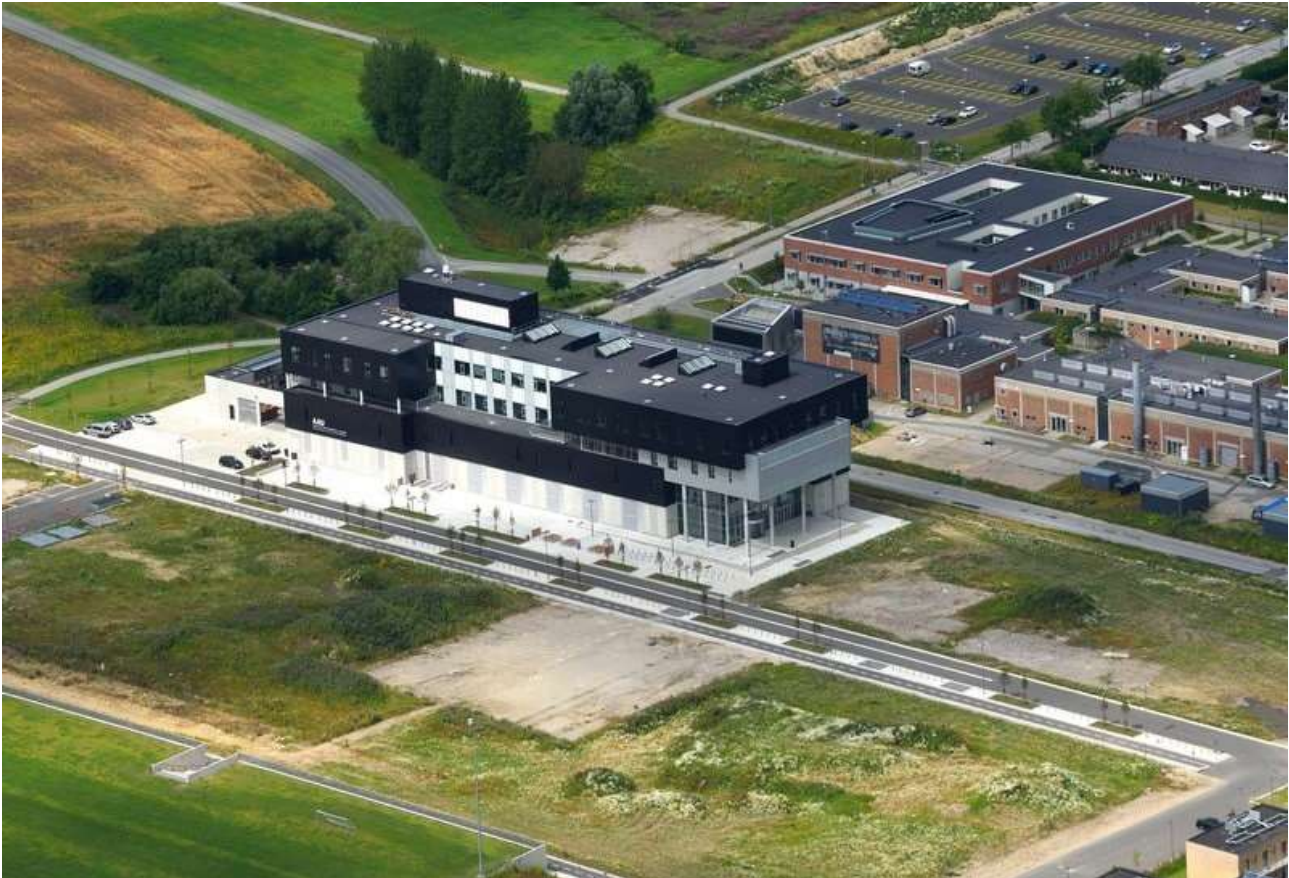
Figure 8: Aerial view of the AAU-TMV building in its surrounding environment on the Aalborg University main campus. The South façade, the East façade and the roof of the building are visible. In 2022, a new building was built on the East side of the AAU-TMV building (right side of the AAU-TMV building in the picture) but was not visible yet in that aerial view. This new building on the East side of the AAU-TMV building was completed and opened on October 2022 (<https://www.aau.dk/grand-opening-e41542>). The measurements on AAU-TMV were carried out in summer 2022, therefore, the external part of the building on the East side was already finished (credit to Aalborg University).

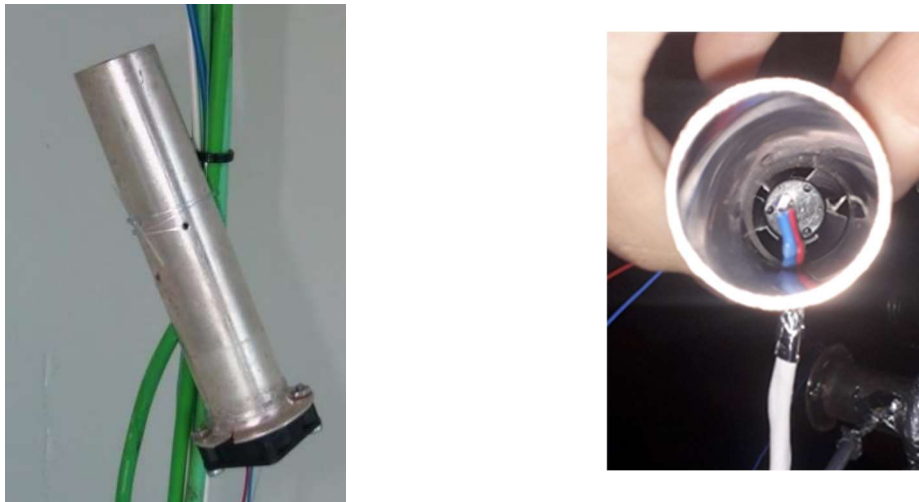
Figure 9: Pt100 temperature sensor placed in a mechanically-ventilated and silver-coated tube.

The presence of direct solar radiation on bare temperature sensors can heavily affect the measurement of air temperature. To tackle this issue, the Pt100 sensors are shielded in a mechanically-ventilated and silver-coated tube [6][7] (see *Figure 9*). Temperature sensors within mechanically-ventilated, shaded tubes are commonly assumed to have errors below 0.1 K [8].

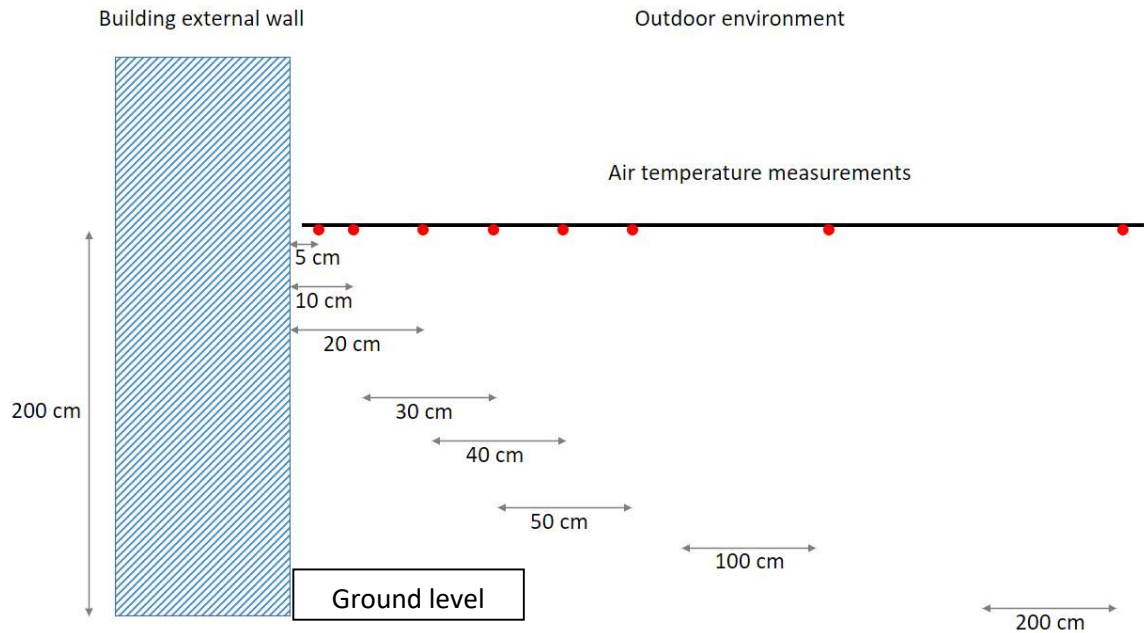
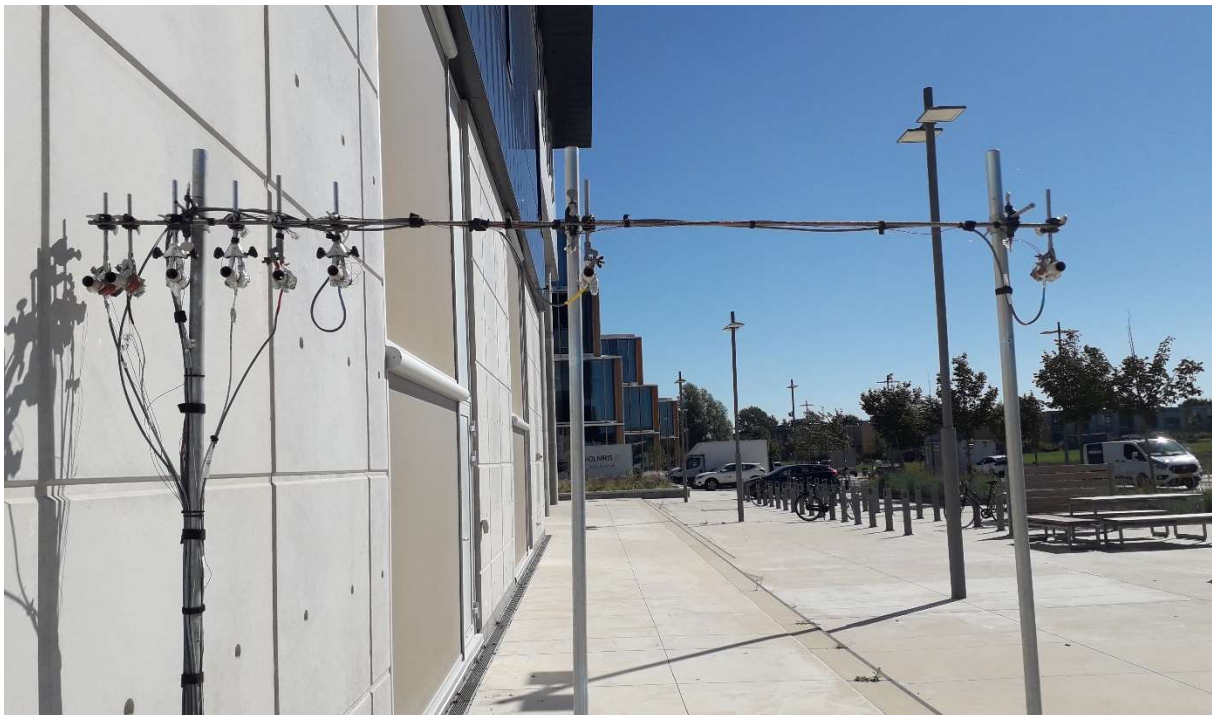
Figure 10: Air temperature measurement setup mounted on the South façade of the building.

The temperature sensors are mounted on racks and poles (see *Figure 10* and *Figure 11*) to measure the air temperature (8 temperature sensors) at 5 cm, 10 cm, 20 cm, 30 cm, 40 cm, 50 cm, 100 cm and 200 cm from the building envelope (South façade, North façade and rooftop). On the North and South facades, the temperature sensors are positioned 2 meters above the ground. The shielding ventilated tubes are mounted horizontally in the East-West direction to avoid any solar radiation from reaching the temperature sensor inside the tube.

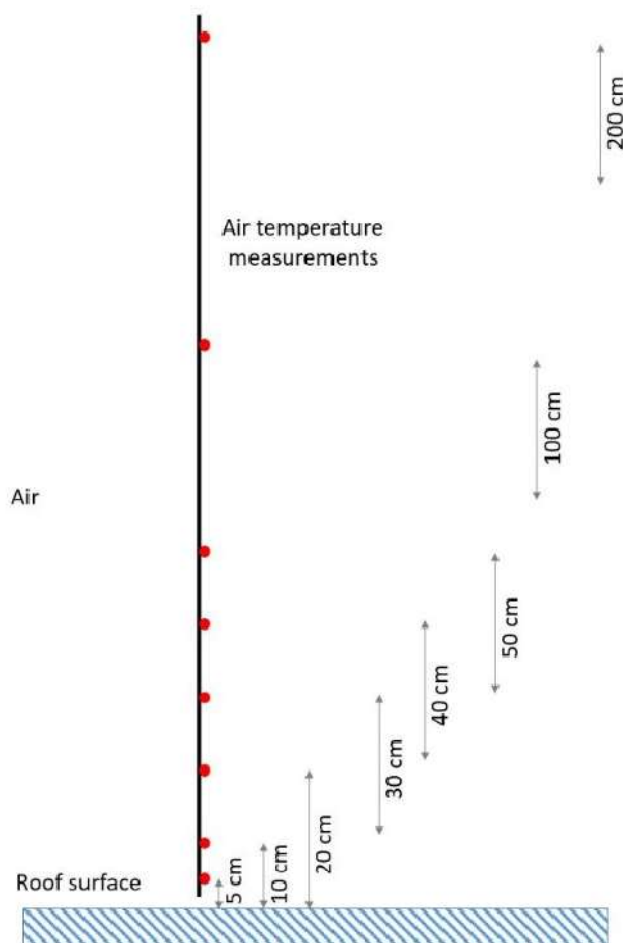
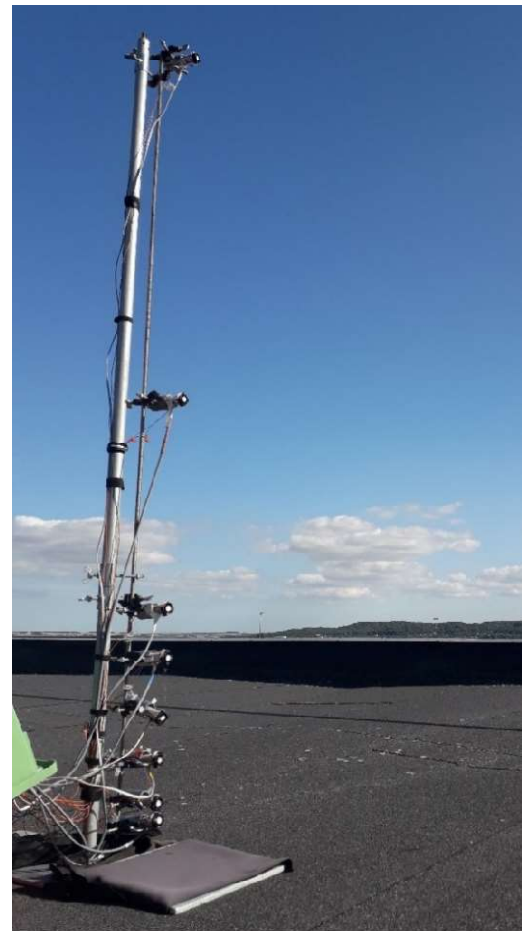
Figure 11: Air temperature measurement setup mounted on the roof of the building.

A black fabric was placed over the silver metal plates of the pole for the roof-mounted setup to replicate the albedo of the surrounding roof (see Figure 11).
