Danish EPA-NR pilot studies

Overall report on the pilot projects

**Energy Performance Assessment
of Existing Non-Residential Buildings**

Overall report on pilot projects

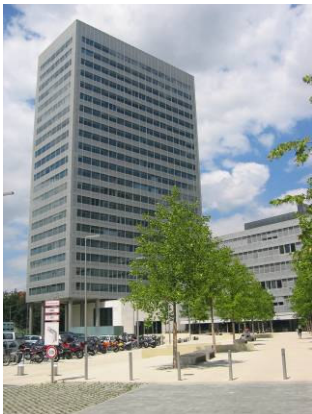
Location And general information	Photo
<div style="text-align: center;">   <p>Munich/Germany</p> <p>Gross area: 27172 m² Year of construction: 2003</p> </div>	<div style="text-align: center;">

</div> <p>Building envelope: Double skin facades with the inner layer as the main thermal insulation, the outer layer is framed glazing, the inner layer has about 70% transparency and 30% opaque areas/ internal solar shadings.</p> <p>Heating/cooling: The building is connected to the district heating system. Heating emission with convectors and ceilings (water pipes in building mass). Meeting rooms are cooled. The cooling generation is realised by a compression refrigeration machine.</p> <p>Ventilation: Hybrid ventilation composed by a central ventilation system with preconditioned air via an earth channel used for winter preheating and summer pre cooling and a big fan in the cellar.</p> <p>Lighting: Lighting is realised by compact discharge lamps with direct mode. The meeting rooms have direct/indirect mode. The ballasts are of the type 'electronic' in the offices and 'low losses' in the other rooms. The lighting control of the office lights is done via the BEMS with an automatic dimming that can be overruled by the user.</p> <p>Specific aspect: The EPBD required certificate was made on the basis of DIN V 18599</p>

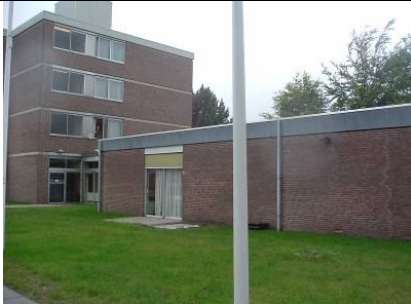
<p>Apeldoorn/The Netherlands</p> <p>Gross area: 3108 m² Year of construction: 1974</p>

<p>Building envelope: Opaque walls are not insulated/ windows consist of double layered glass in second and third floor and single glazed in the two first floors.</p> <p>Heating/cooling: Gas fired high efficiency (condensing) heating system with radiators/ part of building is provided with air conditioning units.</p> <p>Ventilation: Natural ventilation except for toilet and kitchen where exhaust ventilation is installed.</p> <p>Lighting: Conventional fluorescent tube lighting.</p> <p>Specific aspect: Poor indoor air quality due to the low ventilation rates, natural ventilation by opening the windows in winter is not adequate/ the single pane glazing in the two first floors have large dimensions, it's not comfortable in winter.</p>

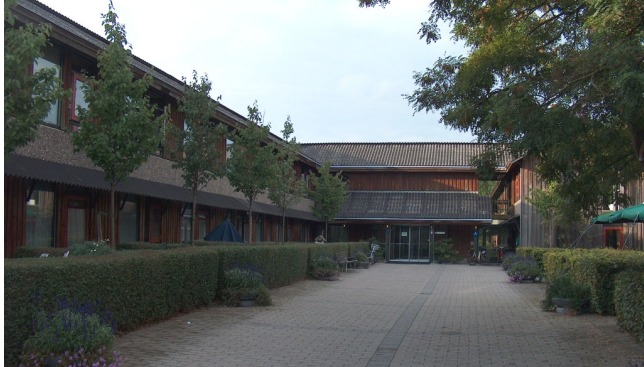
<p style="text-align: center;">Location And general information</p>	<p style="text-align: center;">Photo</p>
<div style="text-align: center;">   <p>Denmark</p> <p>Gross area: 9,562 m² Year of construction: 1977</p> </div>	<div style="text-align: center;">

</div> <p>Building envelope: Pre fabricated concrete elements with wooden covering and minimum insulation (10 cm). Windows are double-glazed. The thermal properties of the claddings are in accordance with building standards of the 70ies. The cladding needs replacement and the rooms upgrade to meet today's standard.</p> <p>Heating/cooling/DHW: Two natural gas boilers operating in cascade supplying a heating system with radiators and DHW; no cooling system. Floor heating system in the bathrooms of the residential sectors.</p> <p>Ventilation: Mechanical ventilation with heat recovery in the service and common sections, natural ventilation in the residential sections.</p>

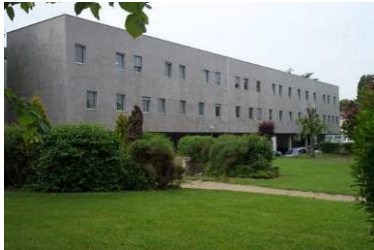
<div style="text-align: center;">   <p>Lagny sur Marne/France</p> <p>Gross area: 9500 m² Year of construction: 1965 + extension in 2003</p> </div>	<div style="text-align: center;">

</div> <p>Building envelope: In renovated and new parts, good insulation of the envelope and double glazing windows with external solar protection / no insulation and simple glazing windows in no renovated part.</p> <p>Heating/cooling: One central heating plant, with two gas fired boilers, connected to different other buildings with heat exchangers in substations for space heating and for sanitary hot water/ floor heating as background emitter and radiators with thermostatic valves/ No cooling system.</p> <p>Ventilation: Mechanical exhaust system and balanced system in renovated and new parts/ ventilation by opening the windows and by infiltration in no renovated part.</p> <p>Lighting: Fluorescent lamps.</p>

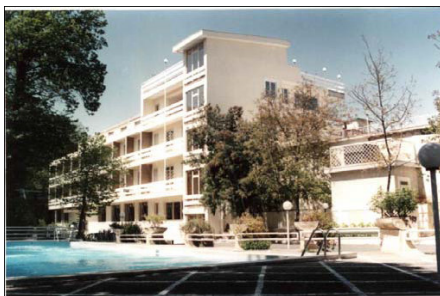
</div> <p data-bbox="301 887 448 916">Fiuggi/Italy</p> <p data-bbox="189 931 558 1021">Gross area: 3200m² Year of construction: late 70' + a new part in 2000</p>	<div data-bbox="756 566 1197 860" data-label="Image">

</div> <p data-bbox="587 878 1370 1001">Building envelop: Old part has a double layer of hollow bricks with air gap , single glazed windows with aluminium frames/ new part has thick alveolar brick with reinforced plastering, double glazing windows with aluminium frames.</p> <p data-bbox="587 1016 1370 1140">Heating/cooling: Two gas boilers feed the heating and DHW systems/ A chiller feeds the fan coil units in the hall and in new rooms and the Air handling units of the restaurant/ radiators in old rooms.</p> <p data-bbox="587 1155 1370 1216">Ventilation: Mechanical ventilation system feeds all the rooms with heat/cool recovery.</p> <p data-bbox="587 1232 1370 1292">Lighting: From obsolete incandescence lamps to compact fluorescent lamps fluorescent lamps manually operated.</p>

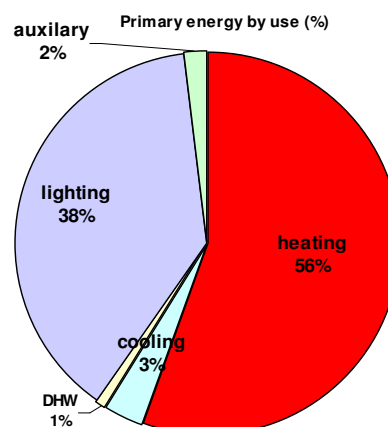
Energy performance assessment with EPA-NR method: the Actual situation

- Primary energy use: **284 kWh/m²/year**
- CO₂ emissions: **63 kg/m²/year**

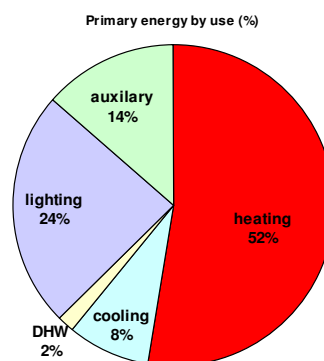
Energy performance assessment with EPA-NR method: the Actual situation

- Primary energy use: **182.5 kWh/m²/year**
- CO₂ emissions: **36.1 kg/m²/year**
