ICCCM'07 : Proceedings of the 2nd International Conference on Coastal Conservation and Management in the Atlantic and Mediterranean

## A HOLISTIC EVALUATION OF A TYPICAL COAST NOURISHMENT ON THE DANISH WEST COAST

### Abstract

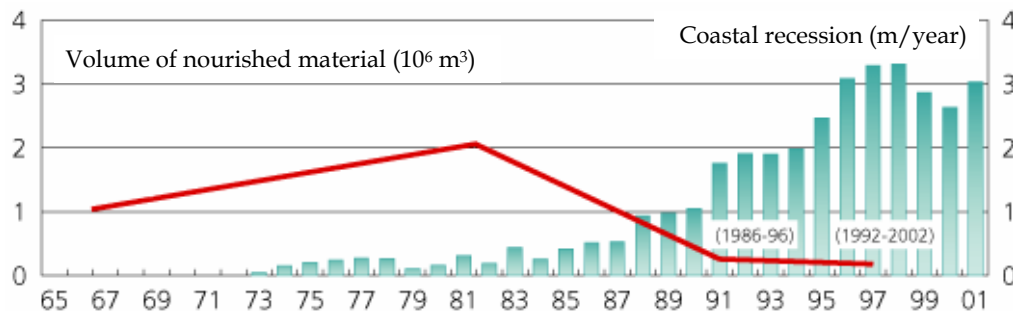
Figure 1. Effect of volume of coast nourishment (bars) applied on coastal erosion (red line) 1966-2001 (Danish Coastal Authority 2007).

Parts of the Danish West Coast are severely eroded and are at present undergoing coastal erosion. Starting in 1875 around 100 groins has been placed in order to protect the coast line (Kystdirektoratet 2005). This kind of system has not been working to well, so new ways of battling coastal recession, together with a change in the common perception of Nature, were invented and applied. This resulted in the realization of the first coast nourishment back in the early 1970'ies (Figure 1).

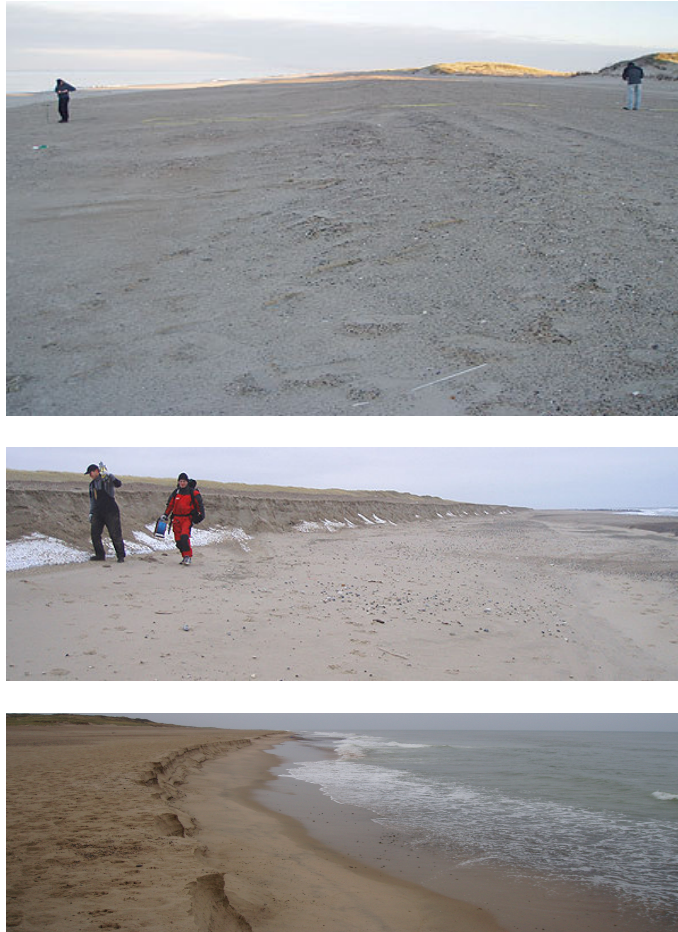
Figure 2. Beach development: gentle slope leading to the shore generates in a dangerous and ugly cliff.

Figure 2 gives examples of the development of the coast nourishment at Ferring. The top photo shows a nice gentle slope beach with characteristics as wanted, while the 2 other photos show an example of the unwanted local cliffs and progressing degradation of the beach. The stick is indicating 1 m height, as much as the vertical extension of the specific slope.

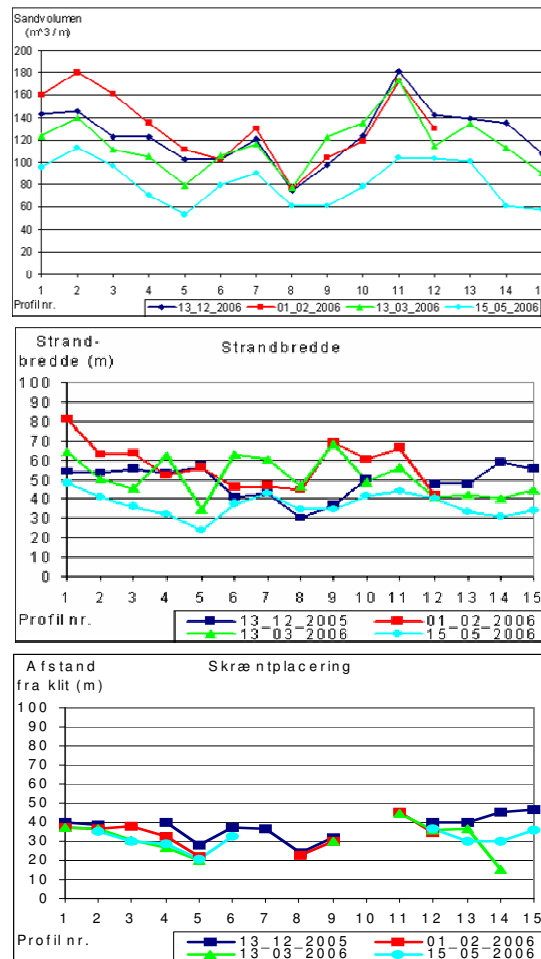
Figure 3. Behavior of the nourishment with regard to the eroded volume in m<sup>3</sup>/m (top), regression of the shore line (middle) and the movements of the cliff (bottom).

The data presented in figure 3 show a considerable regression of the shore line and a reduction of the beach volume of approx. 40 m<sup>3</sup>/m after the winter (Figure 3, top). In a condition where 32% of the initial nourishment is lost after a typical winter, its life time is expected to be only 3- 5 years. In fact, the beach becomes more and more narrow (Figure 3, middle) and after such a period, a new nourishment must be planned. The development of a cliff occurs immediately and the cliff then moves further inland with the protruding regression of the beach (Figure 3, bottom).

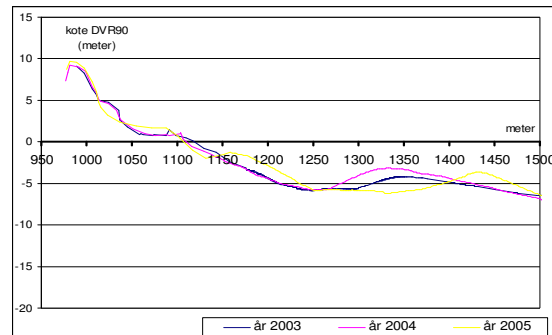
Figure 4. Scanned profiles of the beach at Ferring site (Holmgren et al. 2006b).

In the year of the nourishment (2005) the profile of the beach has been scanned and compared to the profile of the beach of 2004 and 2003 (Figure 4). It is obvious that the eroded volumes deposit just a few meters in the water, creating a very close to shore bank and probably moving the 1,300 m bank to 1,430 m. In this way the bathymetry of the littoral has been changed by the coastal nourishment

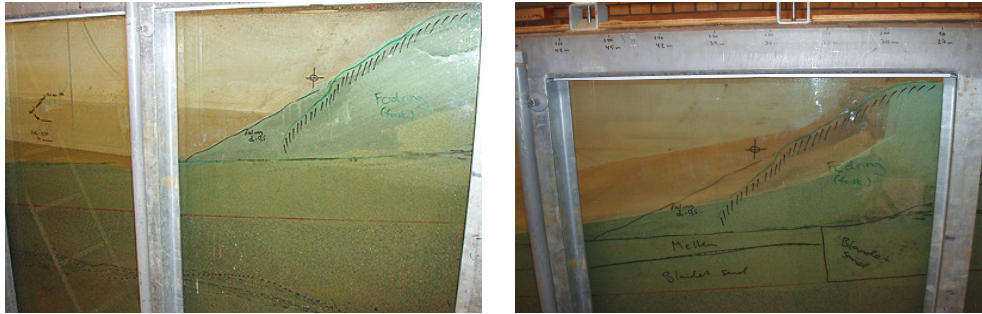
Figure 6. Profile of the beach before (left) and after (right) the test, (Holmgren et al. 2006a).

Measurements have been done at the beginning and at the end of each test (Figure 6). A laser profiler mounted on rails on the flume enabled the estimation of the damage to the protection (Figure 7 left). The laser profiler can plot the results of the profile measurements in real time and constitutes a user friendly interface with the EPro software. In a second time it is possible to calculate the damage in terms of lost volumes to the protection (Figure 7 right). Waves have been measured by wave gauges and generated by AwaSys 5.

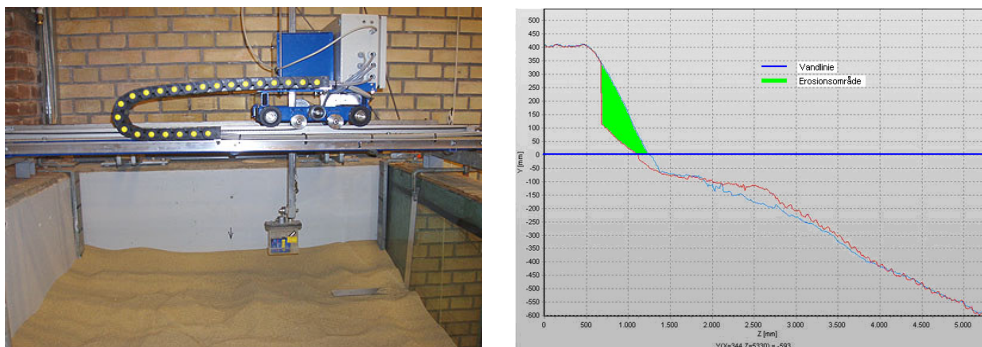
Figure 7. The laser profile and a measurement of the eroded area (section). (Holmgren et al. 2006a).

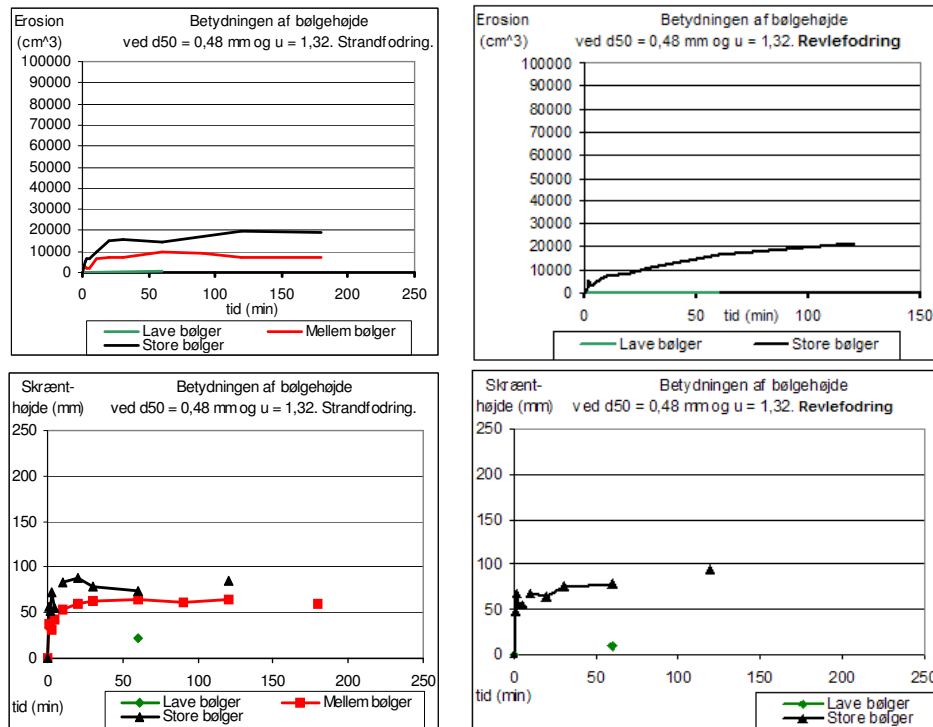
Figure 8. Laboratory results of erosion in volumes (top) and height (down) for the beach (left) and for the sandbanks (right) for a mix sand.

In figure 8 the erosion of the nourishment on the beach (left) and on the sandbanks (right) is reported. On the top, the eroded volumes under small, medium and storm wave regimes for the mixed sand nourishment ( $d_{50} = 0.48$  mm and  $d_{50} = 1.32$  mm in equal parts) appear to increase constantly on the beach. As it is obvious, the higher erosion occurs for storm waves. On the lower graphics, the height of the erosion is plotted against time. It seems as if the erosion of the sandbank reaches the equilibrium before the erosion on the beach.

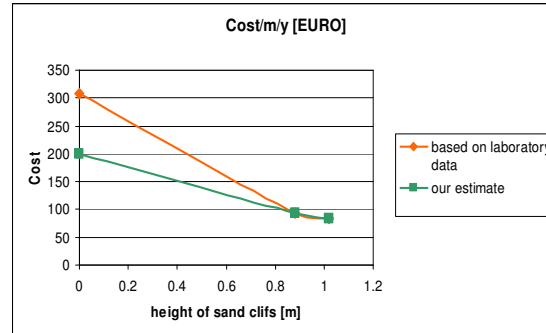
Figure 9. Cost per meter per year for a more efficient nourishment taking into account scale effects.

In figure 9 the cost per meter per year of different nourishments is plotted; the upper curve represents the cost of nourishment works derived from laboratory measurements of eroded volumes of sand, while the lower one is the estimation that takes into account a correction for scale effects on experimental measured eroded volumes.

It appears that in order to avoid the formation of the cliff, the investment on the nourishment work should be twice the actual investment that actually allows the formation of the cliff up to 1 m height. This cost is estimated to be around 200 Euro par meter par year.
