A Holistic Evaluation of a Typical Coast Nourishment on the Danish West Coast

Journal of Coastal Conservation

A holistic evaluation of a typical coast nourishment on the Danish West Coast

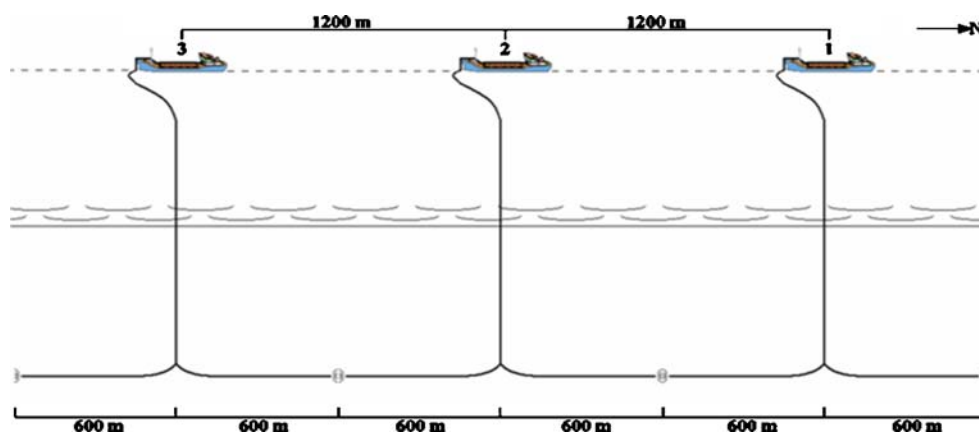
Fig. 4 Sketch of the procedure for beach nourishment

Figure 4 summarizes the procedure for the nourishment: the length of 4.7 km can be covered with four different placements of the sand-pump dredger. Figure 5 shows the final beach profile. Owing to the inherent characteristics of the applied material and the actual wave climate the nourishment developed into an unwanted cliff.

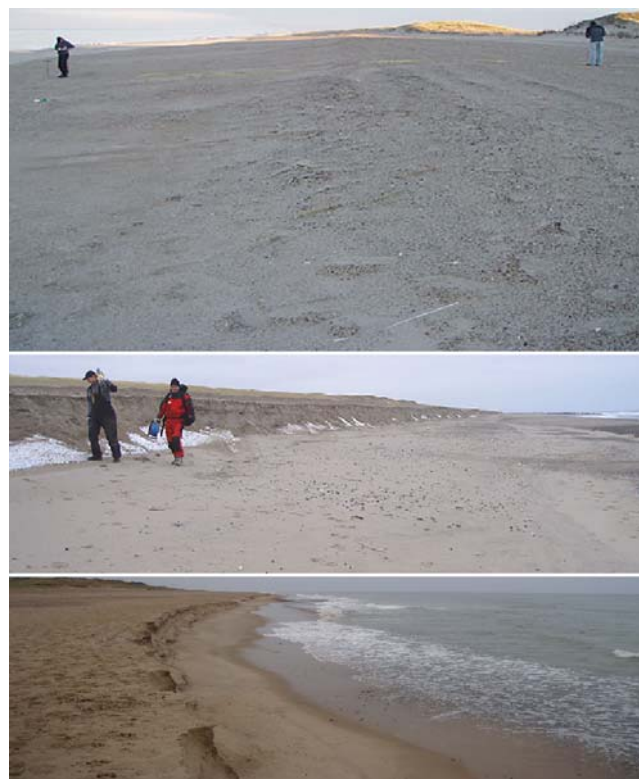
Fig. 6 Beach development: gentle slope leading to the shore generates in a dangerous and undesirable scarp for recreational beach visitors

Figure 6 gives examples of the development of the coast nourishment at Ferring. The top photo shows a nice gentle slope beach with characteristics as wanted, while the two other photos show an example of the unwanted scarp and progressing degradation of the beach.

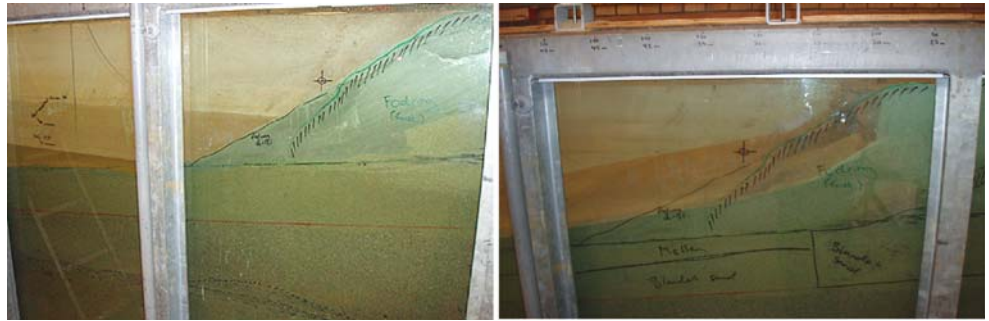
Fig. 11 Profile of the beach before (left) and after (right) the test (Holmgren et al. 2006a, b)

Measurements have been done at the beginning and at the end of each test (Fig. 11). A laser profiler mounted on rails on the flume enabled the estimation of the damage to the protection (Fig. 12, left). The laser profiler can plot the results of the profile measurements in real time and constitutes a user friendly interface with the EPro software (AAU 2004b). In a second time it is possible to calculate the damage in terms of lost volumes to the protection (Fig. 12, right). Waves have been measured by wave gauges and generated by AwaSys 5 (AAU 2004a).

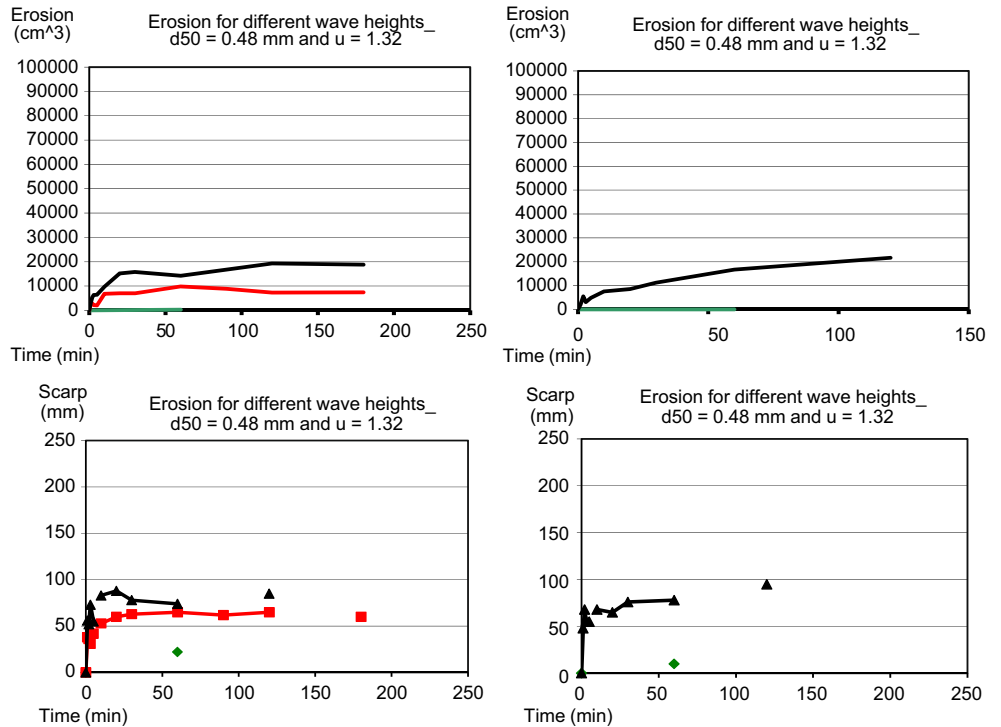
Fig. 13 Laboratory results of erosion in volumes (top) and height (down) for the beach (left) and for the sandbanks (right) for a mix sand. The black line is for large waves corresponding to storm conditions, the red for medium waves and the green line or dots are for small waves

In Fig. 13 the erosion of the nourishment on the beach (left) and on the sandbanks (right) is reported. On the top, the eroded volumes under small, medium and storm wave regimes for the mixed sand nourishment ($d_{50}=0.48$ mm and $d_{50}=1.32$ mm in equal parts) appear to increase constantly on the beach. As it is obvious, the higher erosion occurs for storm waves. On the lower graphics, the height of the erosion is plotted against time. It seems as if the erosion of the sandbank reaches the equilibrium before the erosion on the beach.

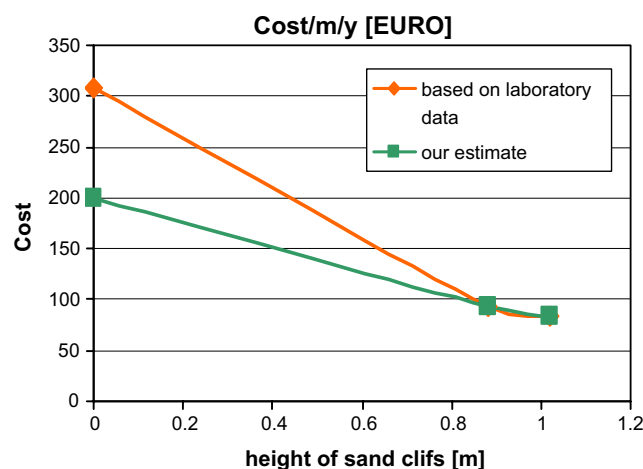
Fig. 14 Cost per meter per year for a more efficient nourishment taking into account scale effects

In Fig. 14 the cost per meter per year of the two different kind of nourishments is plotted; the upper curve represents the cost of nourishment works derived from laboratory measurements of eroded volumes of sand, while the lower one is the estimation that takes into account a correction for scale effects on experimental measured eroded volumes.

It appears that in order to avoid the formation of the scarp, the investment on the nourishment work should be twice the actual investment that actually allows the formation of the scarp up to 1 m height. This cost is estimated to be around 200 Euro par meter par year.
