## Elektrisk miljø i svinestalde

Silva, Filipe Faria Da; Bak, Claus Leth

**3/14/2013**

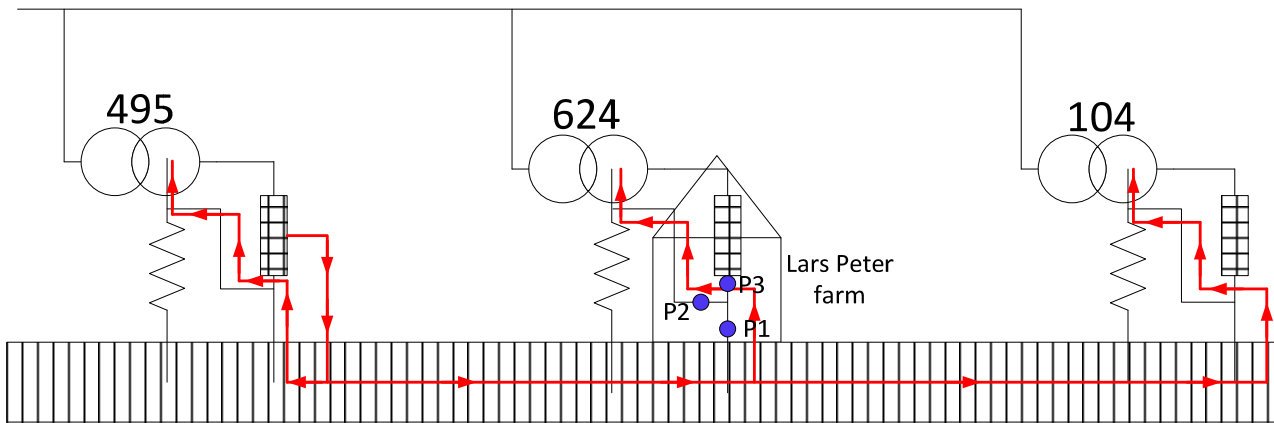
Figure 1 – Current ground return paths

As example, an unbalance at the zone of transformer 495 could result in a distribution of currents as shown in Figure 1, in which for some reason, as a bad connection, the current is flowing to the ground at one point. This current will then flow to the neutrals of the different transformers in the area. The same neutrals that are connected to the ground at the transformer and at the loads though the neutral wire. The path with lower impedance is precisely through the neutral wires, thus, the majority of the current would flow in the ground until the load neutral point, which is also connected to the ground, and then to the transformer neutral in the neutral wire. In this specific example, using a one dimension representation and ground wires of equal length, the only differencing factor would be the ground impedance, resulting in current with a similar magnitude order in all three conductors, being larger in 495 and smaller in 104.

This scenario can also happen if for some reason the neutral wire between one load and the respective transformer has large impedance when compared with the other neutral connections. In this case part of the current would flow to the ground and return through the other neutral wires.

If such scenarios occur the current would flow in the ground around Lars Peter farm and may be responsible for the animals' stress.

This case can be verified on different ways. The most accurate and easy is most likely to measure the current in three points at Lars Peter house:

- Current in the connection between the neutral point and the ground (P1 in Figure 1)
- Current in the neutral wire (P2 in Figure 1)
- Current just before the neutral point from the house side (P3 in Figure 1) – Not necessary, but helpful for the validation of the results
- Current in the transformer's grounding

If the current at P1 is in phase with the current at P2, for a direction ground-to-neutral, it means that this phenomenon is happening.

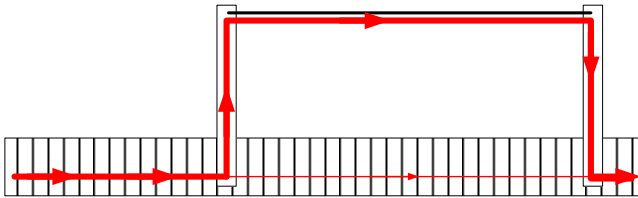
Figure 5 – Measurements of the current flowing in the ground

However, this needs to be checked with a further measurement. Two ground rods will be installed in the ground some meters from each other and then short-circuited. The current in the wire connected the two rods will then be measured as shown in Figure 5.

The current was measured between a grounding stick installed approximately 5m ways from the farm grounding, by short-circuiting both. Only noise was measured.

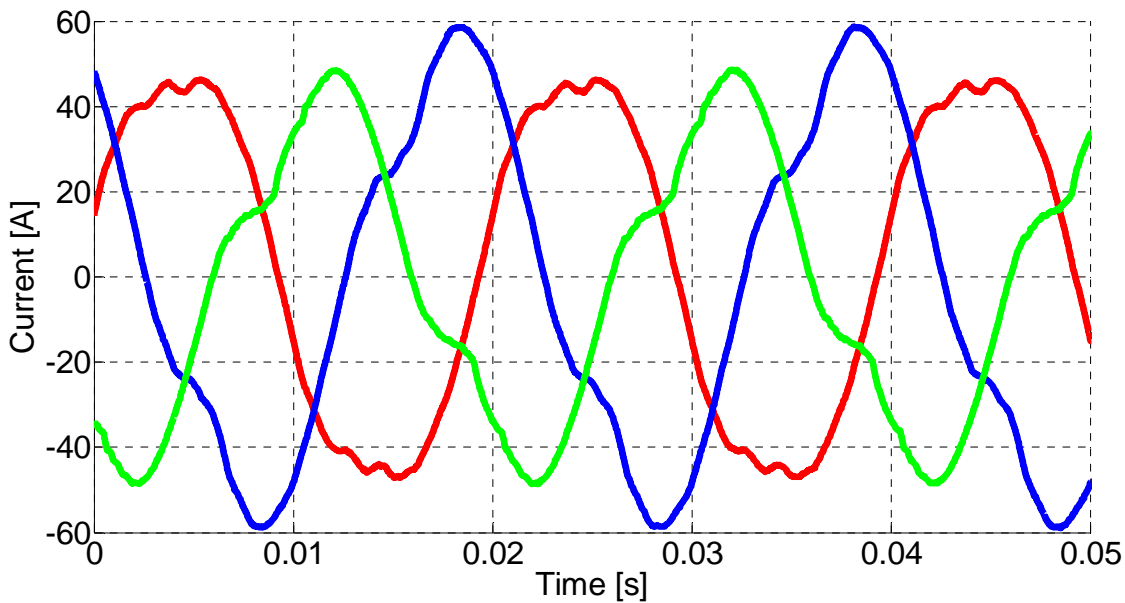
Figure 7 – Currents into the farm: Phase A: Red; Phase B: Blue; Phase C: Green

Figure 7 shows the measurements results. It is possible to manipulate the data so that there is  $120^\circ$  phase difference between the phases and then use these results to estimate the neutral current. It is known that there is an error in the estimation as the currents were not measured at exactly the same instant. Yet, the results can still be used to confirm the previous measurements.

**Current harmonics:** There is a big unbalance between the three phases, as well as strong harmonic content (Figure 7). As the feeder transformer is connected only to the farm, the unbalance is caused by the farm's loads (computers, ventilation, equipment using electronics and power switches, ...).

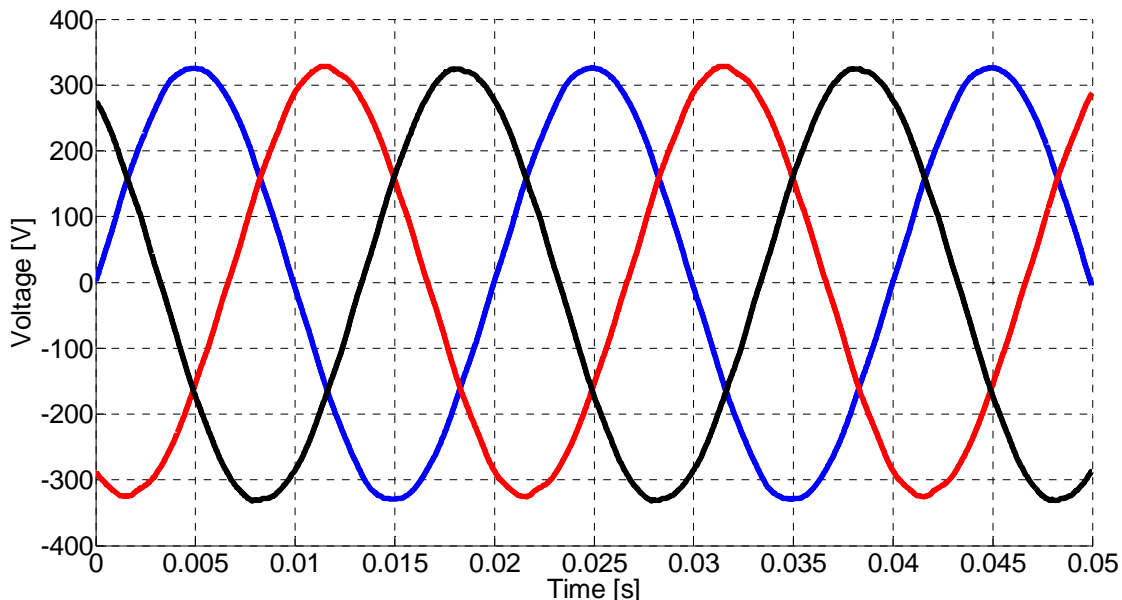
Figure 10 – Voltage from phase-to-neutral

Figure 10 shows the voltage from phase-to-neutral at the entrance of the farm. The voltage is very balance and very small harmonics are present. The waveforms are well inside the standard limits as should not be of concern.
