*case studies detailed report*

# **The Integrated Renovation Process Case Studies Detailed Report**

**DCE Technical Report No. 165**

February 2014

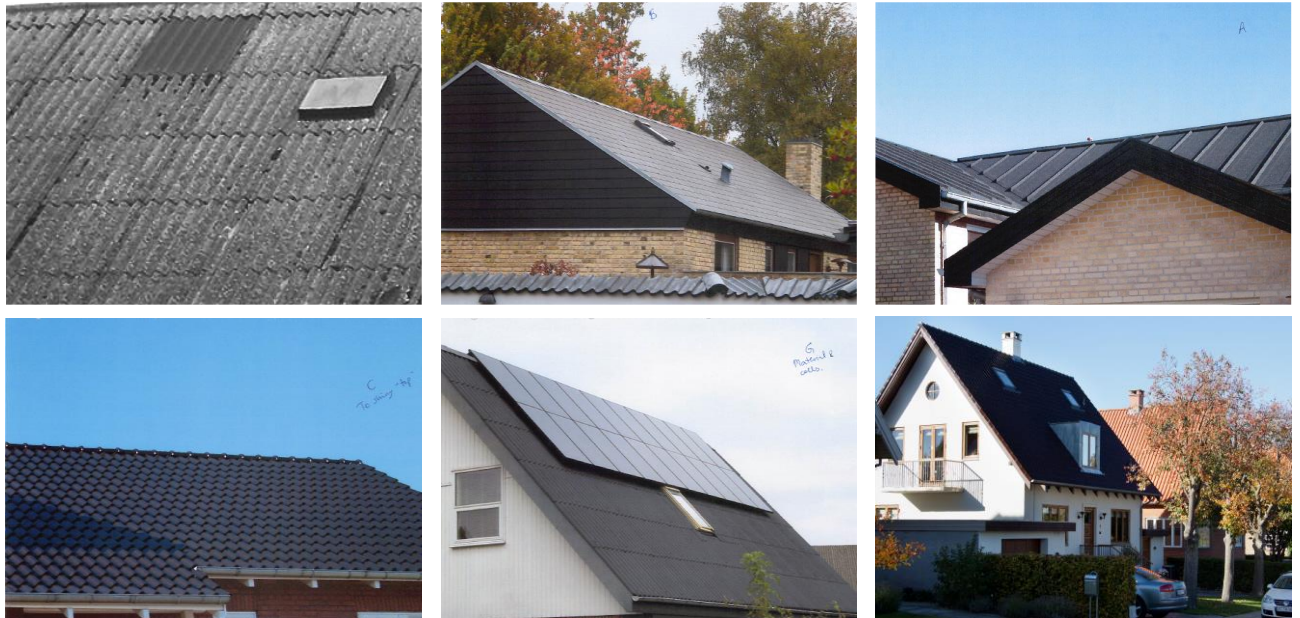
**Figure 97: Examples of visual supports used for the evaluation of the immaterial values (Photographers: Mathias Sønderskov Nielsen & Nicolas Galiotto)**

The evaluation of immaterial values has been based on the same themes used for the evaluation of the house in the existing conditions. Visuals were used by the building expert to illustrate the possibilities of improvement and support the homeowners in case of doubts (see Figure 97).
