Model for Refurbishment of Heritage Buildings

Published in:
ICBEST 2014 - International Conference on Building Envelope Systems and Technologies

T. Valdbjørn Rasmussen

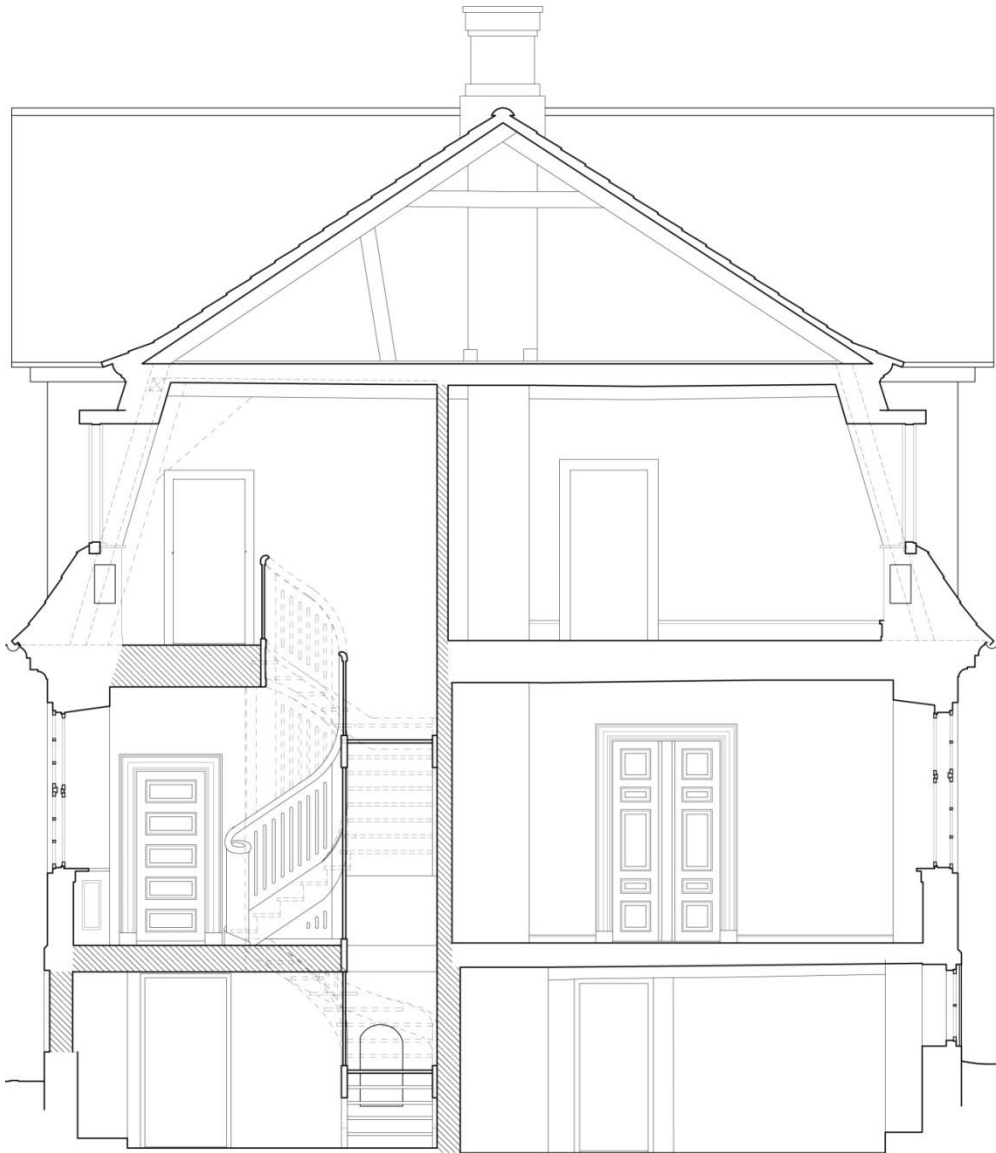
Figure 2. Structural section of the supervisor's residence included in the listed complex, *Fæstningens Materialgård*.

Each of the buildings in the complex has fundamental heritage values. The supervisor's residence was used for the case determining feasible refurbishment measures, as it is recognised as the main building in the complex. The supervisor's residence, see Figure 2, is recognised by its representative character and position in the hierarchy of the complex, the hierarchy between the storeys, the rooms and interiors containing a mix of historic styles and the joinery detailing. The supervisor's residence is characterised as the 'grandest' building in the complex, and there is a desire to expose and enhance the fine, richly furnished interiors.

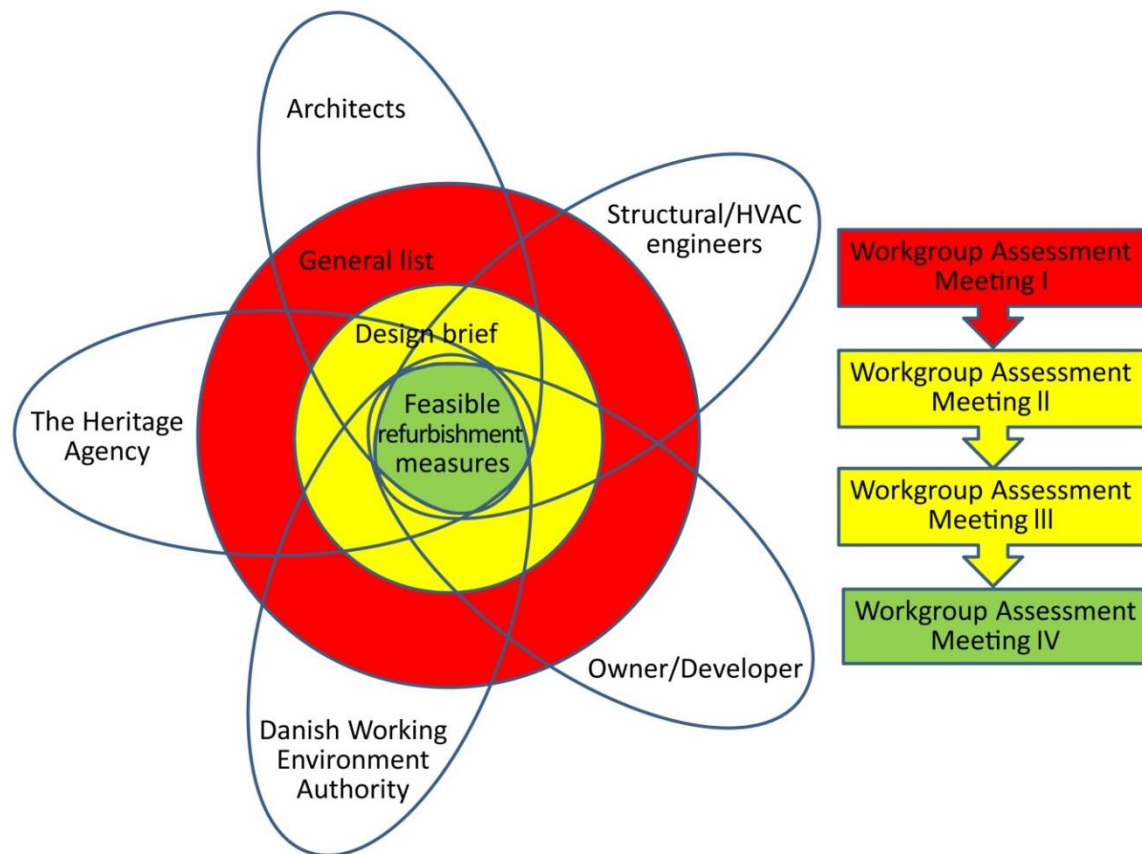
Figure 3. A sketch of the model for cooperation between parties that refurbish heritage buildings.

A sketch of the model for selecting feasible refurbishment measures through a series of workgroup assessment meetings is shown in Figure 3.

The model consists of a series of meetings identifying feasible measures to refurbish and upgrade a heritage building in order to achieve a reduction of the energy consumption. Every process is gathered around a body of decision-making meetings called the workgroup assessment meetings. The aim of the process was to select feasible, acceptable measures. For the shown case, *Fæstningens Materialgård*, the authorities were represented both by the Heritage Agency and the Danish Working Environment Authority. Each specific case might need expertise from a different set of experts and authorities. Figure 3 shows a sketch of the model. The refurbished *Fæstningens Materialgård*, [5] is shown in photos in Figure 4.

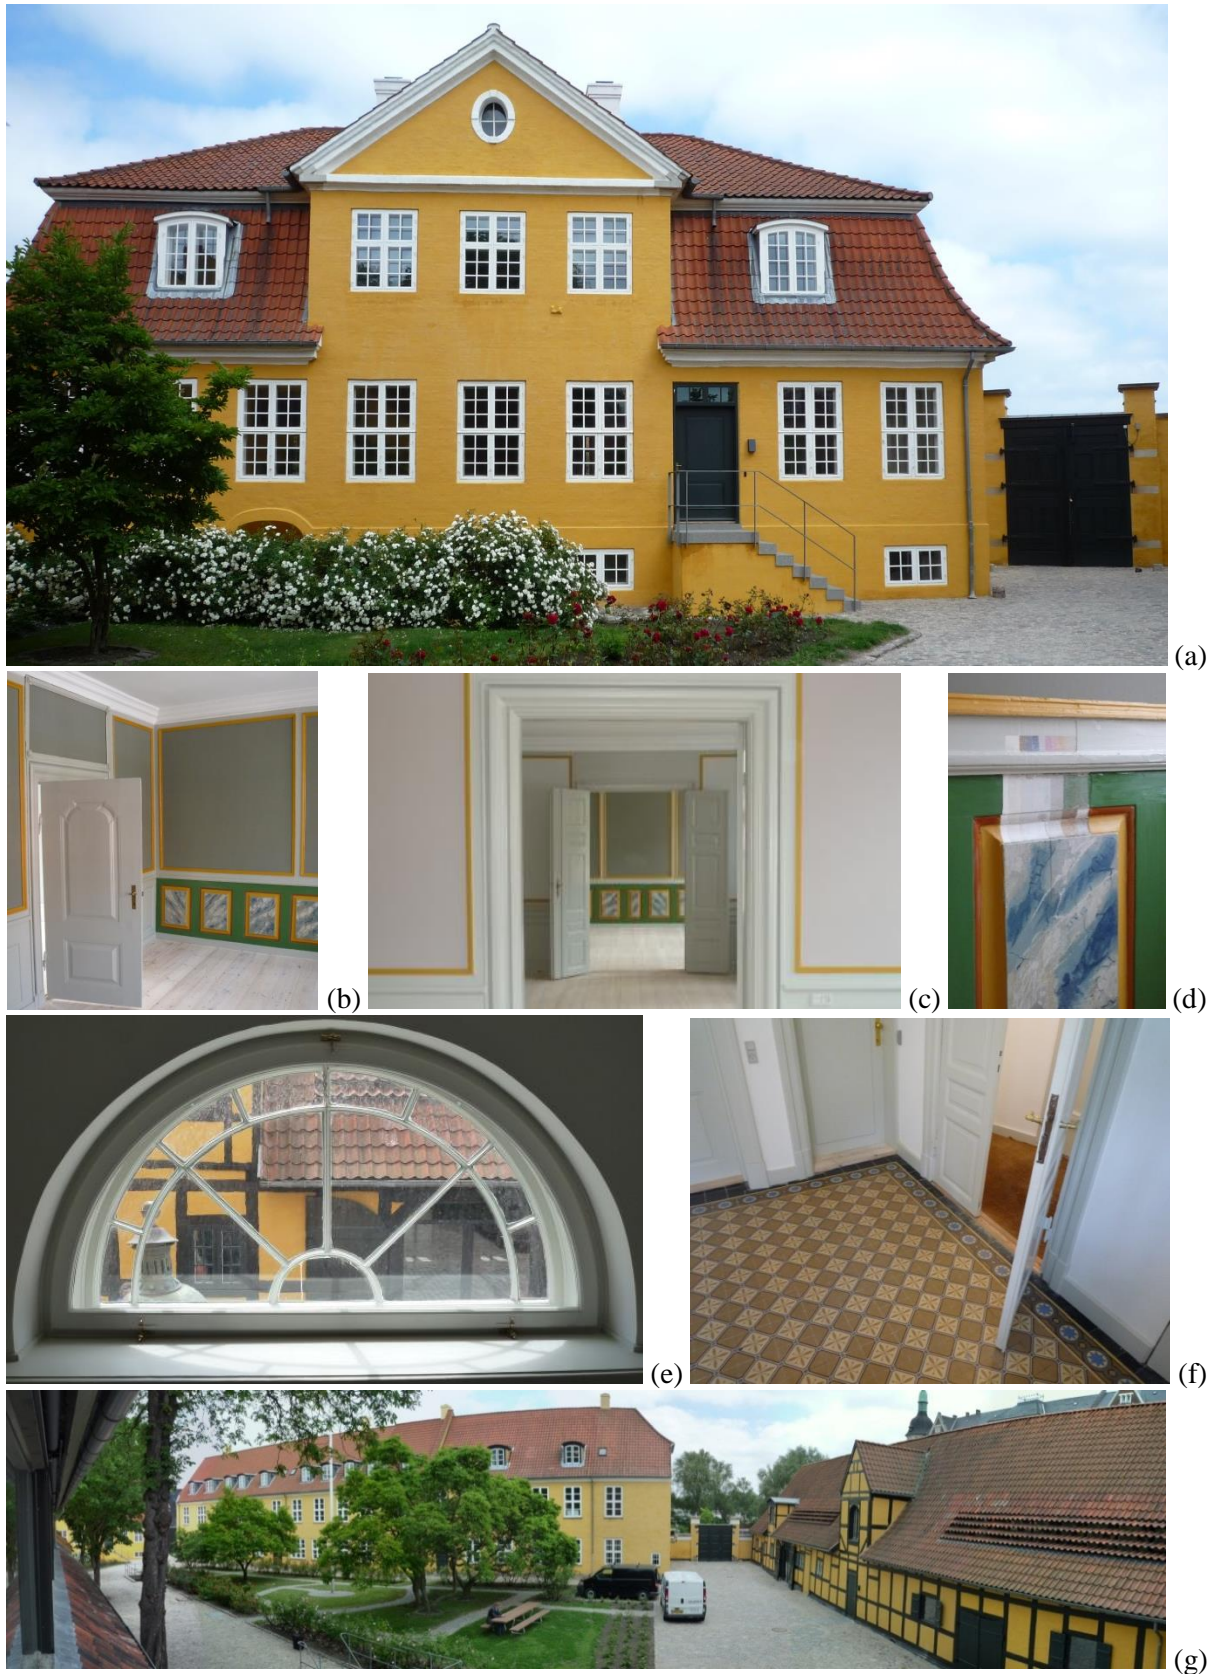
Figure 4. Photos of the refurbished listed complex, *Fæstningens Materialgård*. a) The supervisor's residence including the photos Figure 4 b) to Figure 4 f), b) Entrance to the main living rooms, c) The living rooms, three rooms in a row lying towards the street, d) Layers of paint found during the restoration and now reviled, e) A window in the staircase, f) The floor-tiles in the entrance hall and staircase, g) Panorama view over the courtyard of the refurbished listed complex, *Fæstningens Materialgård*.

Calculations were carefully reviewed and for the supervisors dwelling they showed an overall reduction in transmission loss of 27% and an overall CO₂ reduction of 20% achieving an acceptable workspace with a thermal indoor climate level of Class C. The refurbished supervisor's residence is shown in photos in Figure 4 a) to Figure 4 f).

Individual feasible refurbishment measurements were found for the restoration and energy upgrading of each of the individual buildings included in the listed complex. The refurbished complex is shown in Figure 4 g).
