Vibration-Based Damage Identification in Wind Turbine Blades

Ulriksen, Martin Dalgaard; Tcherniak, Dmitri; Damkilde, Lars

Publication date:
2015

Ulriksen, M. D., Tcherniak, D., & Damkilde, L. (2015). *Vibration-Based Damage Identification in Wind Turbine Blades*. Poster presented at WIND ENERGY DENMARK, Herning, Denmark.

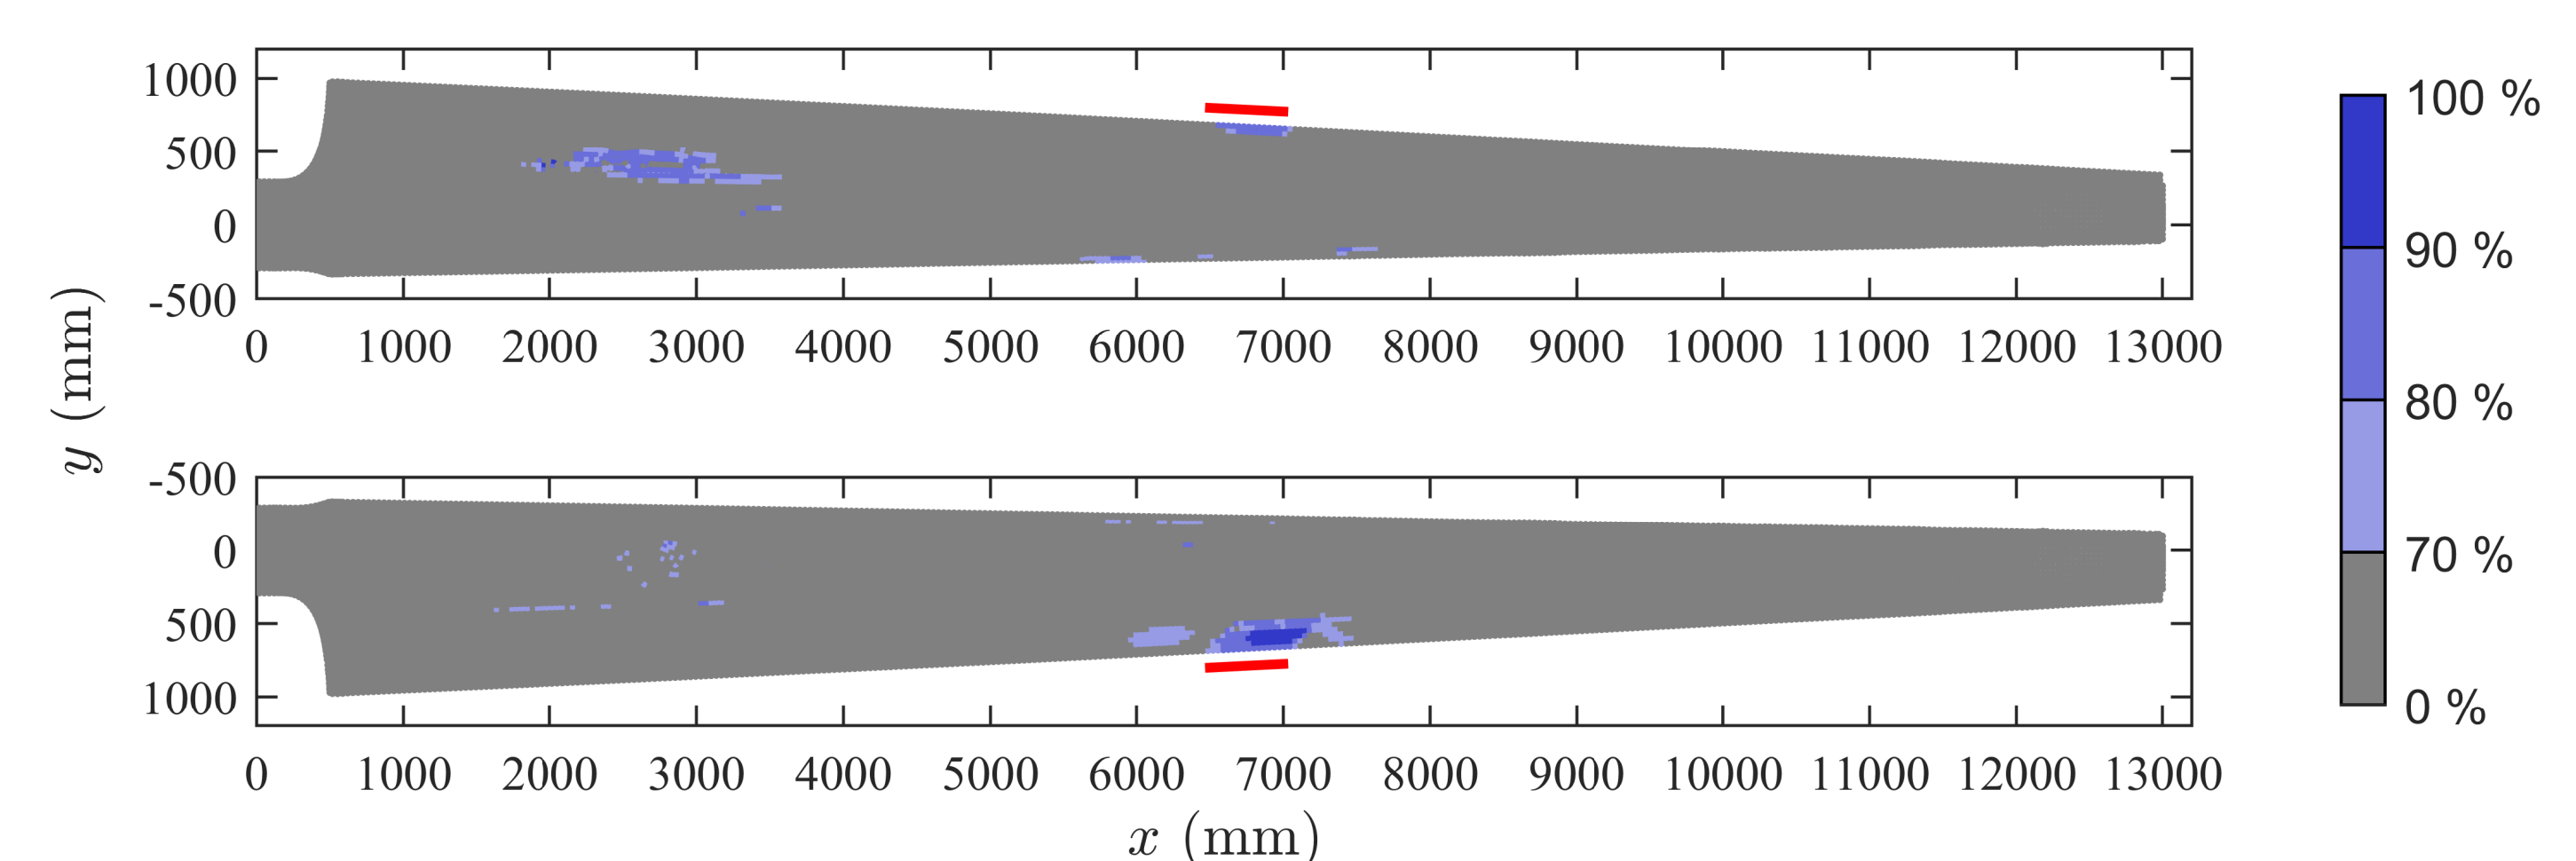
Fig. 3: Localization and assessment of 45 cm crack in idle-conditioned V27 blade. The percentage scale indicates how many times each element has been classified as damaged. The red lines mark the damage location.

► Damage localization and assessment during idle condition [5]:
