## Architectural qualities of Danish office buildings built between 1960 and 1980, seen in a contemporary sustainable perspective

*Published in:*  
Eco-Architecture VI

# Architectural qualities of Danish office buildings built between 1960 and 1980, seen in a contemporary sustainable perspective

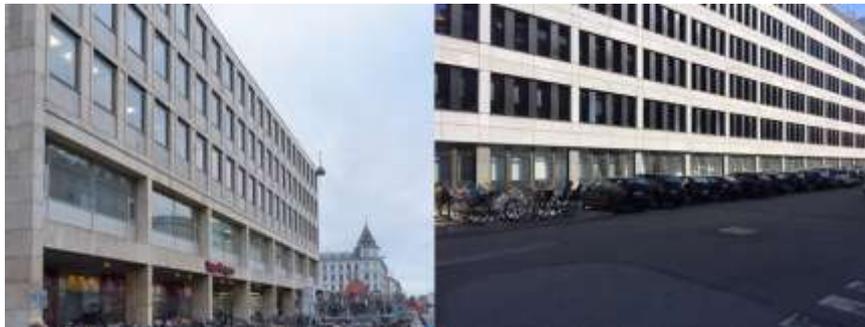
Figure 1: Concrete facades will often be dominated by white or light grey colours.

In this period, concrete was used in many buildings as a facade material, and it was thought to be a durable material. However, later it was shown that it was prone to cracking and the steel reinforcement to rust. The result was discoloration and in many situations the bearing elements were weakened and needed repairing (A. Dragheim) [8]. Due to using different components in the facade, there was a need to use sealing materials and techniques between them. Not all of these materials showed long-term durability, and there were many problems regarding water and wind tightness. Many types of wood used were of low quality and the wood wasn't impregnated properly, which led to some parts, such as window frames, rotting within a short time (A. Dragheim) [8].

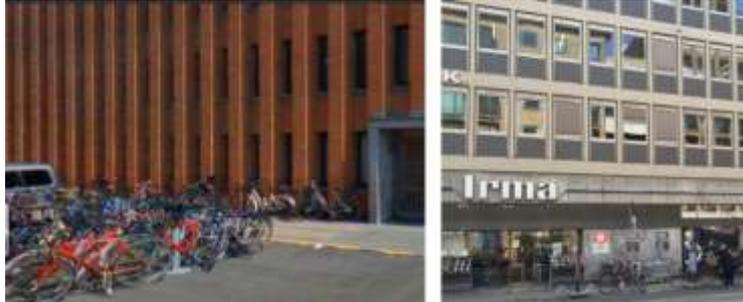
Figure 2: The repetition of similar squared or vertical elements of the facades.

Regularity introduced rhythm and repetition that were achieved by standardized elements and modular coordination. The repetition of similar elements in the facades of the office buildings was noticed in many cases. In some cases, the repetition can, with the help of other effects like shadows, give the facade an interesting pattern that changes with the movement of the shadows through the day.

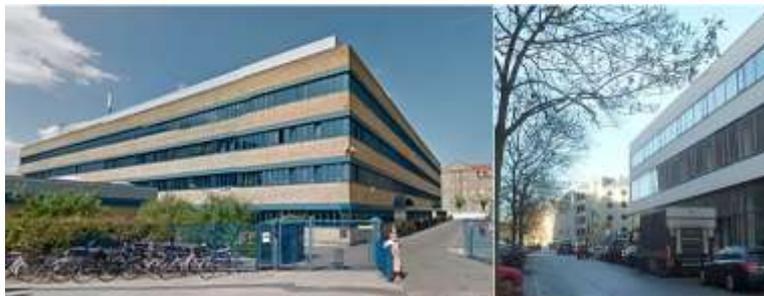
Figure 3: The dominating horizontal lines in some of the facades.

featured horizontal lines and no holes in the facades and which bear only their own weight. Many facades are made of light constructions with continuous window strips and parapets, preferably based on fibre cement plate (A. Dragheim) [8]. The new facade components, such as curtain walls and glass, have aesthetic qualities which are expressed through the concept of surface of volume. The aesthetic principle of surface of volume has been derived from the fact that such architecture has no solid supporting facade walls.

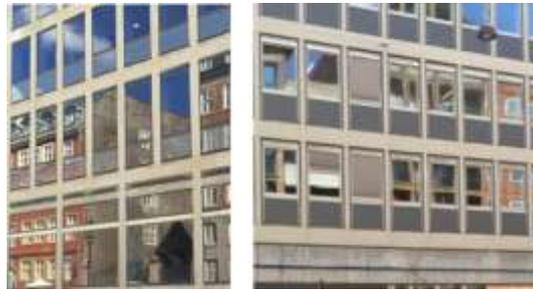
Figure 4: Some of the new cladding materials like metal and dark glass.

There was a focus on the intrinsic elegance of many materials such as aluminium, glass, and concrete, excluding all kinds of decoration with a preference for machine-made architectural details created by new technologies. The most-used materials for facade cladding are fibre cement plates, aluminium plates, steel, pressed mineral wool and glass fibre plates. Heavy materials like bricks were used only exceptionally (A. Dragheim) [8].

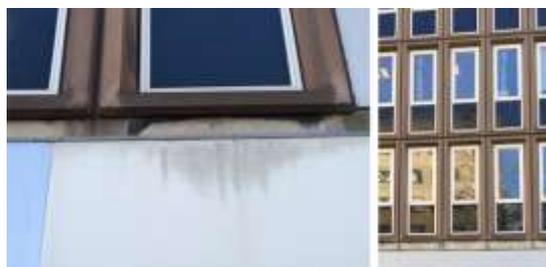
Figure 5: Problems like mould in the façade.

There was a great need for industrialized building components for the construction of office buildings in the sixties and the seventies due to the large demand for office buildings in that period. There were many economic benefits and time savings with this new system, but there were also many characteristic problems that faced the office buildings later on, such as cracks in the concrete carbonates and corrosion of the reinforcements. Some parts of the facades faced problems like mould and fungus, and there were problems with sealing materials (A. Dragheim) [8].

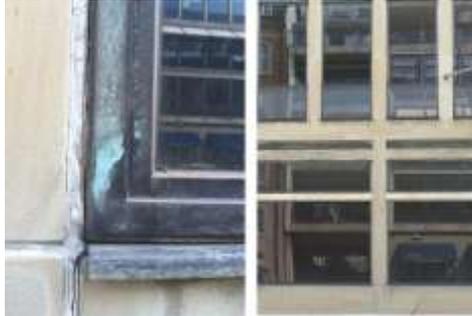
Figure 6: Problems in sealing materials in some parts of the facades.
