*A case study in Denmark*

*Published in:*  
Proceedings of the Healthy Buildings 2017 Asia

# VENTILATION STRATEGIES AND INDOOR ENVIRONMENT IN CLASSROOMS: A CASE STUDY IN DENMARK

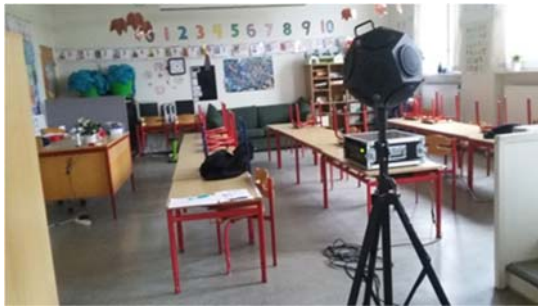
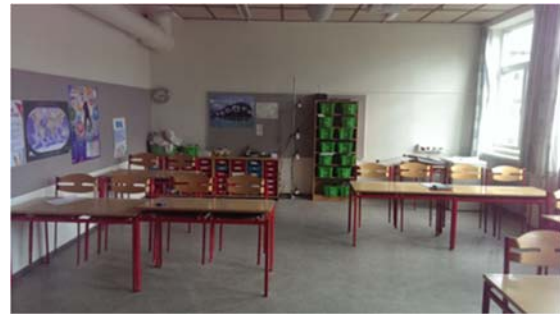
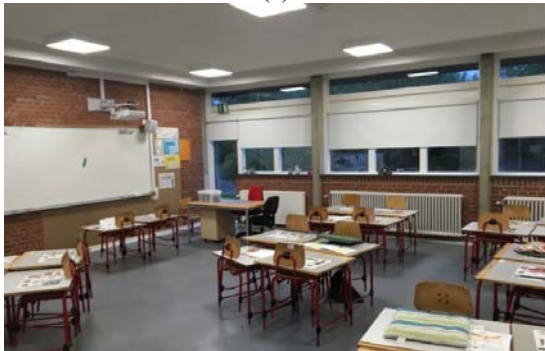
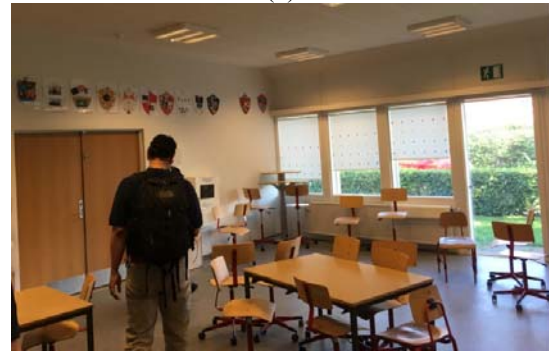
Figure 1. Photos of classroom (a) A1 (b) A2 (c) B1 (d) B2

Two primary schools located in Aalborg, Denmark were selected as case studies. In order to evaluate the indoor environment, a measurement campaign was conducted in four representative classrooms (two classrooms in each school), as shown in Figure 1. The characteristics of each classroom are stated in Table 1. It needs to notice that only classroom A2 is equipped with mechanical ventilation, and the other three classrooms are naturally ventilated. In classroom A2, the air is supplied through a textile diffuser located in the ceiling along the length of the classroom, as indicated in Figure 2. The textile diffuser is 5m in length and is a semi-circle with a diameter of 0.4 m. There are two exhaust openings located in the wall faced to the corridor. One is placed near the ceiling but blocked by the ventilation pipe, while the other is located in the occupied zone behind the furniture.
