Two-Dimensional Model Test Study of New Western Breakwater Proposal for Port of Hanstholm

DCE Contract Report No. 184

December 2016

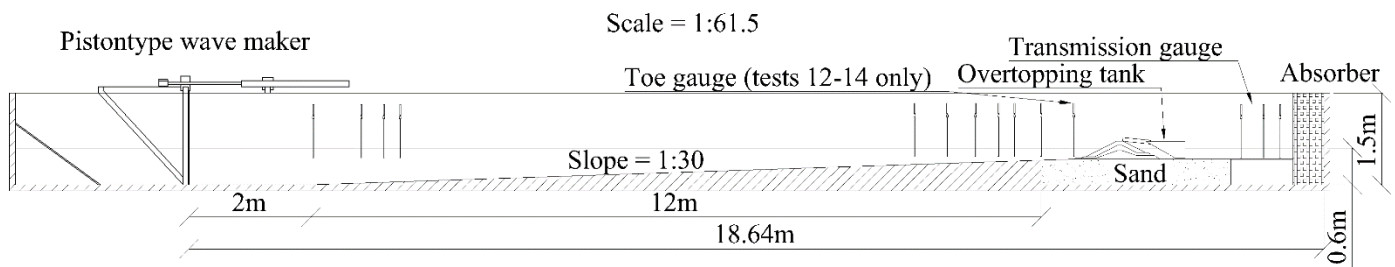
A two-dimensional model was constructed in scale 1:61.5 in a 1.2 m wide and 18.64 m long wave flume at Aalborg University. Fig. 1 shows the test setup in the flume with the breakwater, bathymetry, resistance type wave gauges and overtopping tank. The 1:30 slope used in the model setup reflects the steepest profile measured at the site (value given by client). This steep slope also makes it possible to generate the depth limited conditions in the model tests. The bed near the wavemaker was horizontal corresponding to 37.7 m water depth (CD) in prototype. From this depth, the depth decreased to the toe of the breakwater by a 1:30 foreshore followed by a horizontal seabed. The bathymetry partly consists of a fixed floor and partly of an erodible bed (see Fig. 1). The depth was 11 m (CD) at the toe of the breakwater initially, but increased during testing due to scouring at the toe. The placement of the wave gauges is restricted as a minimum distance of $3h$ in front of the wavemaker for insignificant nearfield disturbance is needed. Moreover, a minimum distance of $0.4L_p$ from the breakwater as suggested by Klopman and Van der Meer (1999) is used for the model tests. After the first 11 tests a wave gauge was placed at the toe to measure the total $H_{2\%}/H_{1/3}$.

Figure 1: Flume layout. Measures in model scale.

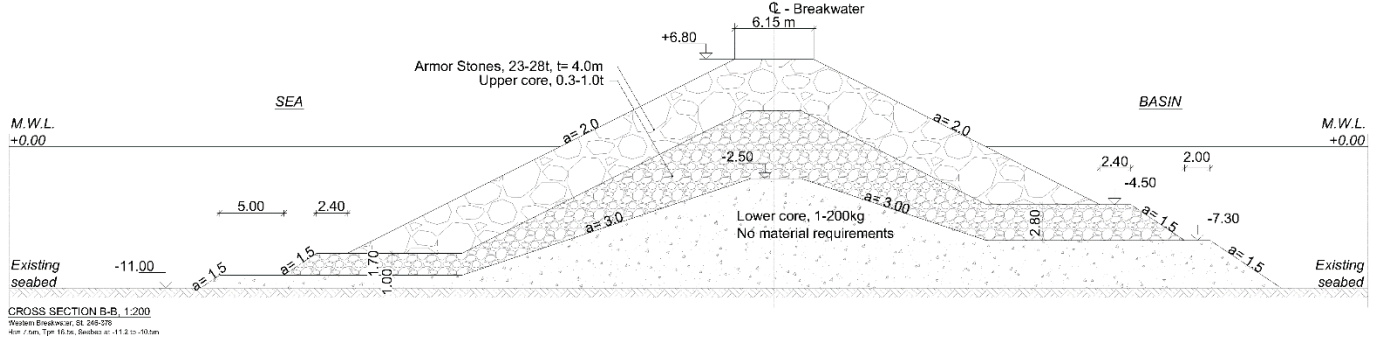
Figure 2: Cross-section proposed by the client, C1.

The proposed cross-sections supplied by the client are presented in Figs. 2 and 3. Cross-section C1 was the original proposal supplied by the client. Cross-section C2 was an additional proposal with a wider toe proposed by the client based on C1 results.

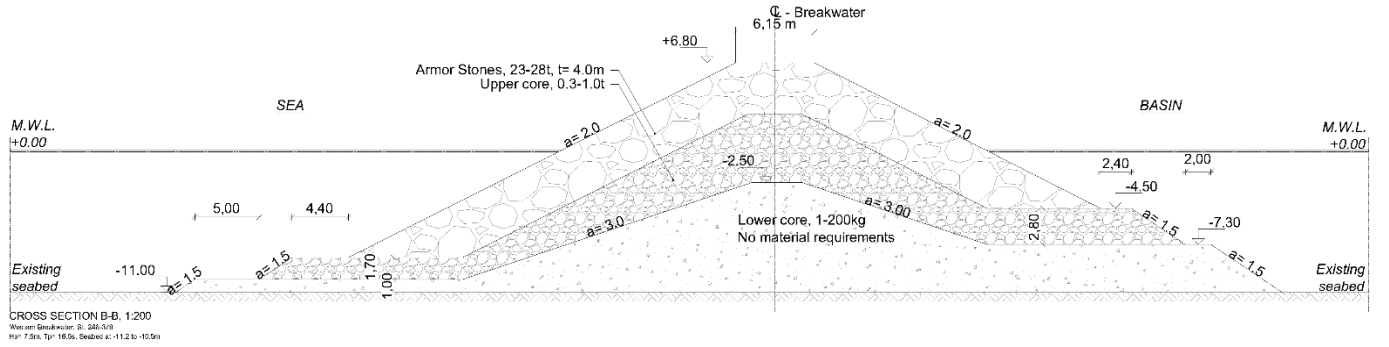
Figure 3: Cross-section proposed by the client, C2.

After Test 11, the stability of the toe was not found acceptable. Therefore, a new cross-section with a wider toe was tested for sea state T1, T4 and T7. The damage after the three tests can be seen on Fig. 19. The toe provided a better protection, but still some armour stones slid down in front of the toe which also flattened very significantly.

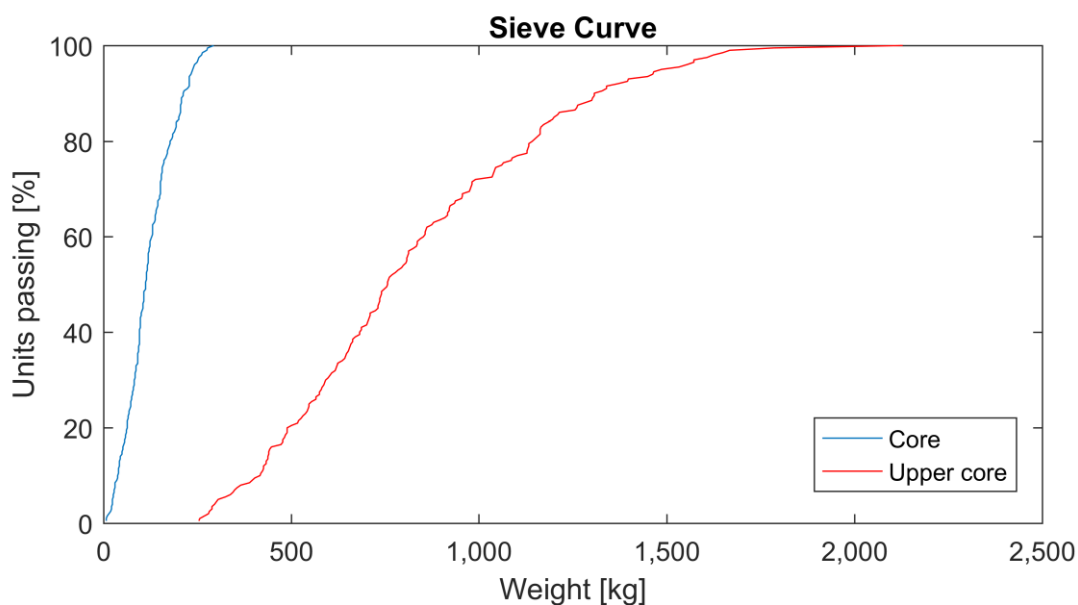
Figure 4: Sieve curve for core and upper core material.

Table 2 shows the material characteristics of the core, upper core and armour rocks. The sieve curves for the core, upper core and armour are given in Figs. 4 and 5. The rock armour size in the model was 3% larger than in prototype. This corresponds to a rock density of 3.04 t/m³ in prototype which is still conservative for Norit (i.e. lower than what is used as basis for the design). Furthermore, the filter stone size when correcting for density was in the model 16% smaller than in prototype which is conservative for the stability of the toe. The size of the filter material was based on keeping the permeability similar in model and prototype.

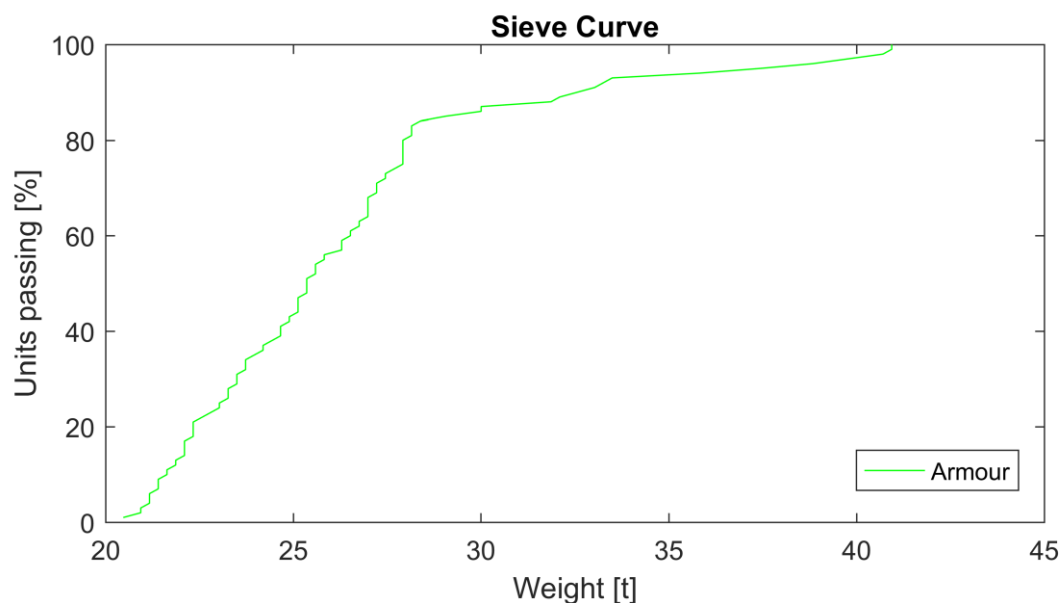
Figure 5: Sieve curve for the armour material.

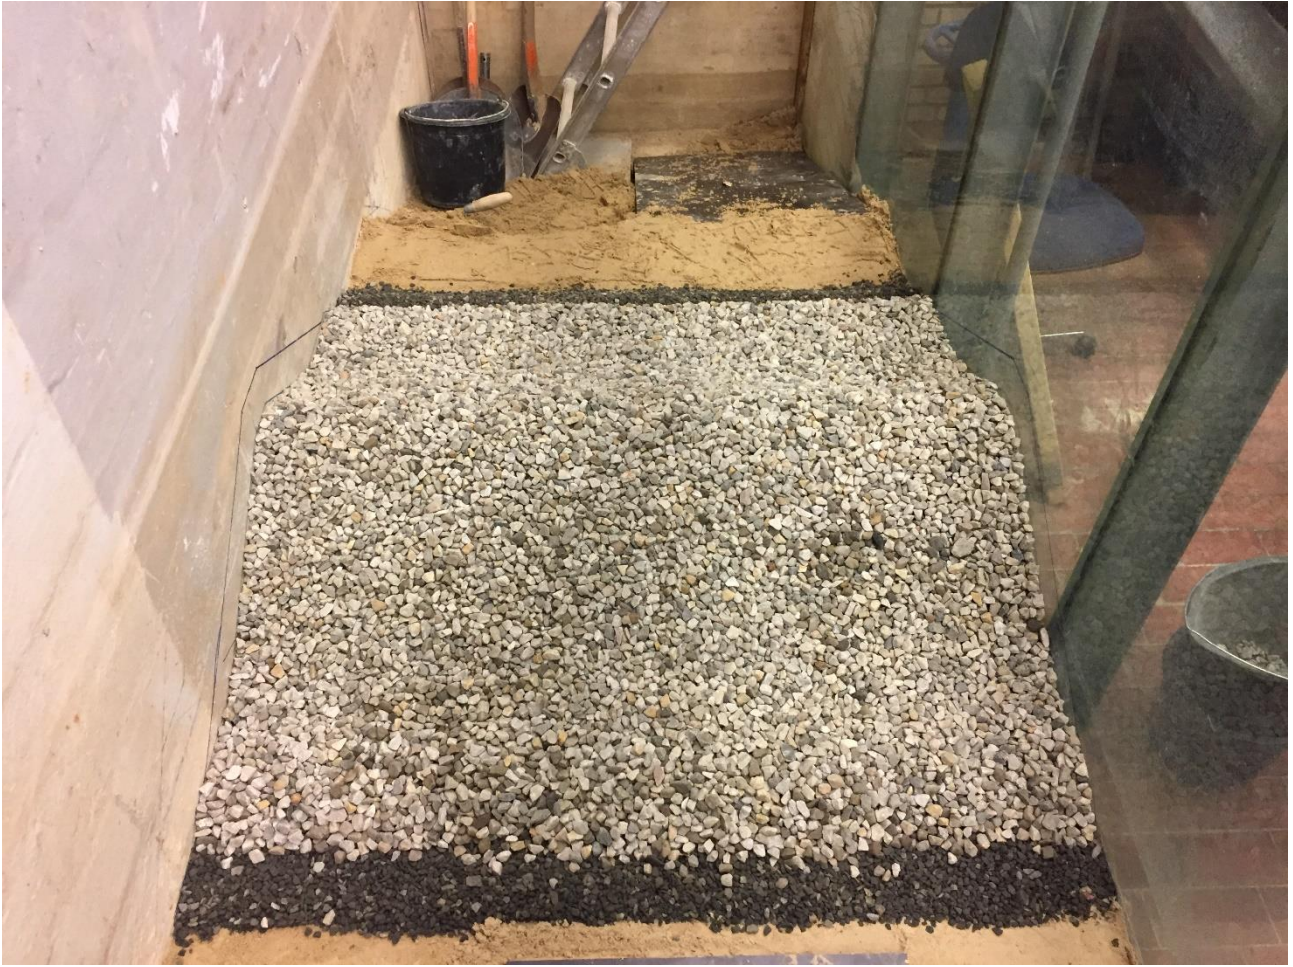
Figure 6: Breakwater with core and upper core for cross-section C1.

The phases of construction of cross-section C1 are shown in Figs. 6 – 8. A final setup of C2 can be seen in Fig. 19. The foreshore was modelled together with a section of the breakwater. The first 12 m of the foreshore was made of plywood and the last 1.6 m was made of fine sand with $D_{n50} \approx 0.17$ mm in model scale (chosen to avoid cohesive response). The armour stones were placed in two layers and profile was measured with the laser profiler to ensure that the averaged profile was a close match to the design profile given by the client.

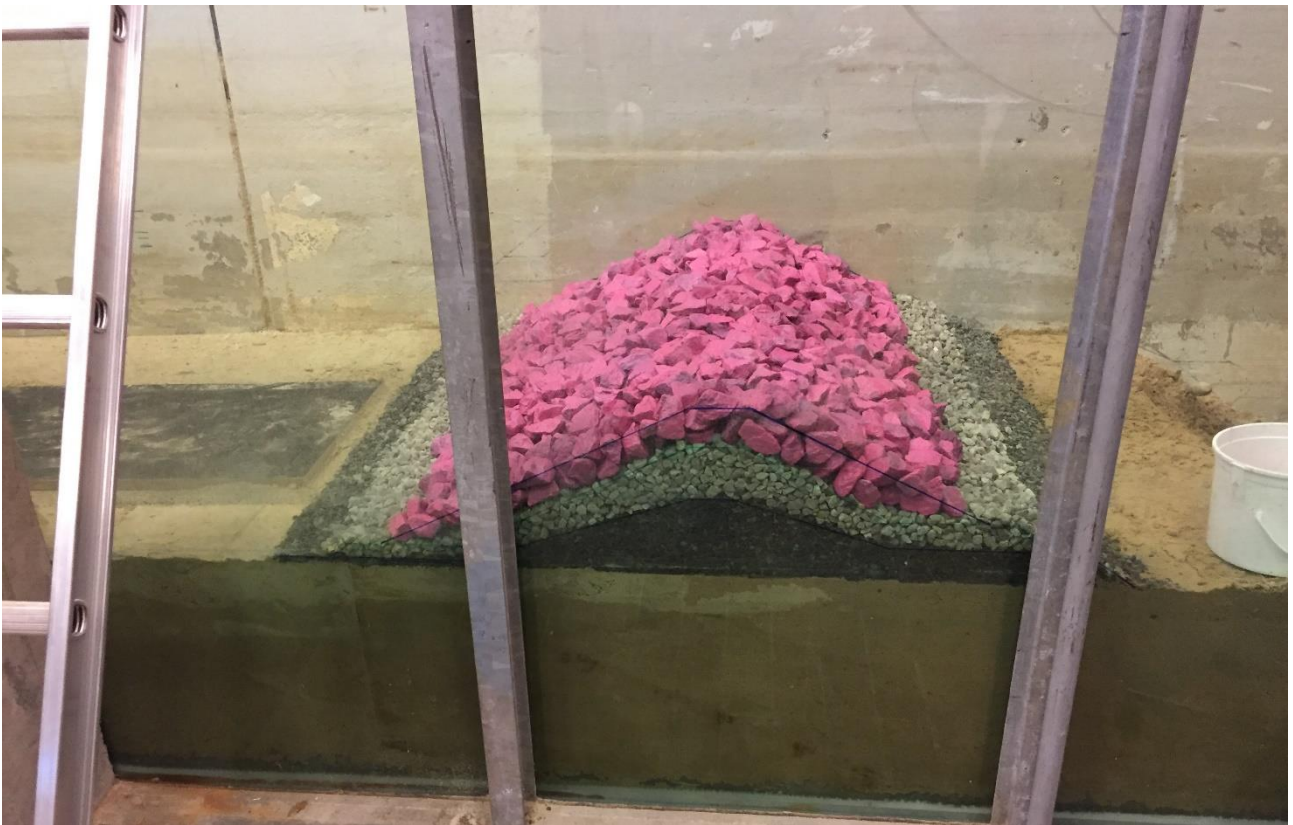
Figure 7: Breakwater with armour layer for cross-section C1.

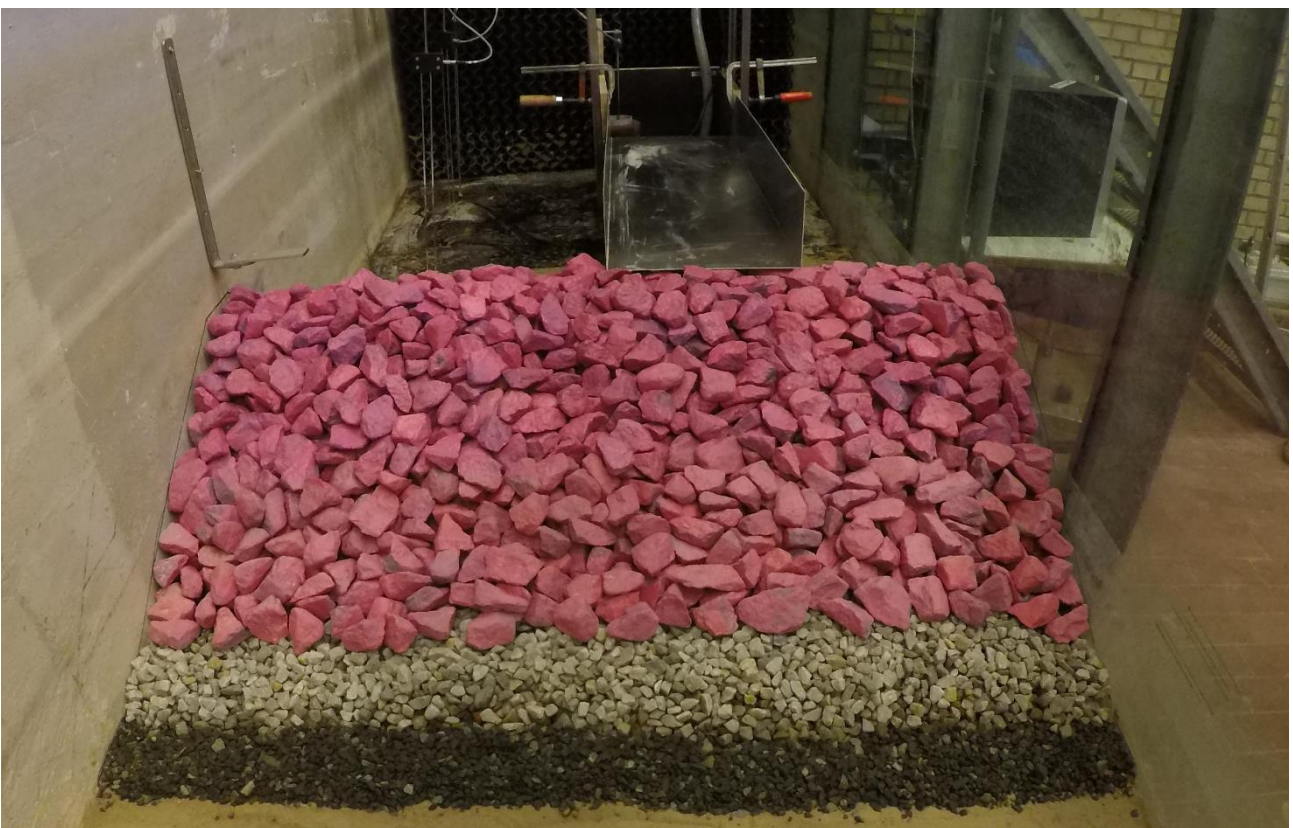
Figure 8: Final setup without water for cross-section C1.

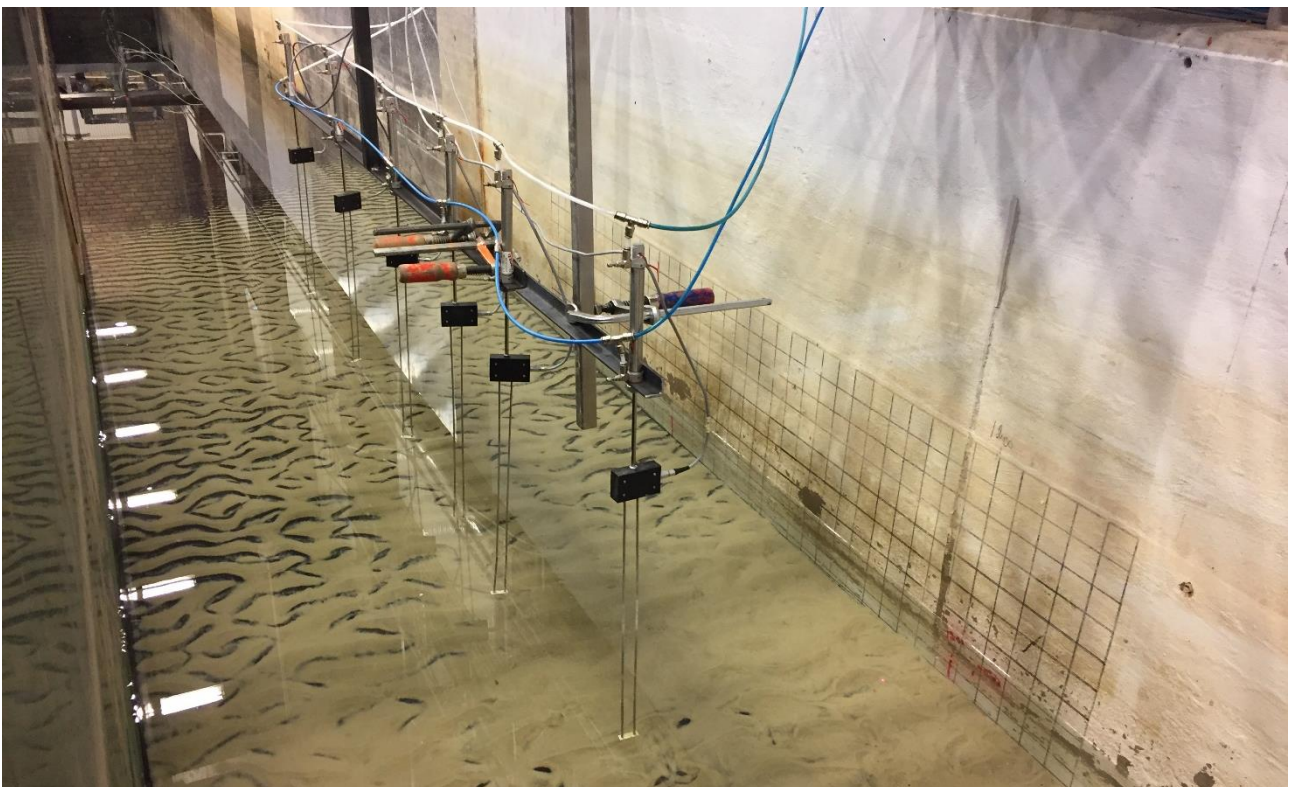
Figure 9: Wave gauges in front of the breakwater.

The data acquisition was done with a sample frequency of 100 Hz using a NI6225 acquisition box and the WaveLab 3 software package (Aalborg University 2016b). Analysis of the waves were performed with WaveLab 3. The wave gauges were calibrated using WaveLab 3 before each test run. The measured surface elevation time series from the gauge were analysed and split into incident and reflected waves using the nonlinear separation method by Eldrup and Lykke Andersen (2016b). A photo of the wave gauge array close to the toe is shown in Fig. 9. In Tests 12-14 a wave gauge was placed at the toe to measure the wave height distribution of the total surface elevation.

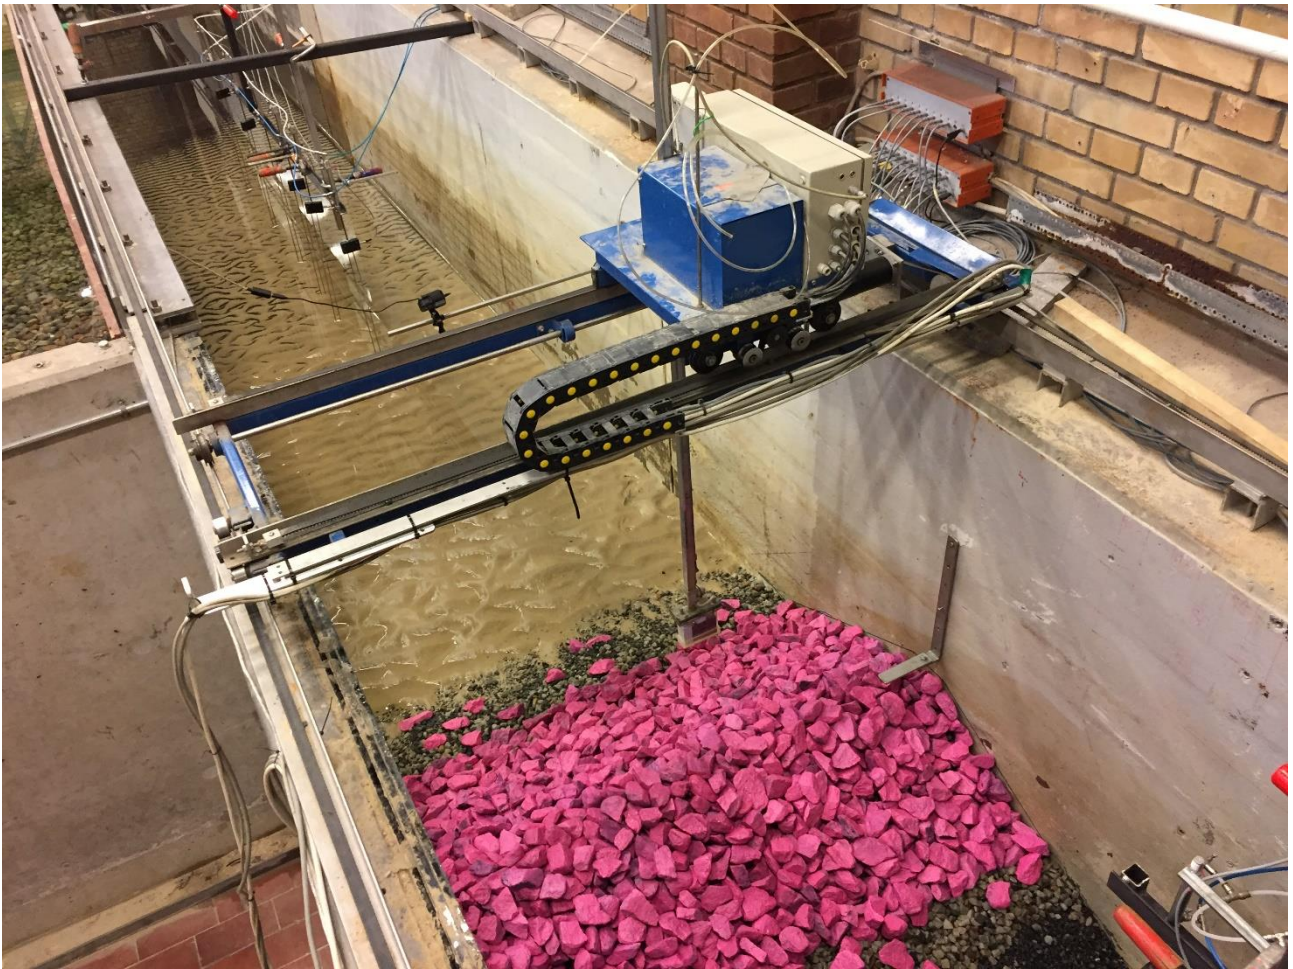
Figure 10: Profiler used to measure eroded area on the breakwater, example with cross-section C1.

Damage of the front slope and crest was measured by a profiler (see Fig. 10) after each test. The rear side of the breakwater was only measured with the profiler for the 100 years return periods and overload cases. The reason for this was that the overtopping ramp was removed for these tests as it was more important to register the rear slope damage over the entire width than the amount of overtopping for these cases, while for the lower return periods it was more important to measure the overtopping also. Additionally, before pictures and after pictures of the breakwater was taken with two GoPro 5 cameras for photo overlay to visually see the damage, see Fig 11. The measured damage for each cross-section is the accumulative damage as the breakwater was not rebuild during the test programme.

With the profiler, the eroded area was measured, and the damage level was calculated by Eq. 5.

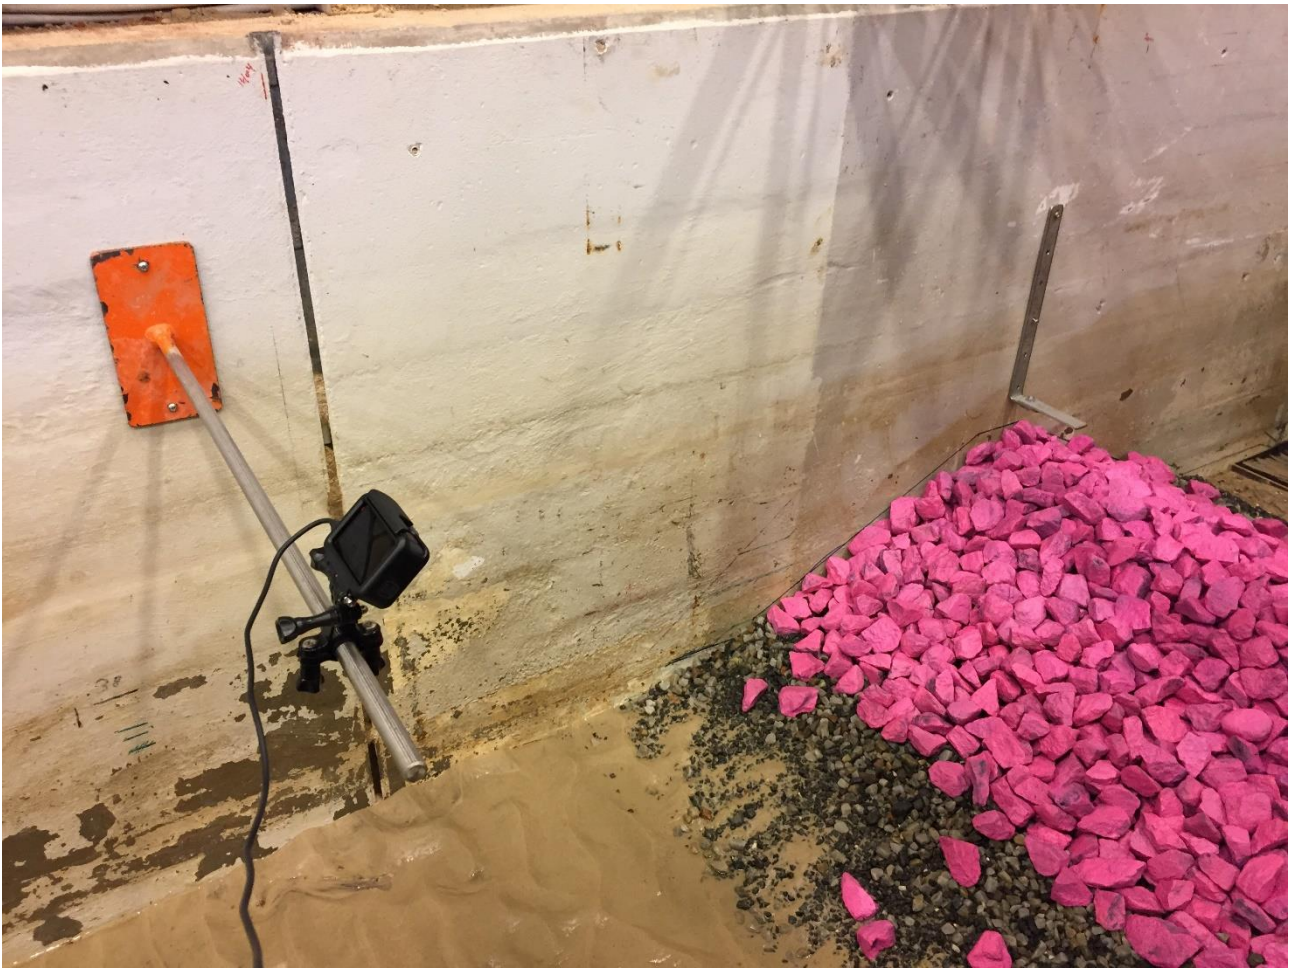
Figure 11: Camera in front of the breakwater, example with cross-section C1.

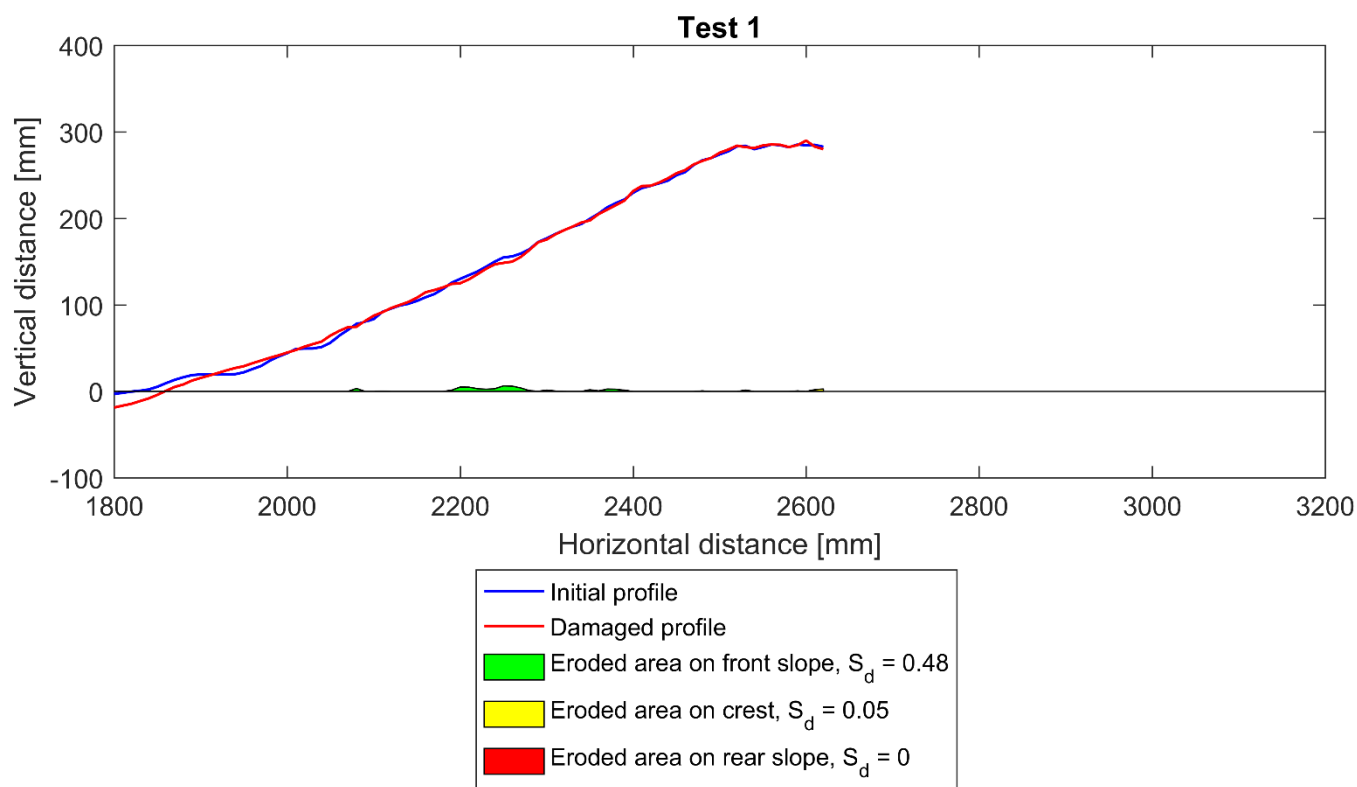
Figure 12: Example of measured average cross-section and calculated eroded area for Test 1 (model scale).

For the toe stability photo overlay is used which showed that after the first test with cross-section C1 the toe was strongly flattened as shown in Fig. 12. Because of the damaged toe the armour layer had less support and might have observed additional damage due to this effect as a few armour stones slid down in front of the breakwater, cf. Fig 13.

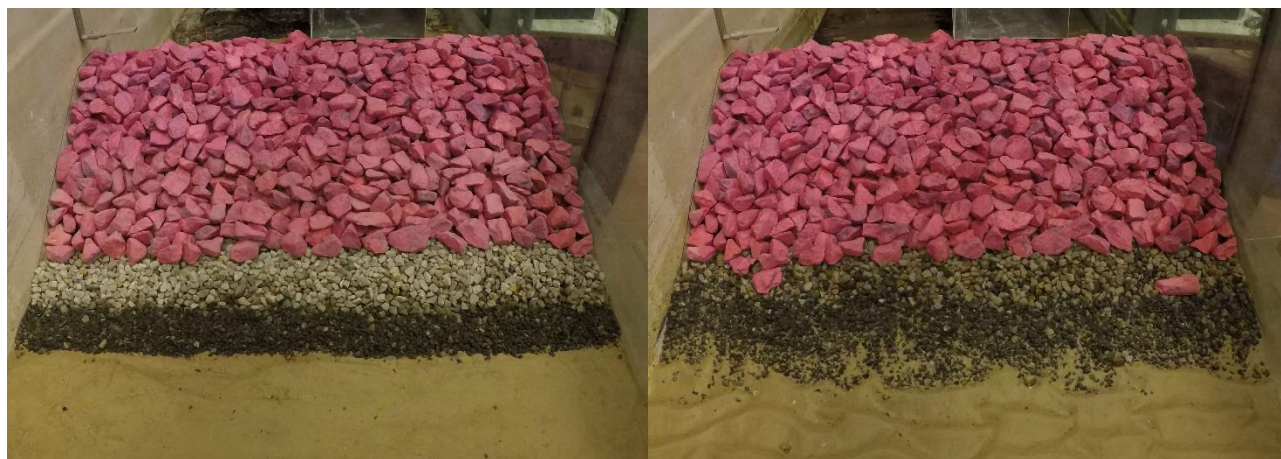
Figure 13: The front of the breakwater (C1) is shown on both pictures. Left shows before tests and right shows after Test 1.

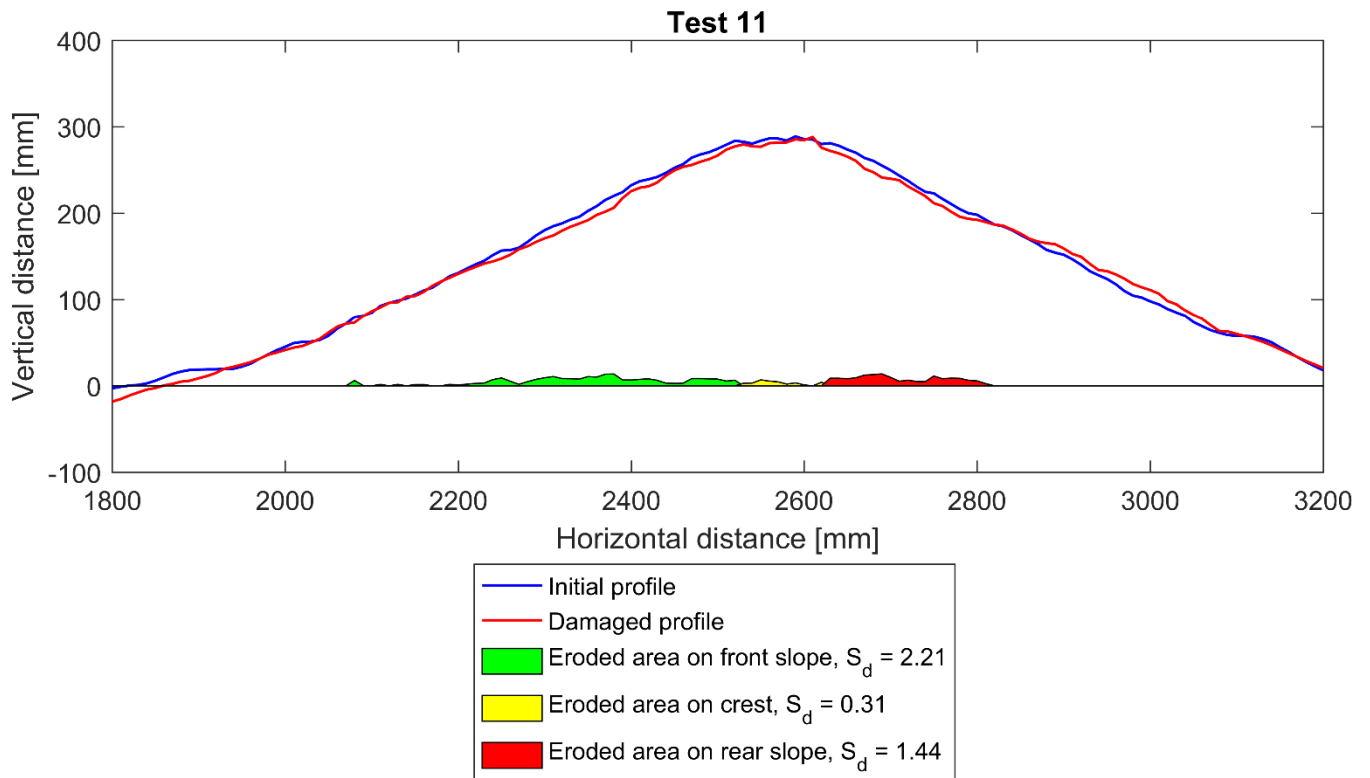
Figure 14: Measured average cross-section and calculated eroded area for Test 11 (model scale).

In Fig. 14 is the measured profile after Test 11 shown. The figure shows no critical damage to the armour layer with S_d around 2 for both front and rear armour. Note though that a part of the rear slope has been protected by the overtopping ramp in the first six tests.

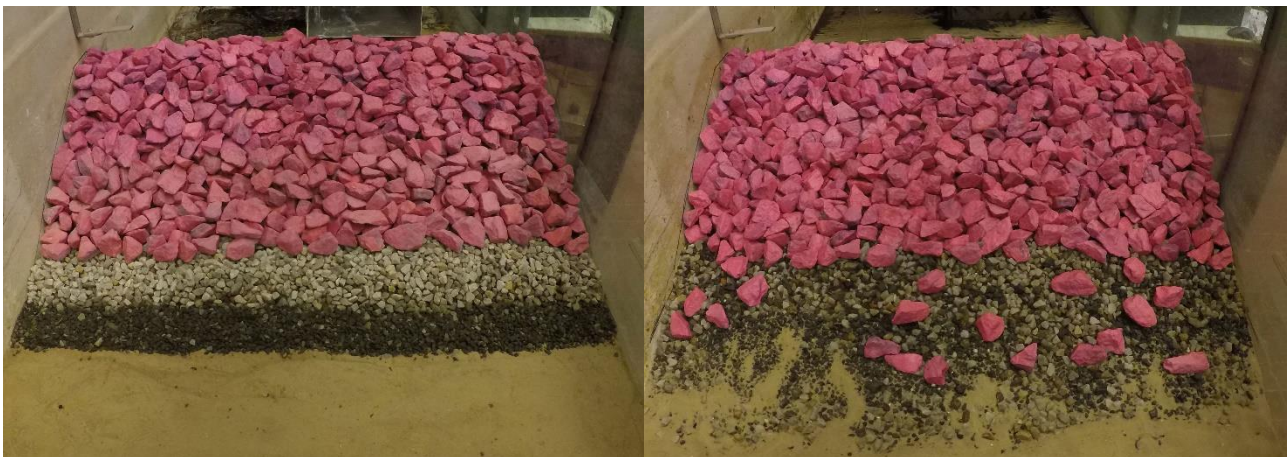
Figure 15: The front of the breakwater (C1) is shown on both pictures. Left shows before tests and right shows after Test 11.

The front of the breakwater before testing and after the last test can be seen in Fig. 15. The figure shows that several stones from the front slope has slid down in front of the highly damaged toe, but except for the toe no critical damage can be observed on the front side of the breakwater.

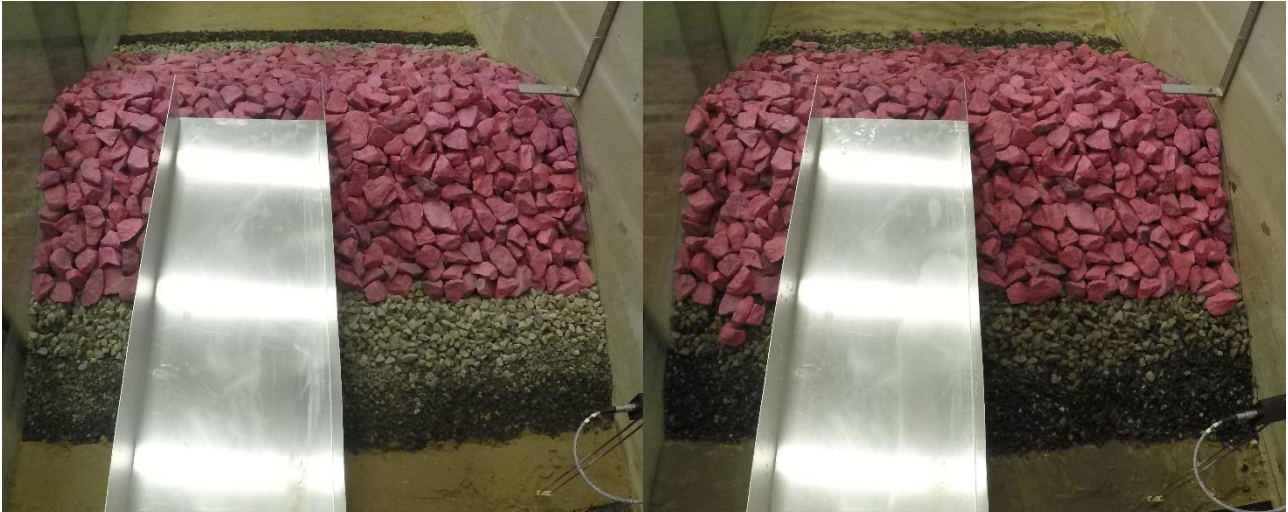
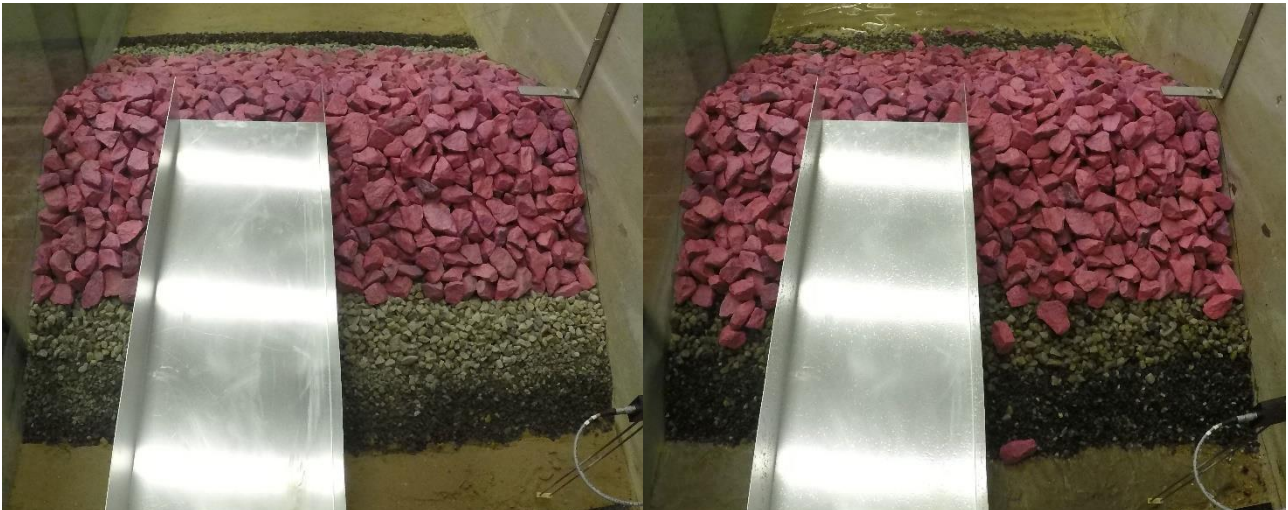
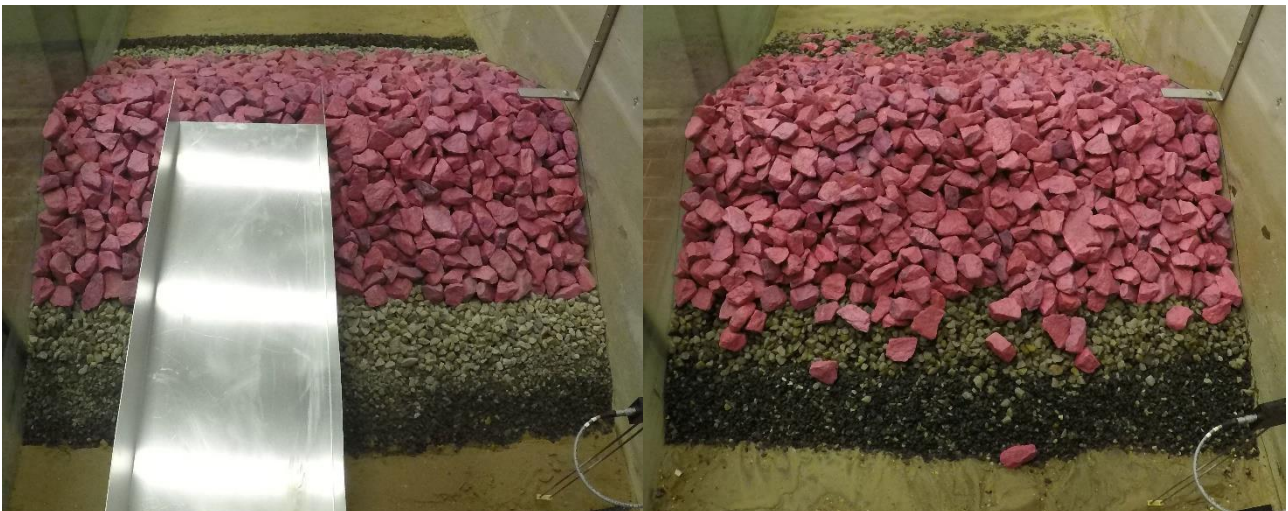
Figure 16: The rear of the breakwater (C1) is shown on both pictures. Left shows before test 1 and right shows after test 3.

Figure 17: The rear of the breakwater (C1) is shown on both pictures. Left shows before Test 1 and right shows after Test 6.

Figure 18: The rear of the breakwater (C1) is shown on both pictures. Left shows before Test 1 and right shows after Test 11.

The damage to the rear side can be observed by comparing photos in Figs. 16 – 18. Damage could be observed after the 1 year events, but some damage is expected as the stones will settle when first exposed to waves/overtopping flow, cf. Fig 16. The damage increased after the 10 year events and could have been more severe if not the overtopping ramp protected the rear side as seen in Fig. 17. The damage after Test 11 is shown in Fig. 18. Some localized holes start to appear due to damage from high overtopping. However, the observed damage seems acceptable but some repair works must be expected after significant storms.

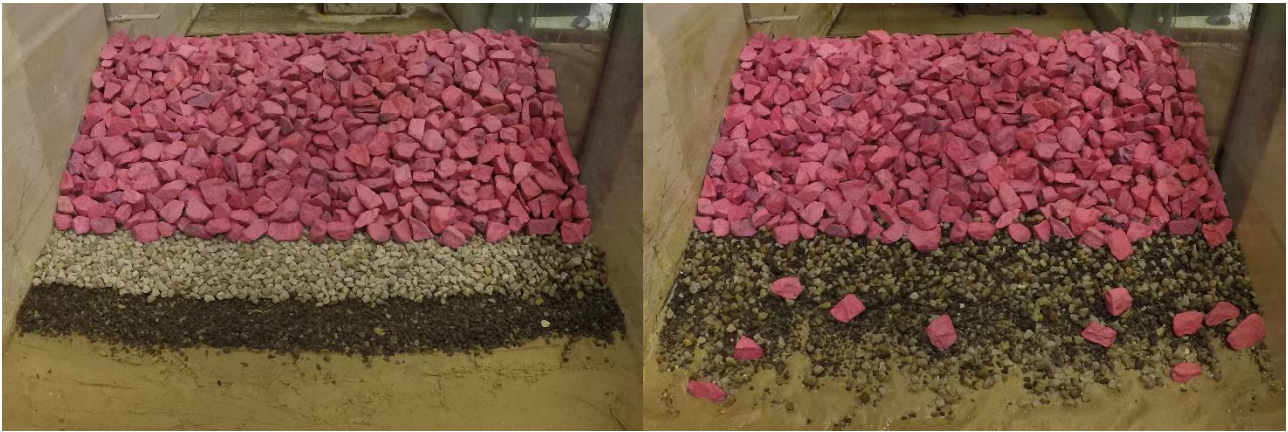
Figure 19: The front of the breakwater (C2) is shown on both pictures. Left shows before Test 12 and right shows after Test 14.

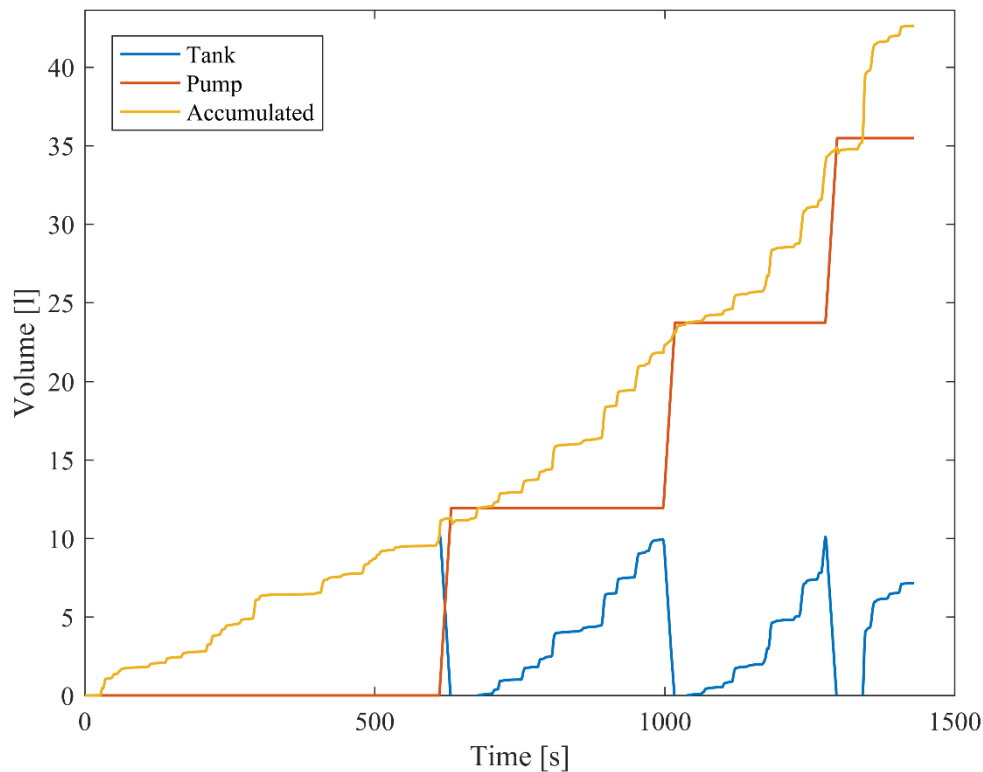
Figure 20: Example of measured overtopping (model scale).

During the tests the overtopping was measured. The overtopping was led to an overtopping tank (capacity ≈ 21 l in model scale) via a ramp (width 30 cm in model scale) extending from the rear side of the crest. A wave gauge inside the tank was used to measure the water level inside the tank. When the tank contained more than 15 l (model scale) a pump was configured to automatically start and empty the tank. Knowing the water level in the tank and the pump capacity and state (on/off), an overtopping discharge time series was calculated (see in Figure 20).

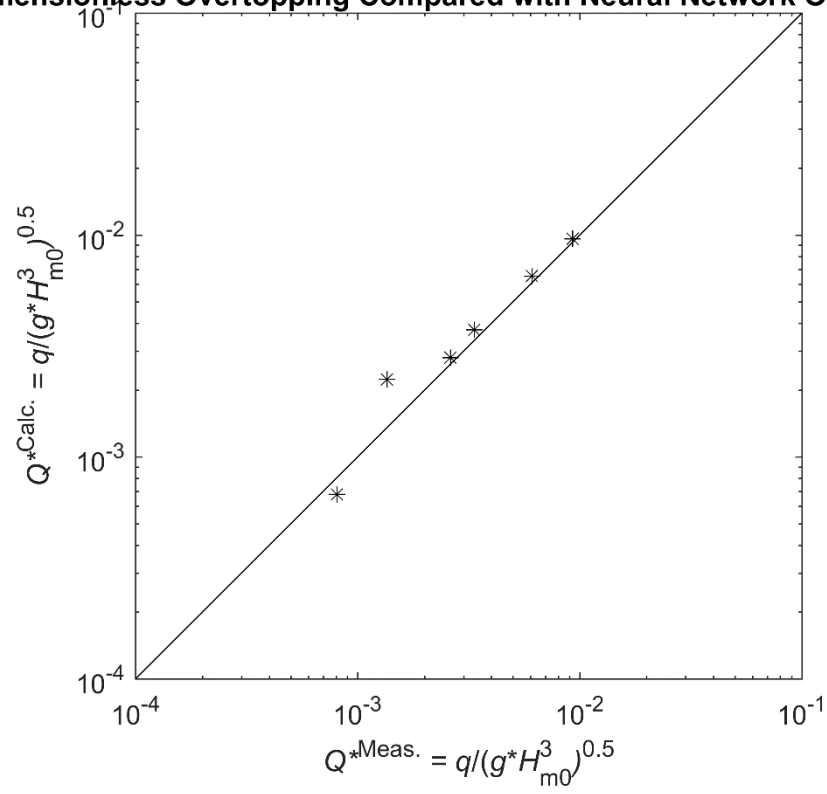
**Figure 21: Measured overtopping compared to Neural Network Overtopping.**

The measured overtopping is compared to the predicted overtopping by CLASH Neural Network (Van Gent et al. (2007)) in Fig. 21. The methods show good agreement between the predicted and measured overtopping.
