Danish EPA-NR pilot studies

Overall report on the pilot projects

**Energy Performance Assessment
of Existing Non-Residential Buildings**

Overall report on pilot projects

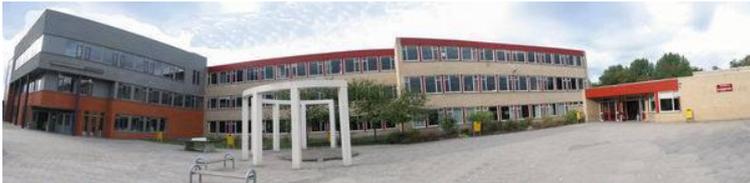
</div> <p>Amsterdam/The Netherlands</p> <p>Gross area: 8040 m² Year of construction: 1984 + extension in 2002</p>	<div style="text-align: center;">

</div> <p>Building envelope : Façades of original part poorly insulated/ the new extended part is insulated according to the year 2002 Dutch building standards/the roof is refurbished and insulated in 2004/ windows are simple glazed.</p> <p>Heating/cooling: Gas-fired high efficiency (condensing) heating system with radiators/ the auditorium is provided with a floor heating system/preheating ventilation air.</p> <p>Ventilation: Air handling unit in multimedia room and auditorium/exhaust ventilation in toilet groups/rest of building naturally ventilated.</p> <p>Lighting: Conventional fluorescent tube lighting.</p> <p>Specific aspects: No building energy management.</p>

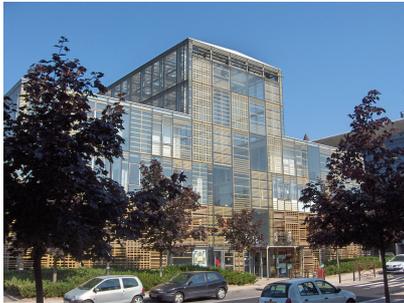
</div> <p>Champs Sur Marne/France</p> <p>One of the buildings of a big university</p> <p>Gross area: 15000 m² Year of construction: 1995</p>	<div style="text-align: center;">

</div> <p>Building envelope: Glazed façades and roof/ around 1/3 of facades can be opened through double glazed metal windows.</p> <p>Heating/cooling: Gas-fired standard collective boiler and radiators (some with thermostatic valves) / the laboratories are cooled by heat pump system/no programmer.</p> <p>Ventilation: Mechanical ventilation.</p> <p>Lighting: Conventional fluorescent lamps and conventional lamps in corridors.</p> <p>Specific aspects: The indoor temperature is unbearable in summer, solar films were added in some windows and individual heat pups were added in some offices. Insulation behind radiators was added to prevent cold wall effect in winter.</p>

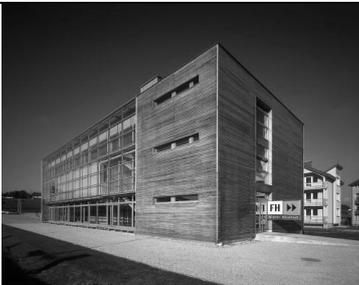
<p>Austria</p> <p>Gross area: 6156 m² Year of construction: 2002</p> </div>	<div style="text-align: center;">

</div> <p>Building envelope: Wooden-frame construction with static elements (inside) made by concrete/ High insulated outer wall components/ .Steel-glaze cladding in the southwest (climate-cladding).</p> <p>Heating/cooling: The pellets boiler plant, which is fully automated, guarantees the energy supply for heating and ventilation/ radiators for heating emission/ air conditioned cold water is used for cooling units on the second floor / The change from heating to cooling happens automatically by the room thermostat/ The whole regulation of the heating and ventilation system works on a DDC-System. Handling of the power control is done by a central building control system.</p> <p>Ventilation : The toilets on each floor are vented by ventilators. In the laboratories on the basement two exhaust air plants are installed - The exhausted air is re-feed by the two-staged delivery air plant in every single room. Both of the lecture rooms and the seminar room at the ground floor are equipped with an independent delivery and exhaust air plant with heat recovery.</p> <p>Lighting: Conventional fluorescent tube lighting with manual switching.</p>

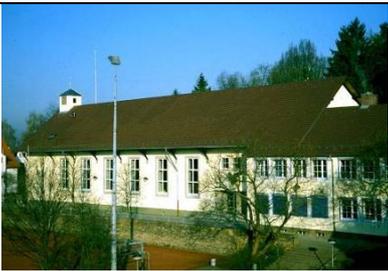
<p>Stuttgart/Germany</p> <p>Includes primary school, secondary school and sports hall</p> <p>Gross area: 5458 m² Year of construction: The school was built in several parts during the 1930ies, 1950ies and 1970ies</p> </div>	<div style="text-align: center;">

</div> <p>Building envelope: Varying concrete constructions with and without multi-layer chipboard insulation since the building was built at different times.</p> <p>Heating/cooling: building1: low pressure steam boiler, buildings 2 and 3: hot water heating system fed by a heat exchanger/ piping and radiators dated from the time of construction.</p> <p>Ventilation: ensured by opening the windows.</p> <p>Lighting: Prismatic diffusers and louvered luminaires with fluorescent tubes manually controlled.</p>

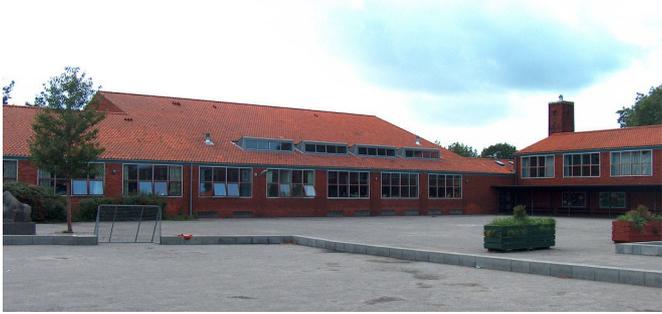
<p>Denmark</p> <p>Gross area: 7700 m² Year of construction: 1950-52:</p> </div>	<div style="text-align: center;">

</div> <p>Building envelope: Facades are the original one from when the school was constructed made of brickwork. It is difficult to make improvements to this type of facade without changing the architectural appearance of the building. In the attic it is though possible to place additional insulation material. In general the windows are up to date as they have been replaced when they were broken.</p> <p>Heating/cooling: Gas-fired high efficiency (condensing) heating system running in cascade with an old boiler (as back up) with radiators.</p> <p>Ventilation: The assembly hall is provided with mechanical ventilation and heat recovery. The rest of buildings are naturally ventilated.</p> <p>Lighting: Conventional fluorescent tube lighting and low energy bulbs.</p> <p>Specific aspects: There is a building energy management system.</p>

The school is the first of its kind in Denmark, in only one plan. It was constructed in 1950-52 as a traditional brick work with cavity wall insulation. The core of the buildings has not been upgraded but the facilities in the class rooms are in a good condition. Most windows are double glazed with a few exceptions with single glazing, mainly in the entrances and the gymnasium. Insulation material have been placed in the attic and improved to 125 mm recently. Compared to today's Danish standard this is not sufficient and additional insulation material can easily be installed.

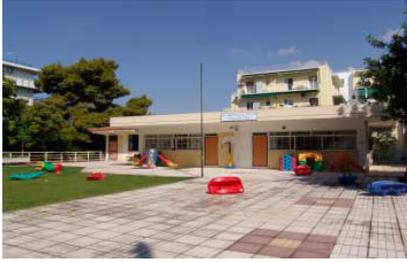
<p>Athens/Greece</p> <p>kindergarten Gross area: 182m² Year of construction: 1996</p> </div>	<div style="text-align: center;">

</div> <p>Building envelope: Thermally insulated building. Brick walls with concrete rendering. Reinforced concrete flat roof. Double glazed windows with aluminium frames and internal curtains.</p> <p>Heating/cooling: One central oil fired boiler for space heating/one electric heater for DHW.</p> <p>Ventilation: Natural ventilation.</p> <p>Lighting: Fluorescent tubes.</p>

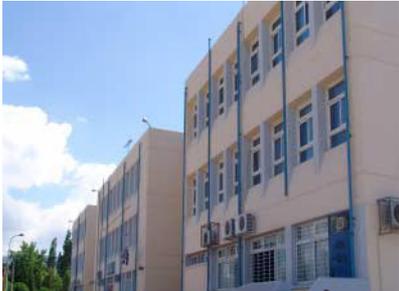
<p>Athens/Greece</p> <p>Secondary school Gross area: 3451m² Year of construction: 1995</p>

<p>Building envelope: Thermally insulated building. Brick walls with concrete rendering. Reinforced concrete flat roof. Double glazed windows with aluminium frames and internal curtains.</p> <p>Heating/cooling: One central oil fired boiler for space heating/ ceiling fans in all classrooms.</p> <p>Ventilation: Natural ventilation.</p> <p>Lighting: Fluorescent tubes.</p> <p>Specific aspects: Indoor thermal conditions during winter are reported very satisfactory, however during sunny winter days there is an overheating problem in many classrooms, resulting in opening the windows while the heating system is operating.</p>

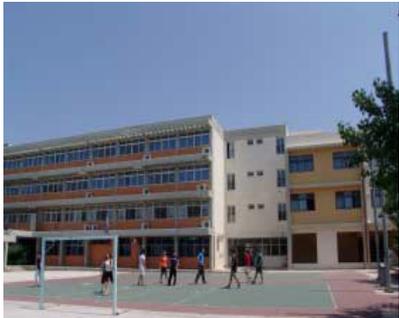
<p>Athens/Greece</p> <p>Secondary school Gross area: 6507m² Year of construction: 1979 + extension in 2004</p>

<p>Building envelope: Partly thermally insulated building. Brick walls partly with concrete rendering and partly with decorative bricks. Reinforced concrete roof (flat and slopped) covered with a reflective coating. Most windows are double glazed with aluminium frames and internal curtains.</p> <p>Heating/cooling: Four central oil fired boilers and one air handling unit for space heating/ electric heaters for DHW in sport hall.</p> <p>Ventilation: Natural ventilation.</p> <p>Lighting: Fluorescent tubes.</p>

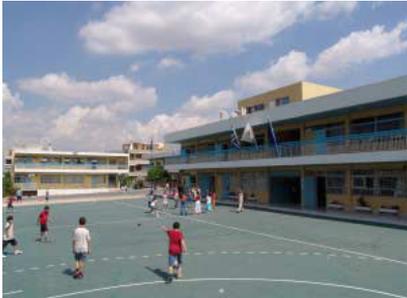
<p>Athens/Greece</p> <p>Primary school and Kindergarten Gross area: 2709 m² Year of construction: 5 buildings, built in different stages 1970, 1976 and 1989</p>

<p>Building envelope: Among the five buildings only one is thermally insulated, the other four have only roof insulation. Brick walls with concrete rendering. Single glazed windows with aluminium frames and internal curtains.</p> <p>Heating/cooling: Two central oil fired boilers for space heating/ electric heaters for DHW/ceiling fans in offices.</p> <p>Ventilation: Natural ventilation.</p> <p>Lighting: Fluorescent tubes.</p>

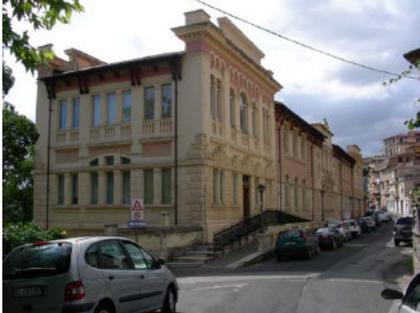
<p>Fiuggi/Italy</p> <p>Gross area: 2380 m² Year of construction: 1932</p>

<p>Building envelope: No insulation / double glazed windows with no thermal break aluminium frame.</p> <p>Heating/cooling: One standard boiler and radiators without any control/ Distribution systems runs inside the walls.</p> <p>Ventilation: Mechanical ventilation.</p> <p>Lighting: New fluorescent lamps manually controlled.</p> <p>Specific aspect: The walls are very thick and heavy, this gives the building a high thermal capacity, the high between floors and ceilings is important (4.20m).</p>

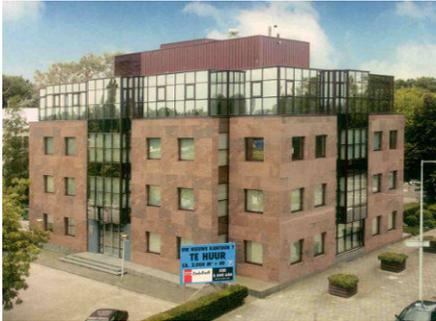
<p>Amsterdam/The Netherlands Gross area: 2250 m² Year of construction: 1990</p>

<p>Building envelope: The façades, roof and floor are insulated according to the year 1990 Dutch building standards/ windows are double layered glass and a sun reflecting foil.</p> <p>Heating/cooling: Gas fired high efficiency (condensing) and radiators/ preheating of ventilation air / small electric boiler for DHW/ The top floor is equipped with 2 build in air conditioners.</p> <p>Ventilation: The whole building is equipped with air handling units.</p> <p>Lighting: Fluorescent tubes in offices/ build-in halogen lamps in Hallways and lounge areas.</p>

The building is heated by a gas-fired high condensing boiler, radiators are used as emission system. Domestic hot water is assumed by small electric boiler. The air for ventilation is preheated. The whole building is equipped with air handling units. The lighting is realised by fluorescents lamps in offices and by build-in halogen lamps in hallways and lounge. Only the top floor is equipped with 2 build in air conditioners.

Since the building is build according to the 1990 standards of Dutch building regulations with insulations of the building envelope afterwards, the energetic quality is relatively good. Therefore the opted amount of measurements are low. An interesting measure is to replace the conventional fluorescent lighting in the office spaces with High Frequency fluorescent lighting including daylight control sensors.

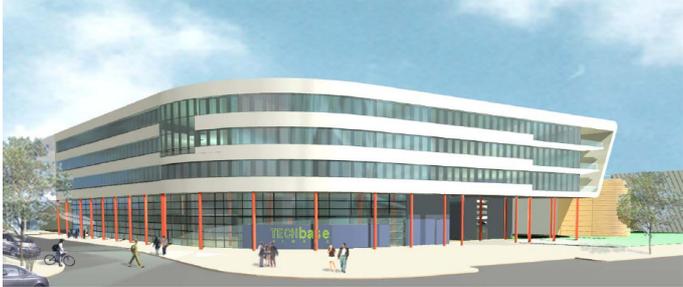
<p>Austria Gross area: 9236m² Year of construction:2005</p>

<p>Building envelope: No insulation / double glazed windows with no thermal break aluminium frame.</p> <p>Heating/cooling: One standard boiler and radiators without any control/ Distribution systems runs inside the walls.</p> <p>Ventilation: Mechanical ventilation.</p> <p>Lighting: New fluorescent lamps manually controlled.</p> <p>Specific aspect: The walls are very thick and heavy, this gives the building a high thermal capacity, the high between floors and ceilings is important (4.20m).</p>

Office building in Vienne												
<p>The building constructed in 2005 is located in a new industrial & research area in north-east district of Vienna. On the ground floor including the first floor are situated the event area, halls and laboratories as well as the canteen and staircases. The upper 3 floors include offices, seminar rooms, plant rooms, laboratories and restrooms.</p> <p>The opaque parts of the external façade are thermally insulated with EPS; humid exposed parts and the flat roof are insulated with XPS. Windows are double-glazed and low-emission-coated. For sun protection flexible external sun blinds are mounted on the east, south and west façade of the building. The north orientated façade is equipped only with inner jalousies. All blinds and jalousies have to be adjusted manually.</p> <p>Heating and cooling of the building is done by an HVAC-system. The central heating system is driven by a natural gas boiler and supplies heat to radiators. There are local electrical water heaters for restrooms and kitchenettes. Only the communication area of the office floor is mechanically ventilated with a heat recovery system. The offices are supplied with fresh air by natural ventilation. The air temperature of the offices is controlled separately in each room by thermostatic valves. There are fan coils in each office which are cooled by a central compression chiller system. The rejected heat of the compression chiller system is transferred to ambient air by using a dry cooling tower. Heating and cooling operation is technically not foreseen. It has to be determined manually when the heating or cooling period starts or ends.</p>

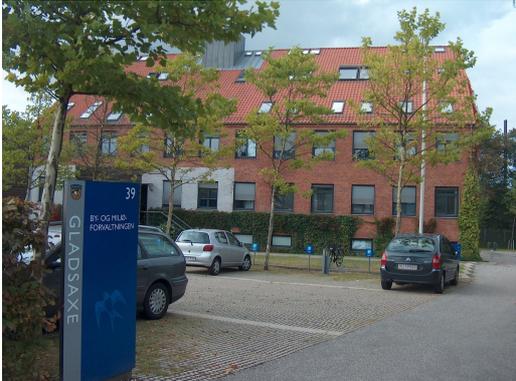
<p>Denmark</p> <p>Gross area: 3300 m² Year of construction: 1952/62:</p> </div>	<div style="text-align: center;">

</div> <p>Building envelope: The building is made of traditional brickwork with cavity wall insulation. All glazing is mounted in wooden frames and is double pane. Some windows are with low energy glazing. There are solar protections integrated in the windows at the two floors in the attic.</p> <p>Heating/cooling: Six small natural gas boilers running in cascade supplying both heating and domestic hot water via a 250 litre storage tank. There is a small cooling system in the canteen.</p> <p>Ventilation: Balanced mechanical ventilation with heat recovery in the new part of the building and natural ventilation in the old part.</p> <p>Lighting: Fluorescent tubes and task lightning in offices/ low consumption lamps in corridors.</p>

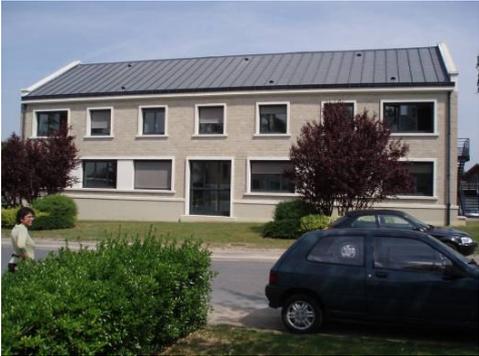
<p>Champs sur Marne/France</p> <p>Gross area: 715 m² Year of construction: in the 50' + renovation in 2002</p> </div>	<div style="text-align: center;">

</div> <p>Building envelope: Good internal insulation of the envelope without being lawful/double glazing windows with aluminium frame and external solar protections.</p> <p>Heating/cooling: Electric heating with integrated control device/, Electric domestic hot water with 200l storage.</p> <p>Ventilation: Balanced mechanical ventilation.</p> <p>Lighting: Fluorescent tubes in offices/ low consumption lamps in corridors.</p>

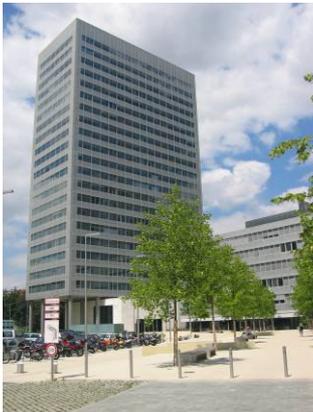
<p>Munich/Germany</p> <p>Gross area: 27172 m² Year of construction: 2003</p> </div>	<div style="text-align: center;">

</div> <p>Building envelope: Double skin facades with the inner layer as the main thermal insulation, the outer layer is framed glazing, the inner layer has about 70% transparency and 30% opaque areas/ internal solar shadings.</p> <p>Heating/cooling: The building is connected to the district heating system. Heating emission with convectors and ceilings (water pipes in building mass). Meeting rooms are cooled. The cooling generation is realised by a compression refrigeration machine.</p> <p>Ventilation: Hybrid ventilation composed by a central ventilation system with preconditioned air via an earth channel used for winter preheating and summer pre cooling and a big fan in the cellar.</p> <p>Lighting: Lighting is realised by compact discharge lamps with direct mode. The meeting rooms have direct/indirect mode. The ballasts are of the type 'electronic' in the offices and 'low losses' in the other rooms. The lighting control of the office lights is done via the BEMS with an automatic dimming that can be overruled by the user.</p> <p>Specific aspect: The EPBD required certificate was made on the basis of DIN V 18599</p>

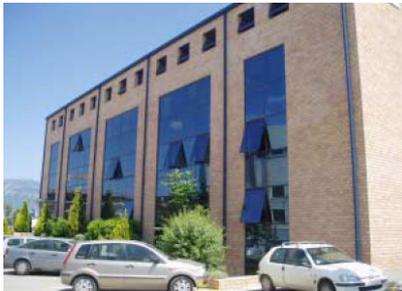
<p>Athens/Greece</p> <p>Gross area: 1910 m² Year of construction: 2000</p> </div>	<div style="text-align: center;">

</div> <p>Building envelope: Thermally insulated building. Brick walls with decorative bricks. Reinforced concrete sloped roof, covered with iron sheet. High efficiency double glazed windows with aluminium frames and internal blinds.</p> <p>Heating/cooling: Nine VRV heat pumps for heating and local air handling units for space heating and cooling/ electric tankless heaters for DHW.</p> <p>Ventilation: Mechanical ventilation by air handling units.</p> <p>Lighting: Fluorescent tubes and spots</p>
<div style="text-align: center;">

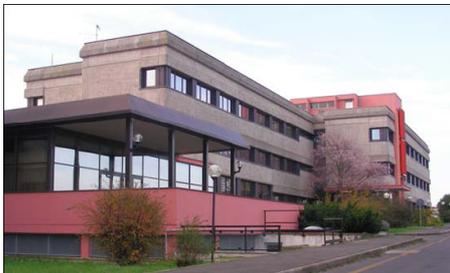
<p>Rome/Italy</p> <p>Gross area: 3200 m² Year of construction: 1990</p> </div>	<div style="text-align: center;">

</div> <p>Building envelope: External insulation/reflective double glazing windows with aluminium frame without thermal break/ no insulation in concrete ground floor.</p> <p>Heating/cooling: Gas boiler for heating and chillers with cooling tower for cooling/ fan coil units are used as emission system/ electric boilers for DHW.</p> <p>Ventilation: Two air handling units are installed for offices, these AHU are also used for heating and cooling and ventilation for conference room.</p> <p>Lighting: Fluorescent lamps.</p> <p>Specific aspect: The stairs volume should be in principle separated by the heated volume by double glazed doors but in practice these doors are always open.</p>

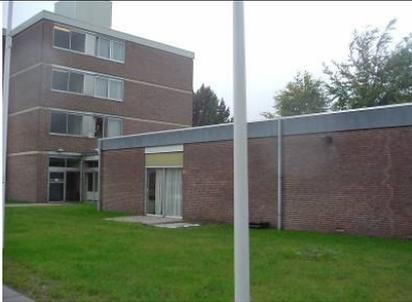
<p>Apeldoorn/The Netherlands</p> <p>Gross area: 3108 m² Year of construction: 1974</p>

<p>Building envelope: Opaque walls are not insulated/ windows consist of double layered glass in second and third floor and single glazed in the two first floors.</p> <p>Heating/cooling: Gas fired high efficiency (condensing) heating system with radiators/ part of building is provided with air conditioning units.</p> <p>Ventilation: Natural ventilation except for toilet and kitchen where exhaust ventilation is installed.</p> <p>Lighting: Conventional fluorescent tube lighting.</p> <p>Specific aspect: Poor indoor air quality due to the low ventilation rates, natural ventilation by opening the windows in winter is not adequate/ the single pane glazing in the two first floors have large dimensions, it's not comfortable in winter.</p>

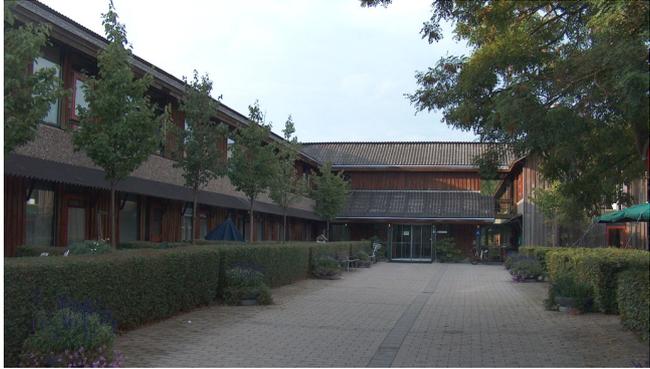
<p>Denmark</p> <p>Gross area: 9,562 m² Year of construction: 1977</p>

<p>Building envelope: Pre fabricated concrete elements with wooden covering and minimum insulation (10 cm). Windows are double-glazed. The thermal properties of the claddings are in accordance with building standards of the 70ies. The cladding needs replacement and the rooms upgrade to meet today's standard.</p> <p>Heating/cooling/DHW: Two natural gas boilers operating in cascade supplying a heating system with radiators and DHW; no cooling system. Floor heating system in the bathrooms of the residential sectors.</p> <p>Ventilation: Mechanical ventilation with heat recovery in the service and common sections, natural ventilation in the residential sections.</p>

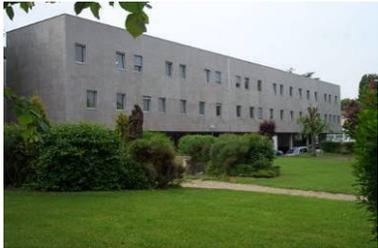
<p>Lagny sur Marne/France</p> <p>Gross area: 9500 m² Year of construction: 1965 + extension in 2003</p>

<p>Building envelope: In renovated and new parts, good insulation of the envelope and double glazing windows with external solar protection / no insulation and simple glazing windows in no renovated part.</p> <p>Heating/cooling: One central heating plant, with two gas fired boilers, connected to different other buildings with heat exchangers in substations for space heating and for sanitary hot water/ floor heating as background emitter and radiators with thermostatic valves/ No cooling system.</p> <p>Ventilation: Mechanical exhaust system and balanced system in renovated and new parts/ ventilation by opening the windows and by infiltration in no renovated part.</p> <p>Lighting: Fluorescent lamps.</p>

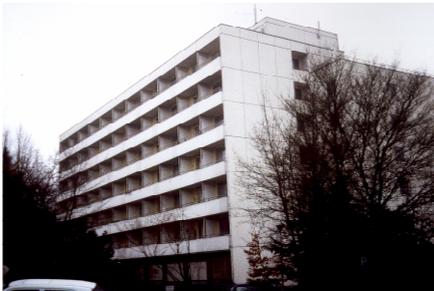
<p>Stuttgart/Germany</p> <p>Gross area: 9647 m² Year of construction: 1965</p>

<p>Building envelope: No insulation of opaque walls. Double paned windows in wooden frames. The roof includes a minor cork insulation.</p> <p>Heating/cooling: Two gas boilers. Radiators with thermostats.</p> <p>Ventilation: Mechanical supply and exhaust ventilation system including electrical heating without heat recovery in the bathrooms and corridors at the inner core.</p> <p>Lighting: Incandescent lamps in the patient rooms, fluorescent lamps in corridors.</p>

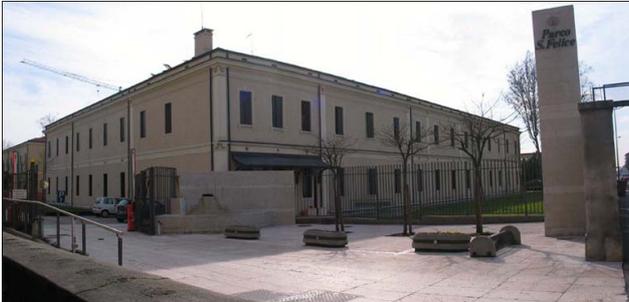
<p>Vicenza/Italy</p> <p>Gross area: 1320 m² Year of construction: early 20th century</p>

<p>Building envelope: Very poor insulation/simple double glazing windows with wooden frame.</p> <p>Heating/cooling: Single group of conventional boilers serving a group of 10 buildings for heating, air handling units and DHW/ radiators without local control/ Single chillier serving the group of buildings, it produces cold water for batteries of AHU/ the chillier is not designed to satisfy the whole cooling demand but to cool down the air entering into the building through the mechanical ventilation system.</p> <p>Ventilation: Mechanical ventilation system feeds all the rooms with heat/cool recovery.</p> <p>Lighting: Fluorescent lamps manually operated.</p> <p>Specific aspect: The walls are very thick and heavy, this give the building a high thermal capacity.</p>

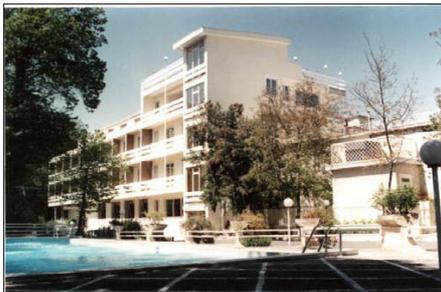
</div> <p data-bbox="301 887 448 916">Fiuggi/Italy</p> <p data-bbox="189 931 558 1021">Gross area: 3200m² Year of construction: late 70' + a new part in 2000</p>	<div data-bbox="756 568 1197 860" data-label="Image">

</div> <p data-bbox="587 878 1370 1001">Building envelop: Old part has a double layer of hollow bricks with air gap , single glazed windows with aluminium frames/ new part has thick alveolar brick with reinforced plastering, double glazing windows with aluminium frames.</p> <p data-bbox="587 1016 1370 1140">Heating/cooling: Two gas boilers feed the heating and DHW systems/ A chiller feeds the fan coil units in the hall and in new rooms and the Air handling units of the restaurant/ radiators in old rooms.</p> <p data-bbox="587 1155 1370 1216">Ventilation: Mechanical ventilation system feeds all the rooms with heat/cool recovery.</p> <p data-bbox="587 1232 1370 1292">Lighting: From obsolete incandescence lamps to compact fluorescent lamps fluorescent lamps manually operated.</p>

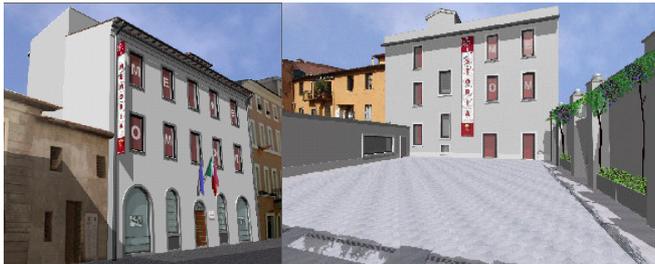
<p>Rome/Italy</p> </div> <p data-bbox="220 833 533 958">Mixed library and offices Gross area: 810 m² Year of construction: early 1900, refurbished in 2005.</p> <p data-bbox="193 987 560 1171">A 3 floors block with the two main façade south and north oriented host the offices. The library is hosted in the block at the ground and consists of one level only</p>	<div data-bbox="647 560 1302 824" data-label="Image">

</div> <p data-bbox="587 846 1370 967">Building envelope: The envelope of the building consists of plastered massive stone walls. Non insulation was added during the refurbishment. Double glazing units with aluminium frame with thermal break were installed.</p> <p data-bbox="587 987 1370 1171">Heating/cooling: Condensing boilers are installed to feed the heating and DHW systems, and the air handling units. The chiller feeds the fan coils units and the air handling units. These units have energy recovery installed. Different artificial light sources (from obsolete incandescence lamps to compact fluorescent lamps) are installed in the building.</p> <p data-bbox="587 1189 1370 1245">Ventilation: Mechanical ventilation system feeds all the rooms with heat/cool recovery.</p> <p data-bbox="587 1263 1370 1319">Lighting: From obsolete incandescence lamps to compact fluorescent lamps.</p>
