A lime based mortar for thermal insulation of medieval church vaults

Proceedings of the 4th Historic Mortars Conference, HMC2016

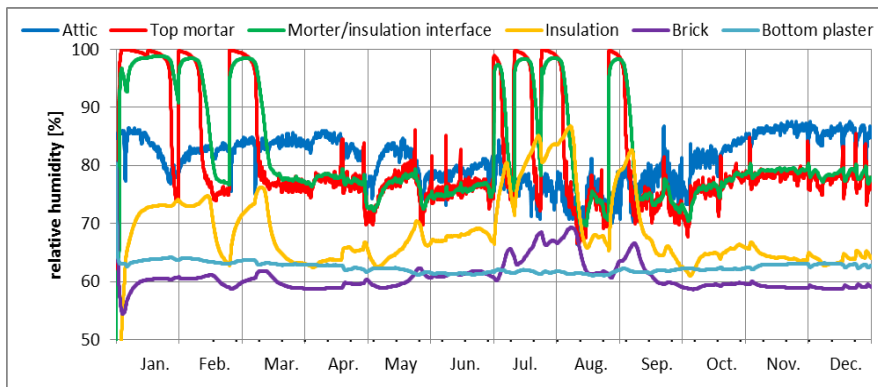
Figure 3: Yearly simulation of church vault with 100mm insulation mortar

Simulation results of relative humidity through the construction are expressed in Figure 3.

The simulation results indicated that only the upper three output points were clearly affected by the exterior water loads. The exterior water loads added in winter and summer, seemed to have a significant influence on humidity conditions in layers down to the middle of the insulation layer, but not further, towards the brick layer. It was seen, that the interface area between brick and insulation, as well as the middle of the brick layer, was influenced during summer periods, but to no severe extent. In the summer period the superficial layers dried out quicker than in winter due to increased temperature, which also made the vapour pressure in the attic increase and cause the deeper penetration of moisture during summer. Neither the bottom part of the brick or the bottom layer of plaster was affected by the external water loads at any time.

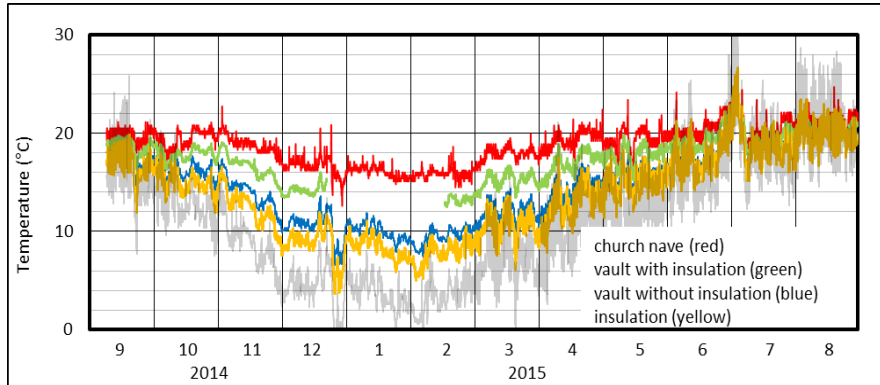
Figure 4: Temperature measurements from Annisse Church

Results from in situ measurements of temperature and relative humidity are shown in Figure 4 and Figure 5.

The temperature measurements, seen in Figure 4, show that the temperature of the insulated vault was 2-3° warmer than the un-insulated vault during winter. The temperature measured in the insulation was slightly colder than the uninsulated vault. In the summer period, the temperature in both vaults and in insulation were very similar. The measured relative humidity is depicted in Figure 5. It is seen that the humidity in the insulated vault is initially a bit higher than the uninsulated vault, but due to drying of building moisture, the insulated vault reaches humidity levels resembling interior conditions within ½ year. The humidity measured in the insulation mortar, is higher for a while, with a peak in October 2014. The peak was likely caused by the carbonization process of lime, which expels water, also explaining the high humidity declining in the insulation layer. In the period where the humidity reaches 100 % in the insulation, it is seen to not affect the underlying brick in any essential way. The relative humidity in the uninsulated vault has less variation.

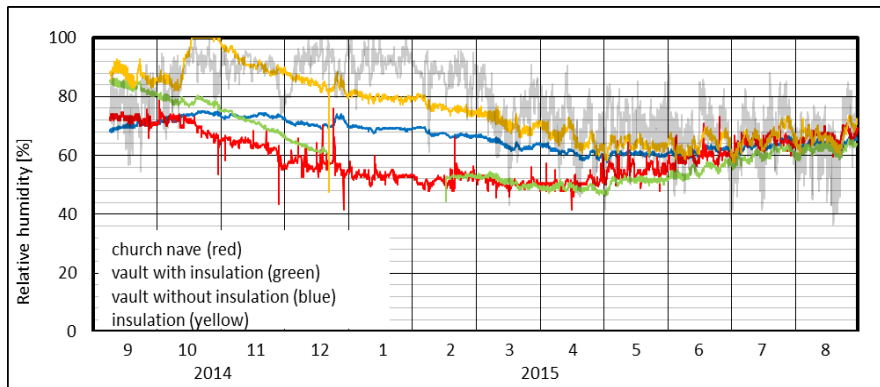
Figure 5: Relative humidity measurements from Annisse Church
