Understand, simulate, anticipate and correct performance gap in NZEB refurbishment of residential buildings

Flourentzou, Flourentzos; Antonov, Yovko Ivanov; Pantet, Samuel

Published in:
Journal of Physics: Conference Series (Online)

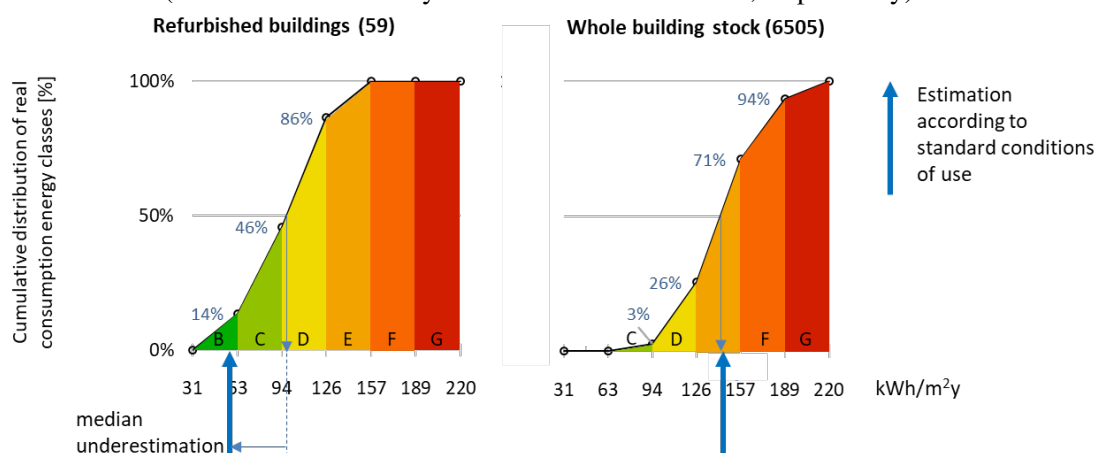
Figure 1. Cumulative distribution of energy classes in Geneva Canton for refurbished buildings (left) and the whole building stock (right). Arrows indicate compliance calculations with standard conditions

of use. The left graph illustrates a significant underestimation of compliance calculations for high performance refurbished buildings and the right graph a good matching with the mean energy consumption of the existing building stock.

On figure 1 the left graph shows cumulative distribution of energy classes for the real performance of refurbished buildings with high energy target. As evident from the figure, only 14% of the refurbished buildings comply with energy class B and nearly half of the buildings fall into category D. The blue arrow shows the expected energy performance estimated using the standard conditions of use, according to the Swiss norms (**Table 1**).

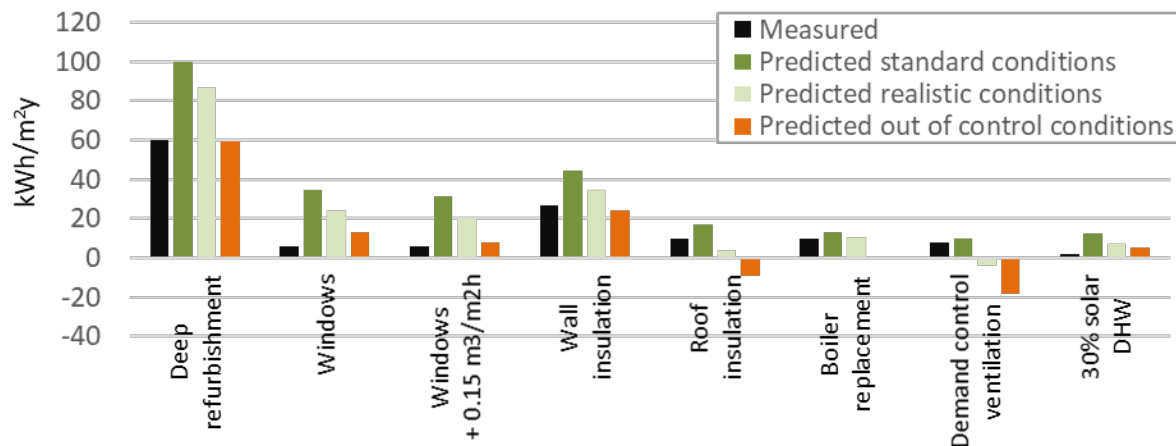
Figure 3. Observed and simulated energy savings according to standard, realistic and out of control conditions of use

Results presented in **Figure 3** compare measured [14] and estimated energy savings according to the proposed conditions of use in **Table 1** for the reference building using the software Lesosai. The results suggest that for deep refurbishment, windows and wall insulation, estimation with out of control conditions fits better to the real energy savings. For roof insulation, out of control conditions are too pessimistic. This is explained from the fact that wall and window insulation affect the interior temperature of all the dwellings making it difficult for convenient control, while roof insulation impacts only the top storey. For actions on installations (boiler replacement and demand control ventilation), standard and realistic conditions are closer, while out of control conditions may exist mostly on existing buildings before intervention rather than after refurbishment. For these actions, it is more important to use the correct conditions of use for the initial energy consumption before refurbishment. For solar domestic hot water situation is more complex. Realistic and out of control conditions fit better to the real performance because during summer the boiler produces mostly high temperature hot water to complete solar energy production. It is well known that condensing boilers are less efficient with high temperatures. However, even with this, real energy savings are lower. Other technical problems due to lack of monitoring decrease solar energy production.

On Figure 3 we observe that real energy consumption for deep refurbishment fit perfectly with out of control conditions. This is normal as the great majority of the observed buildings have never been monitored for optimisation. Energy savings using “realistic” conditions of use suggest 87 kWh/m²y instead of 100 of the standard conditions and 60 of the statistical observations and estimation with “out of control” conditions of use. This result fits perfectly with the optimised building mentioned in paragraph 2. This building was consuming after refurbishment in 2012 and 2013 up to 97 kWh/m²y which is very near to the mean of 100 kWh/m²y of our statistical sample. After 3 years of optimisation the energy performance of the building in 2017 was decreased to 69.7 kWh/m²y, saving extra 27 kWh/m²y, similar to the real energy savings suggested by the estimation according to realistic conditions on Figure 3.
