## Sustainable refurbishment by public clients

*Innovation and procurement strategies and practices*

SBI 2013:33

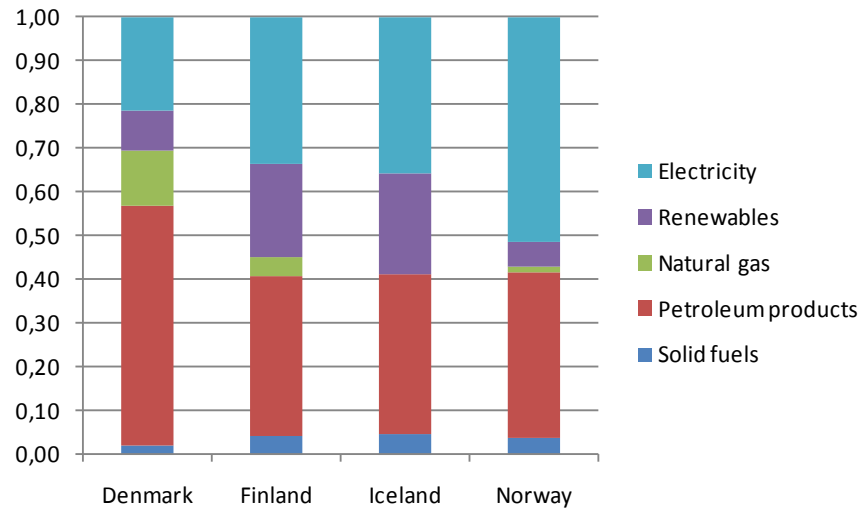
Energy production differs very much between the four countries as illustrated in Figure 6. The combined ratio of solid fuels, petroleum and natural gas is around 70 % for Denmark, but only 40 % for the other three countries. Electricity is primarily produced by burning of fuels in Denmark, burning of fuels and nuclear energy in Finland, hydro power and geothermal energy in Iceland and hydropower in Norway. The different energy sources result in different emissions and energy prices. Energy prices also depend on whether a country is connected to an international energy distribution net or not. Hydro power and nuclear power as such give very low CO<sub>2</sub> emissions and general-

Figure 6. Energy production by source. Source: Eurostat.

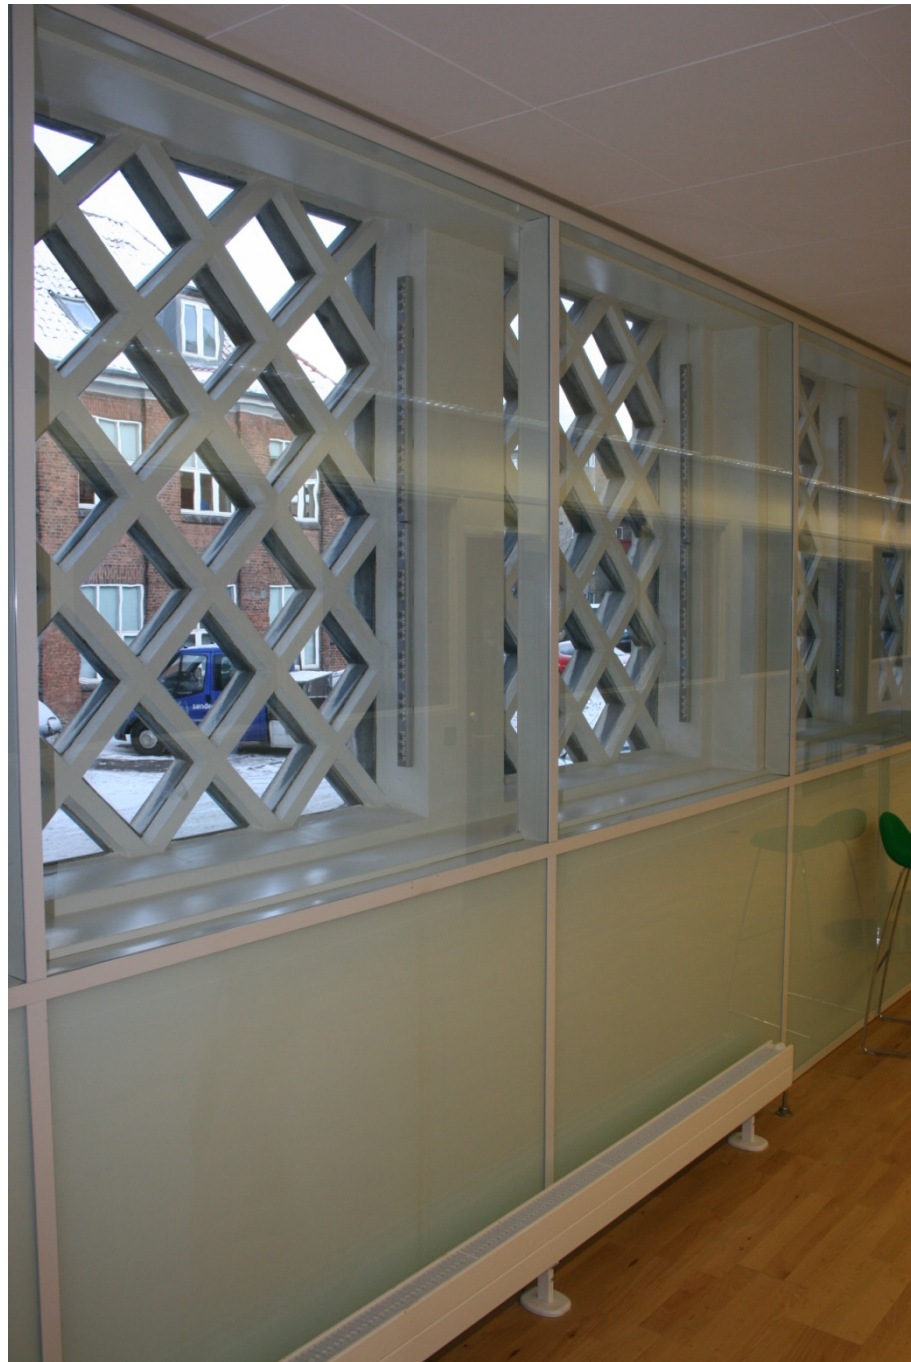
Figure 70. A solution was chosen where the whole facade was placed behind a “glass wall” (from the inside) as the very special windows could not be renovated in ordinary ways. Photo: (Kim Haugbølle).

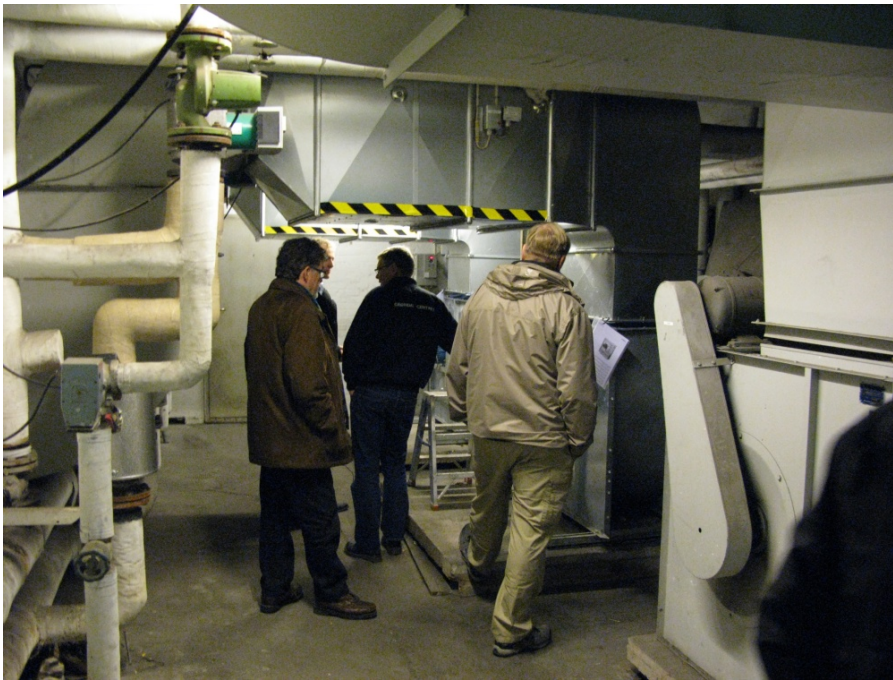
Figure 75. The old heating system is still working, but is part by part being renewed. Photo: (Peter Vogelius).

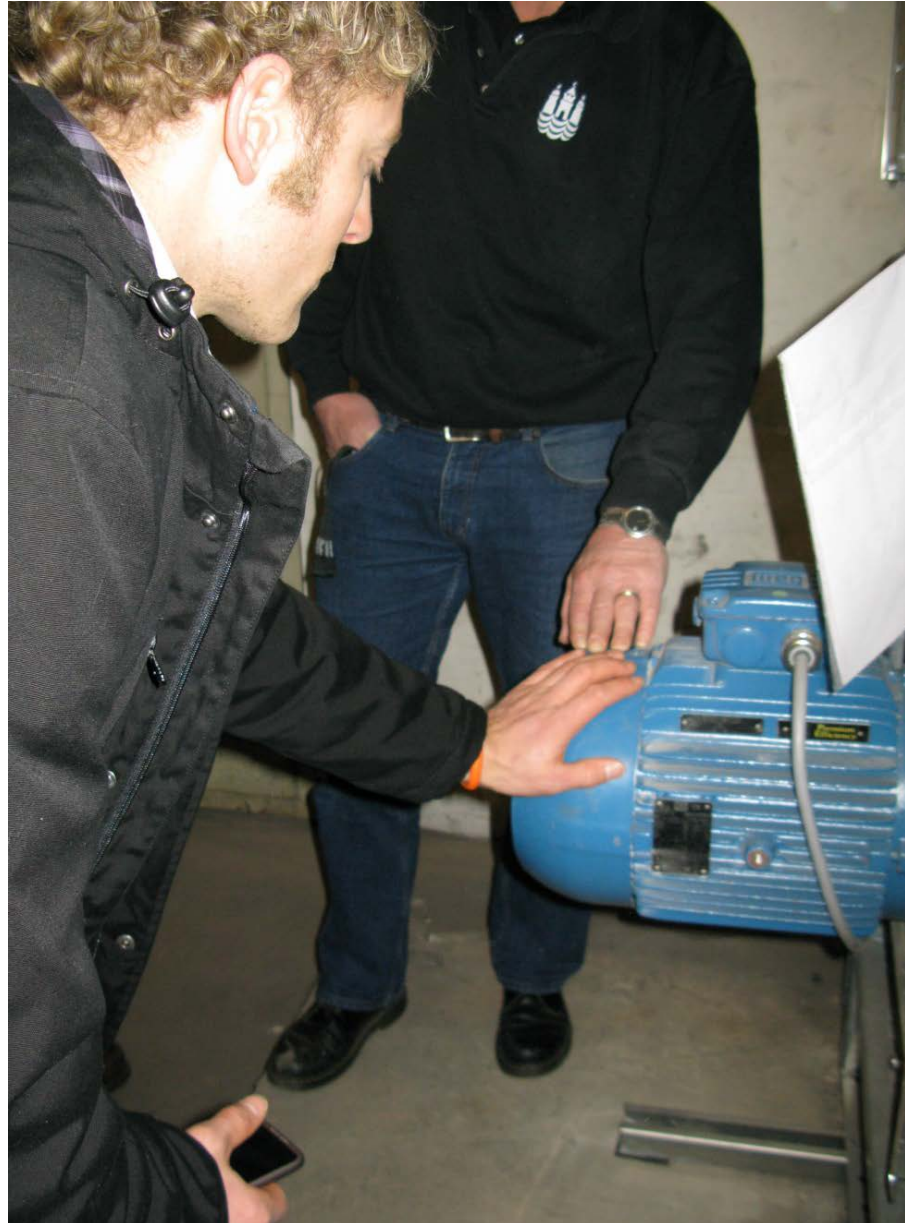
Figure 76. Circulation pumps are replaced mostly by low-energy models, which also facilitate and interface to the intranet. Photo: (Peter Vogelius).

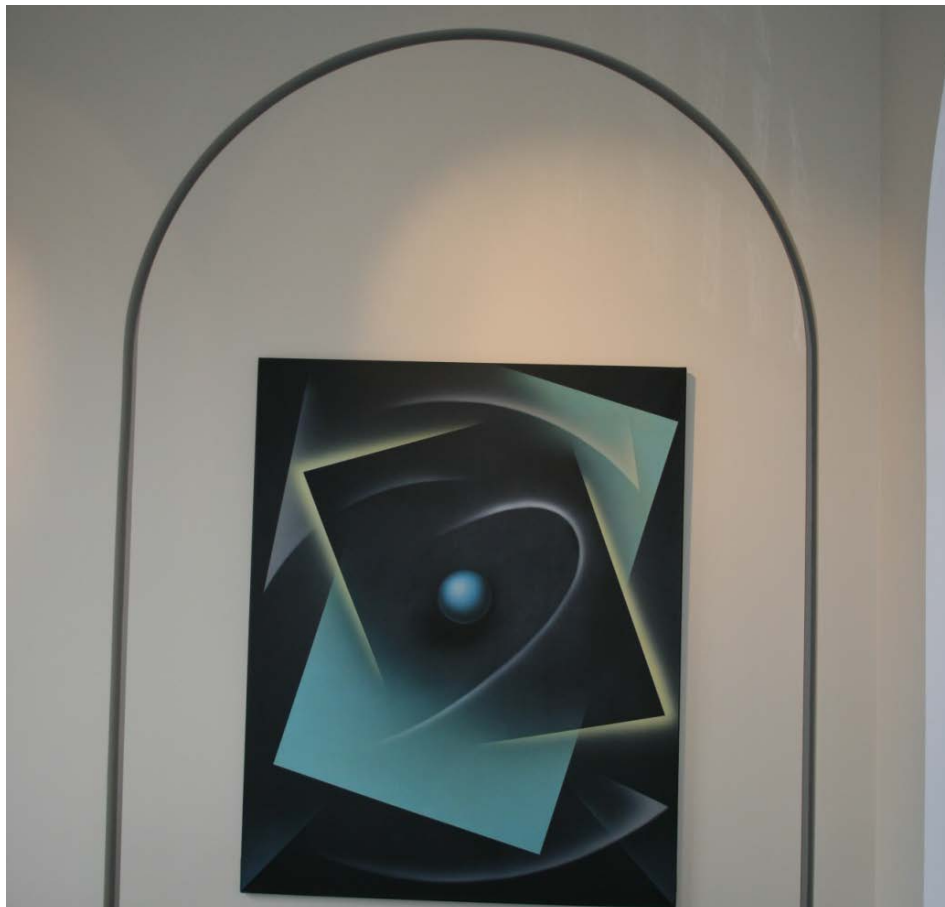
Figure 83. Ventilation system integrated in the wall. The painting on the wall is "From space to space" by Finn Mickelborg in 1995. Photo: Kim Haugbølle.

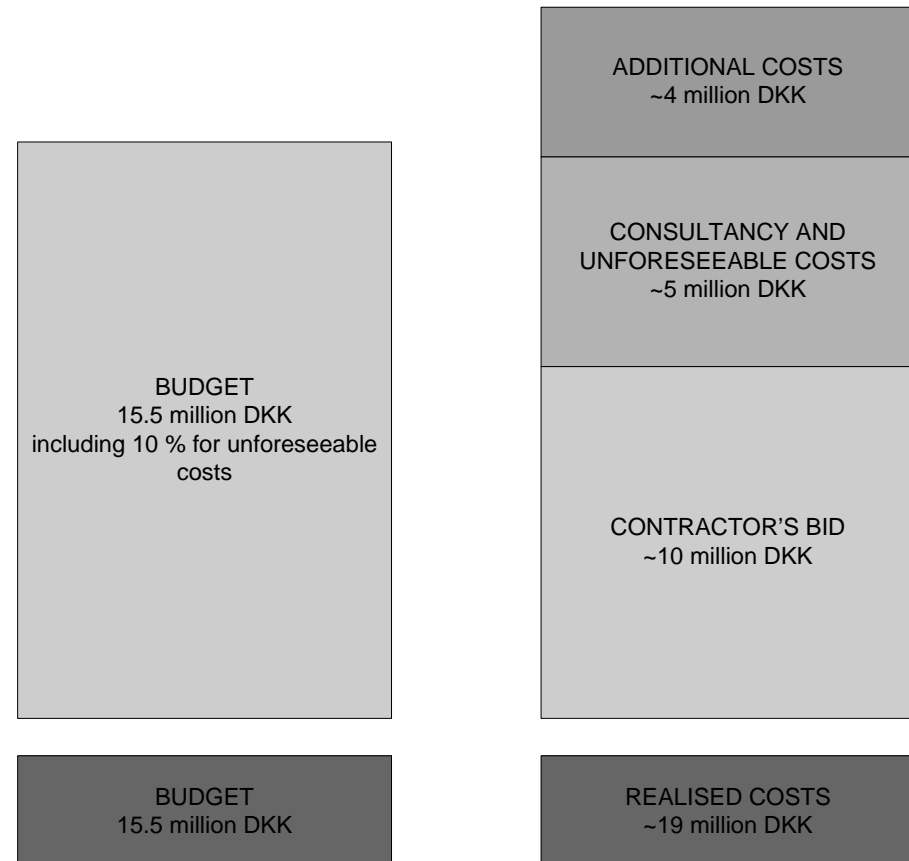
Figure 84. Illustration of the budget and realised costs for the refurbishment (without VAT).

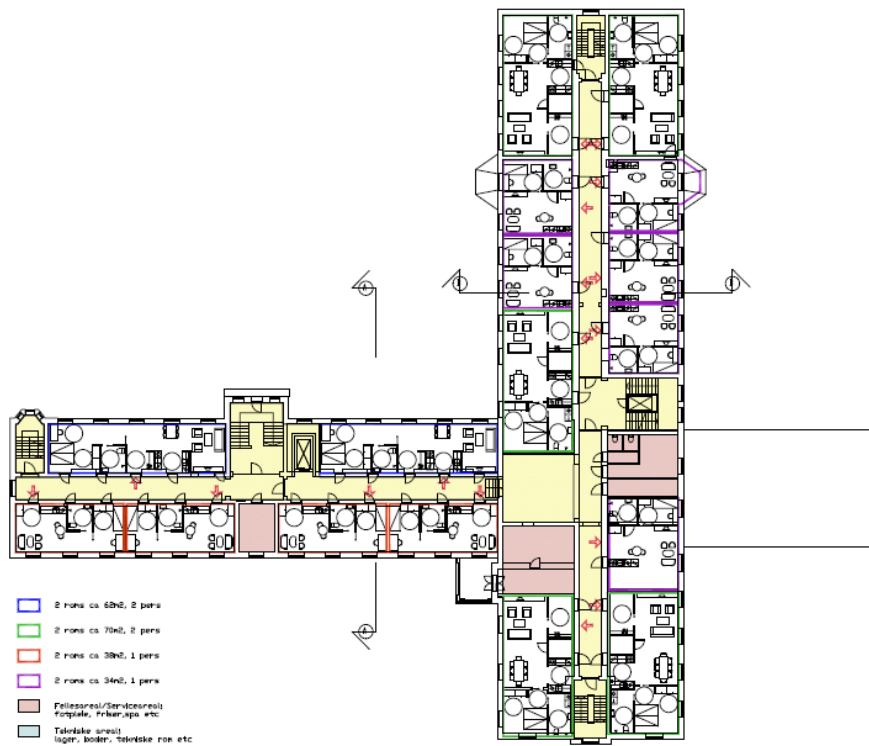
Figure 99. Second floor, as planned with apartments. Source: (Optimo – Entra Eiendom).

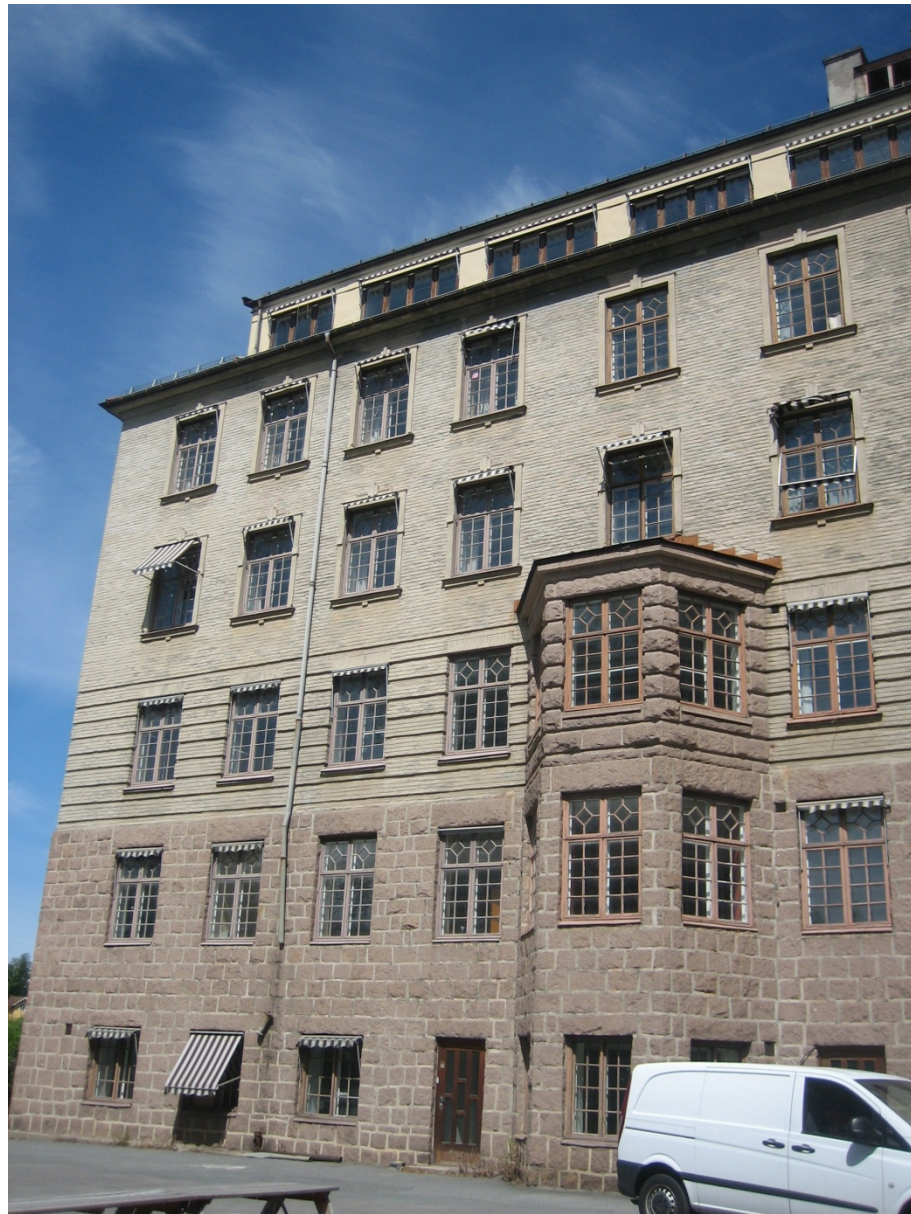
Figure 100. Outer wall façade. There is a clear distinction between the stone wall and the brick wall. Photo: (Anders-Johan Almås).

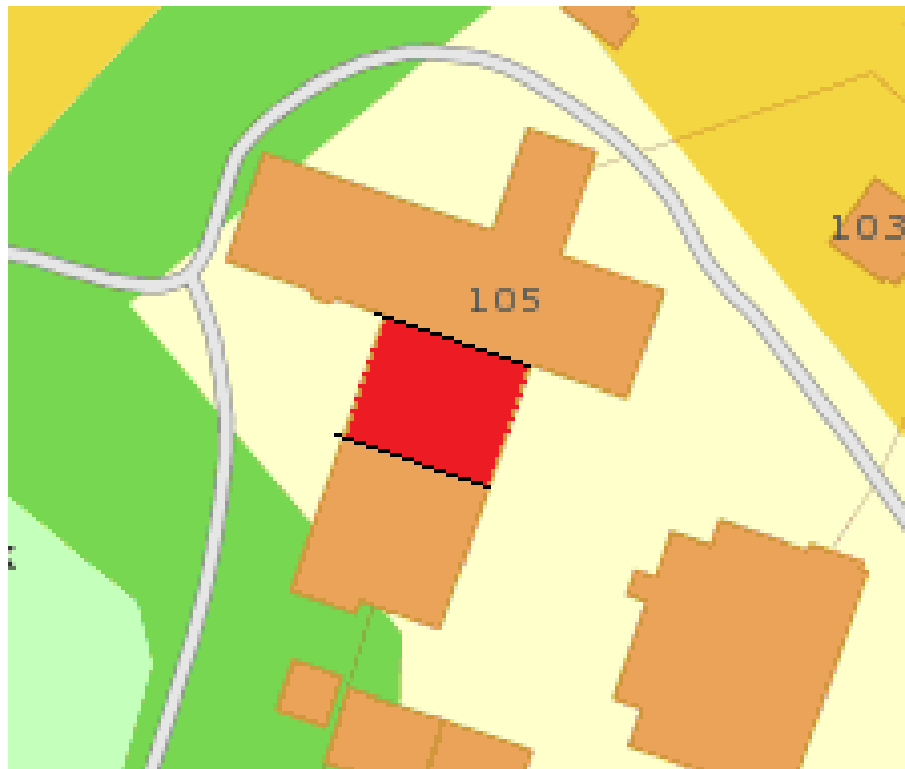
Figure 103. The air tightness was tested in the red area. Source: Adapted by Anders-Johan Almås.

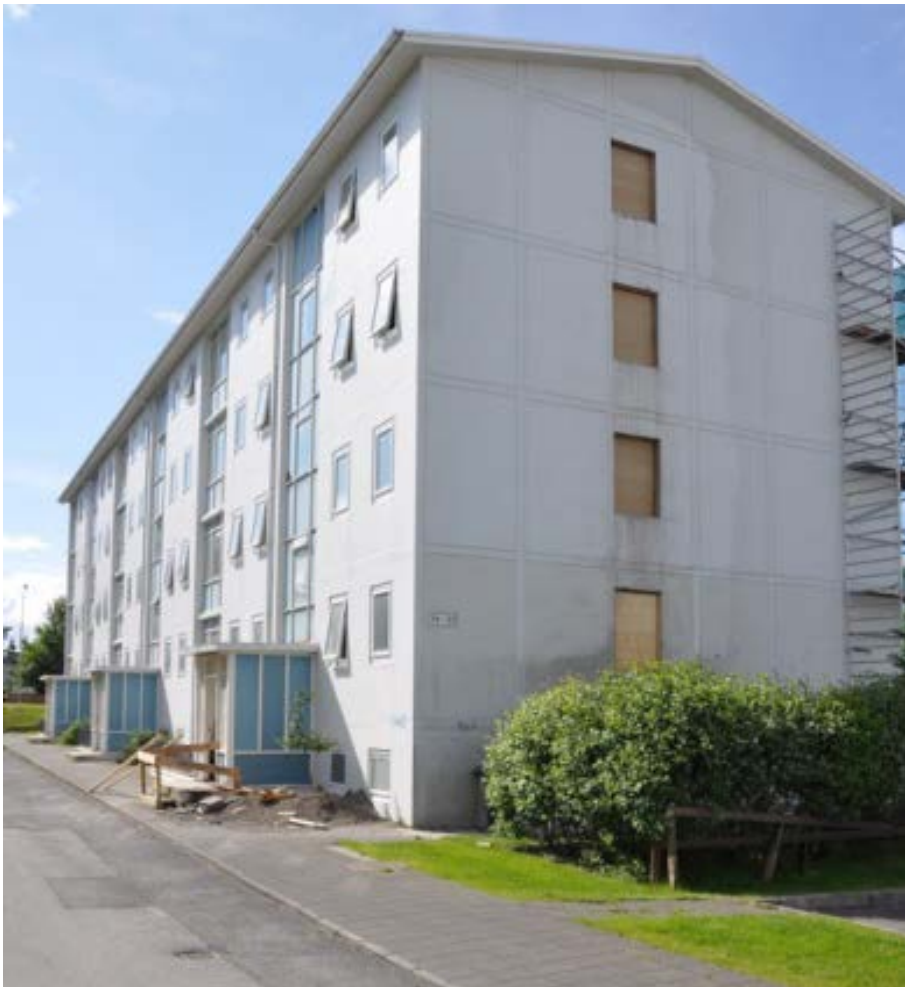
Figure 108. North view. New window openings have been cut out on the gable wall (during refurbishment). Photo: (Björn Marteinsson).

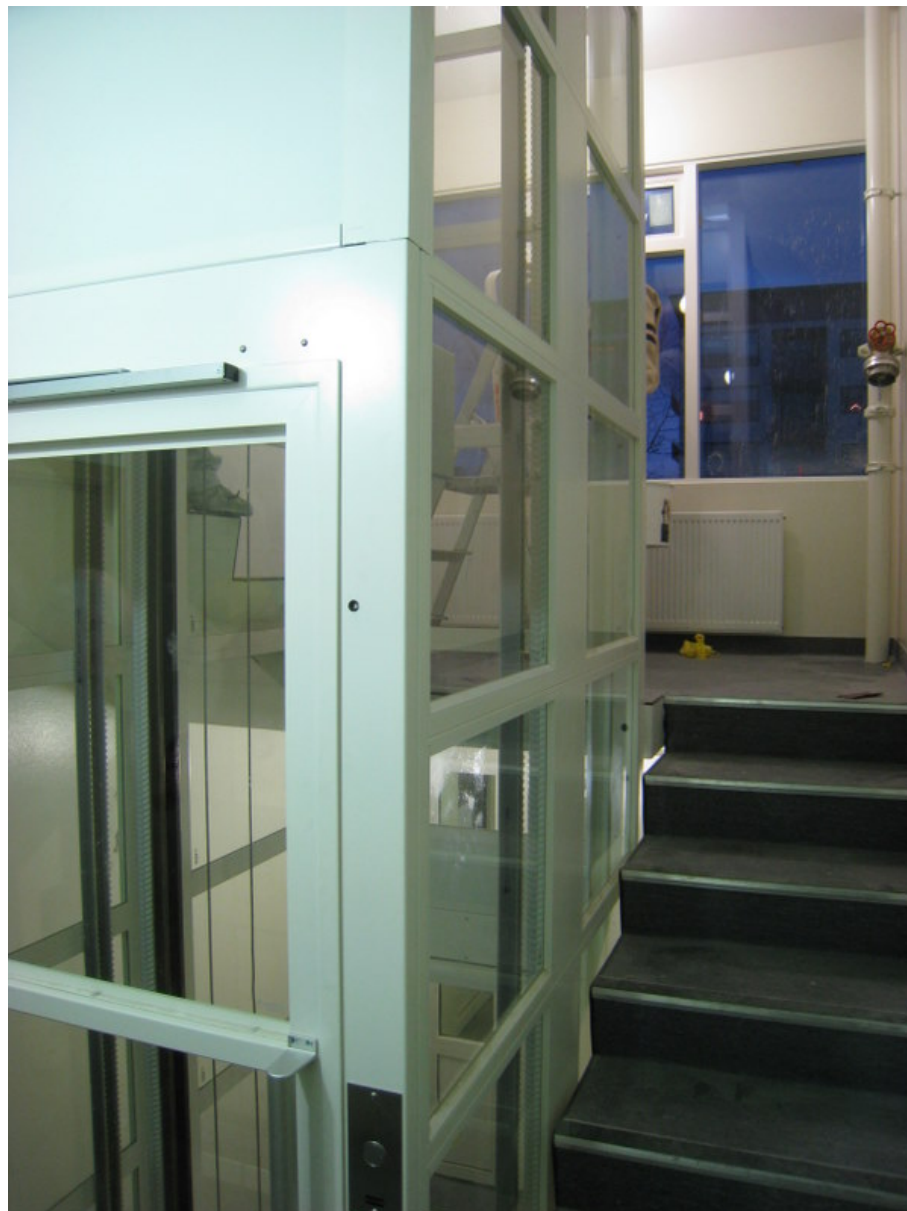
Figure 110. Existing staircase with an elevator built in. Photo: (Björn Marteinsson).

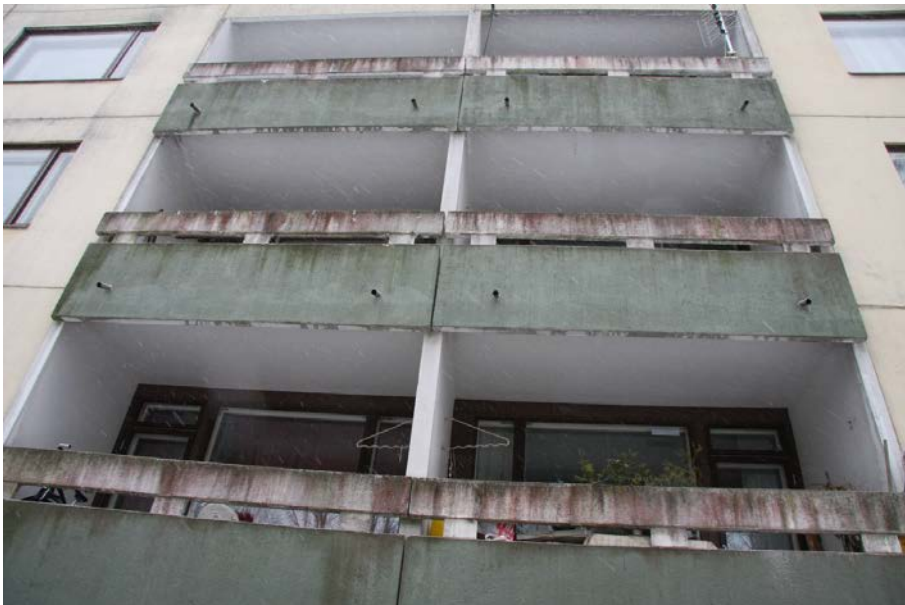
Figure 113. Sahatie 2: balconies in poor condition. Photo: (Pekka Huovila).

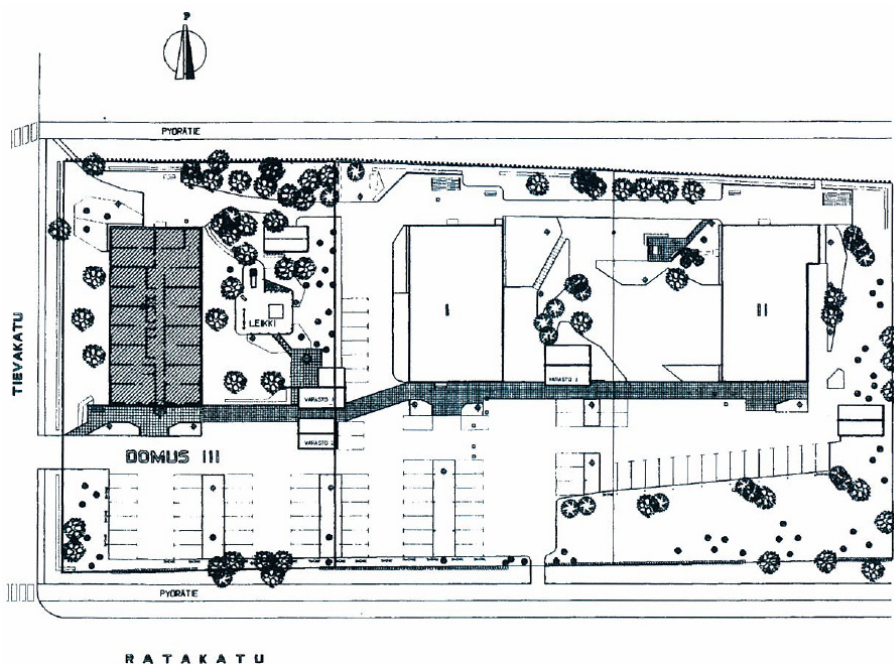
Figure 120. DAS III site plan. The building's gross floor area is 2,443 m<sup>2</sup> with 46 apartments and total net floor area 1,923 m<sup>2</sup>. Source: (DAS, 2009: 5).

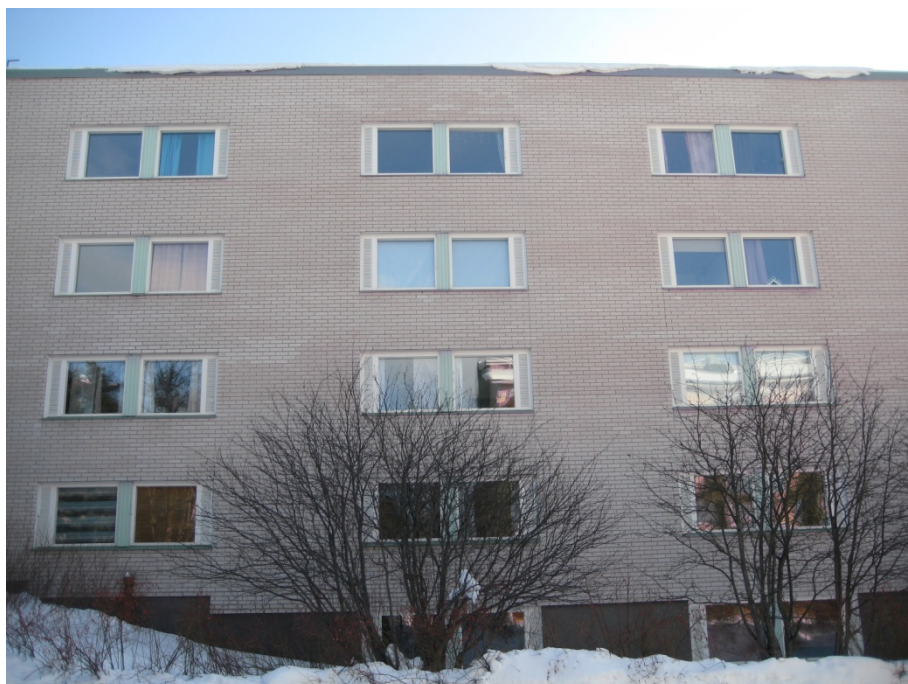
Figure 121. DAS III has a ventilated masonry facade. Photo: (Jyri Nieminen).

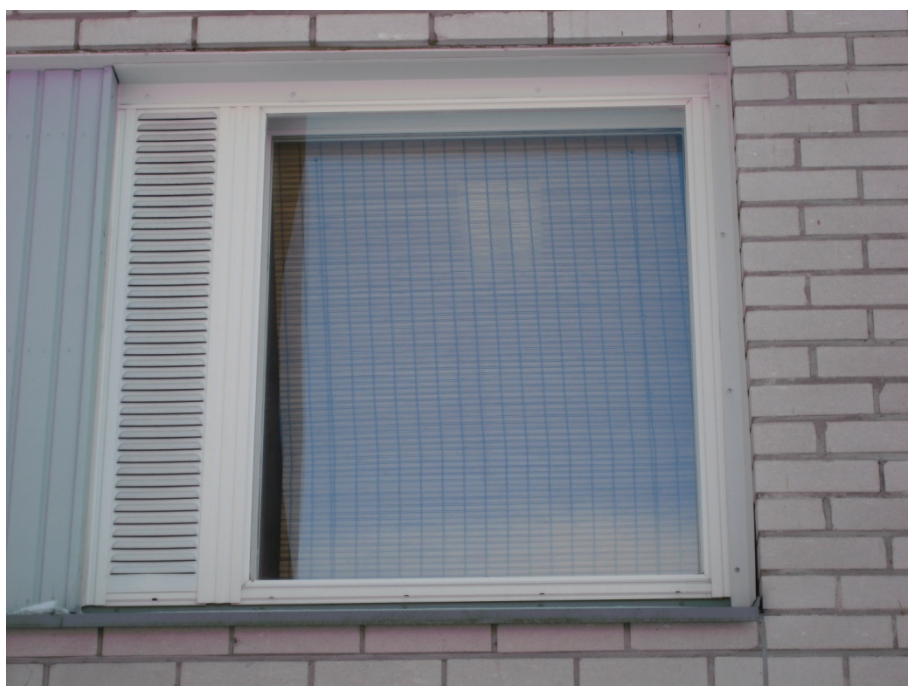
Figure 122. The windows were upgraded in 1995. Photo: (Jyri Nieminen).

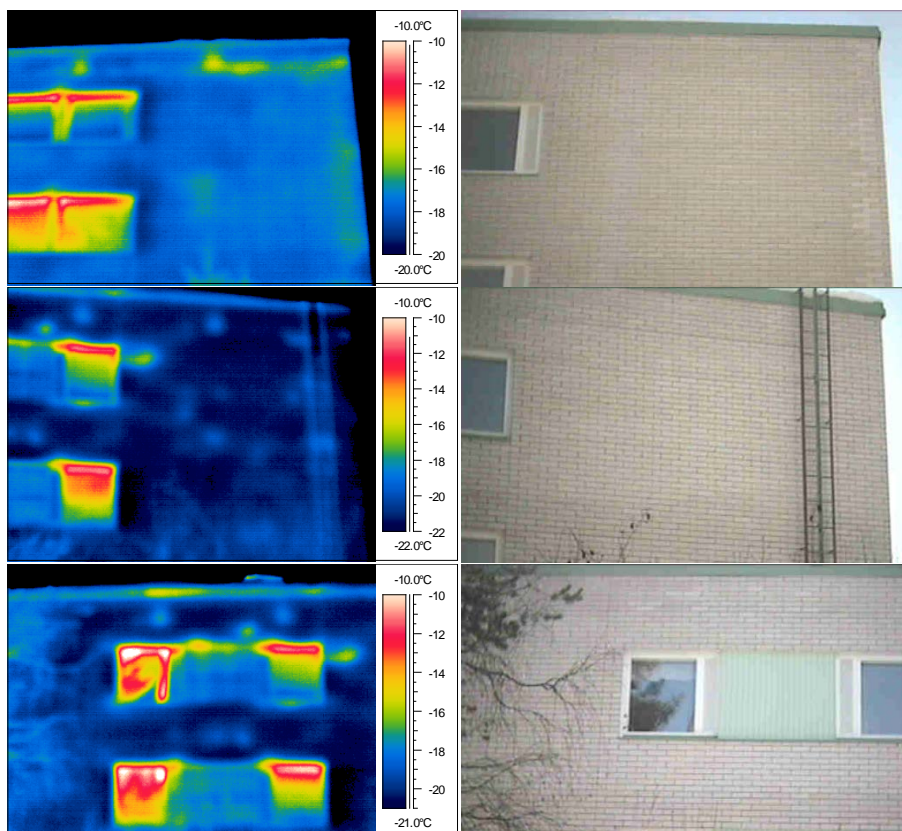
Figure 125. Selected results from thermo-graphic analysis. In general, the survey did not show any major problems with the building. Photos: (Jyri Nieminen).

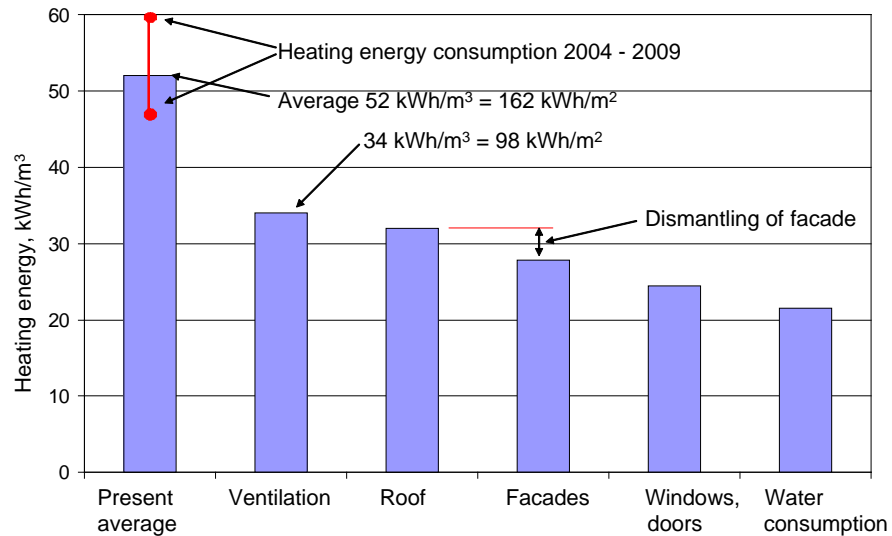
Figure 126. Impacts of energy saving measures in DAS III. Source: (Jyri Nieminen).
