Ecological Engineering

10 years after the largest river restoration project in Northern Europe: Hydromorphological changes on multiple scales in River Skjern

E.A. Kristensen ^{a,*}, B. Kronvang ^a, P. Wiberg-Larsen ^a, H. Thodsen ^a, C. Nielsen ^a,
E. Amor ^a, N. Friberg ^a, M.L. Pedersen ^b, A. Baattrup-Pedersen ^a

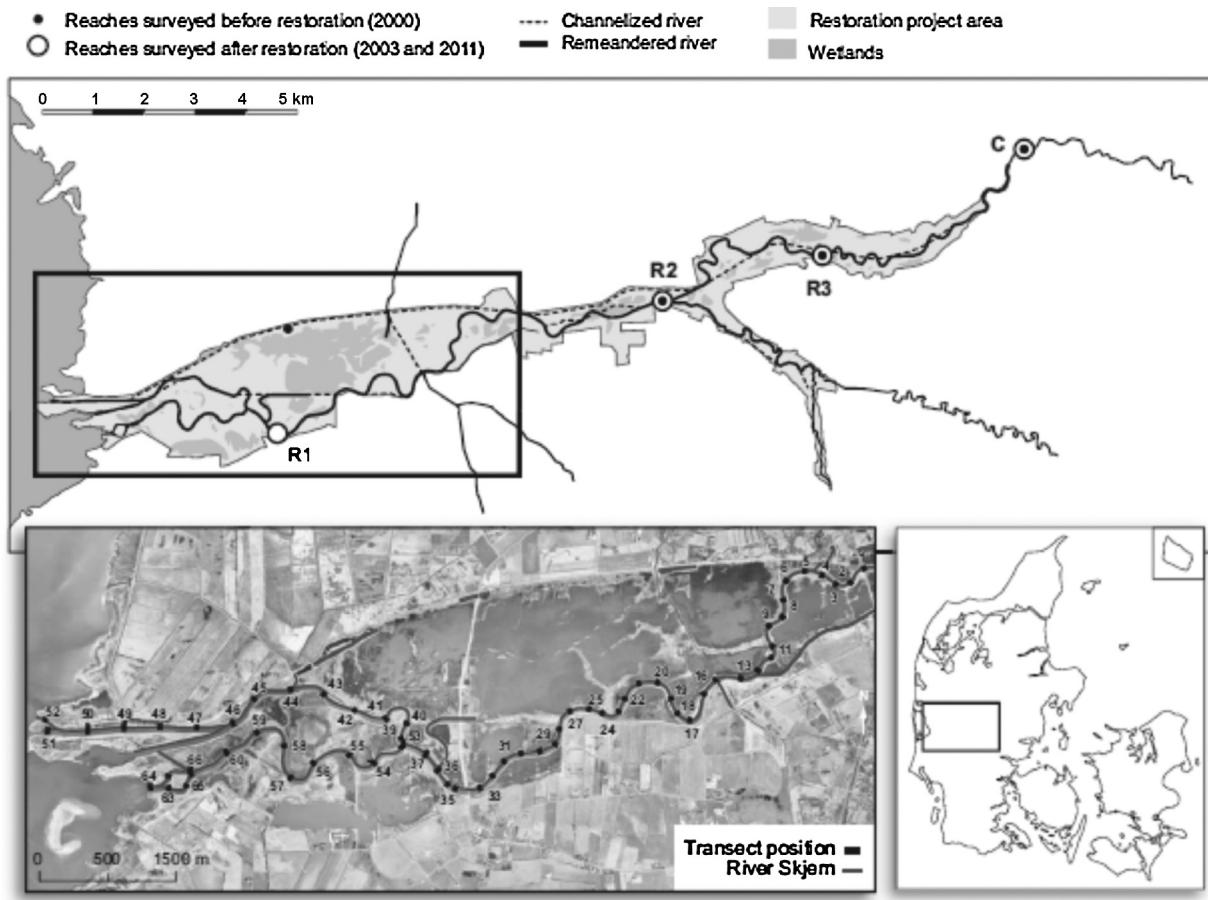
Fig. 1. Map showing the study area, study sites for in-stream habitats (R1, R2, R3 and C), and the position of transects used to measure channel stability (1–66).

the restored River Skjern (R1, R2, R3, Fig. 1) based on a comparison with a 300 m long control reach (C, Fig. 1) located upstream of the restoration area (Pedersen et al., 2007b). All four reaches was sampled once before the restoration (2000) and again immediately after the restoration (2003; Pedersen et al., 2007b). After the restoration the location of R2, R3 and C remained at the same location as pre-restoration, while, as a result of the restoration and filling-up of major parts of the channelized river, reach R1 was in 2003 moved from the northern drainage channel to the newly excavated river channel located app. 2 km south (Fig. 1). For this study, we re-sampled these four reaches in 2011 providing data for a long-term evaluation (app. 10 years) of the restoration on in-stream habitats. Identical surveying methods were used in all three years to allow for cross-year comparison, for a detailed description of the methodology, see Pedersen et al. (2007b). In brief, six transects were placed equally spaced along each of the four reaches and each transect was divided into 1 m × 1 m quadrats across the entire width. A GPS was used to exactly identify location of each transect. At each quadrat, depth (to nearest cm), current velocity (at 10 cm above the stream bed), dominating substrates (using seven categories according to the Wentworth-scale (Wentworth, 1922) and macrophyte coverage (%) was recorded. Recording of in-stream variables was done in September 2000, August 2003 and September 2011 and it was aimed to collect data at similar discharge levels. However, the summer 2003 was drier than normal and mean monthly discharge for August 2003 was 12.7 m³/s, while mean monthly discharge for September 2000 and September 2011 was 19.4 m³/s and 19.1 m³/s, respectively.

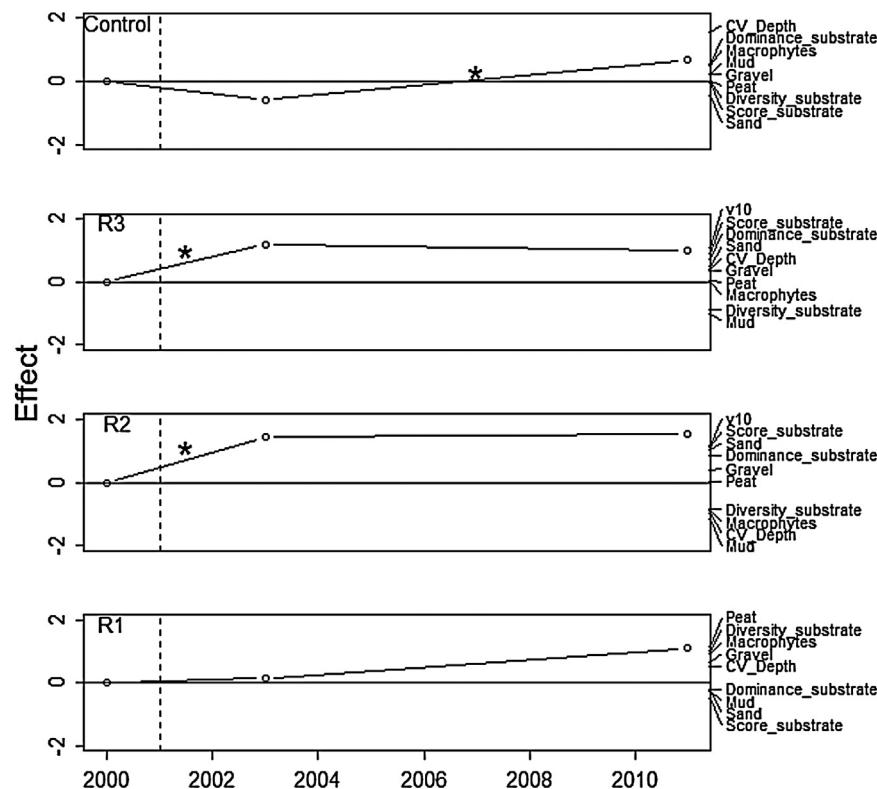
Fig. 2. Principal response curve analyses of the development of in-stream habitat parameters in four different sites of the vegetated zone (depths 0–130 cm) of River Skjern: control upstream the restored reaches (R1, R2, R3).

When comparing RDA scores, we found no significant overall change to in-stream habitats in the vegetated zone of the control reach from 2000 to 2003 ($P=0.493$; Fig. 2) however, from 2003 to 2011 there was a significant change ($P=0.0008$; Fig. 2). This change was primarily caused by an increase in CV Depth, indicating more heterogeneous stream profiles with larger variation in depth in

2011 compared to 2003. In the vegetated zone of R3 and R2 the restoration resulted in a significant change to in-stream habitats ($P=0.022$ and $P=0.026$, respectively). In this zone of R3, the restoration resulted in higher current velocities (v10), a coarser substrate (Score_substrate) although still dominated by sand, a higher coverage of gravel, a reduction in coverage by mud and consequently a lower substrate diversity (Fig. 2). In the vegetated zone of R2, the restoration also resulted in increased current velocities (v10), a coarser substrate (Score_substrate) although still dominated by sand, a relatively higher coverage of gravel, lower coverage of mud and a lower substrate diversity (Fig. 2). In addition, the analysis showed that the overall significant changes to in-stream habitats of the vegetated zone of R3 were also related to a reduction in macrophyte coverage (Fig. 2).

The observed changes to in-stream habitats in the vegetated zone of R3 and R2 were stable over time showing no change from 2003 to 2011 ($P=0.906$ and $P=0.722$; Fig. 2). The in-stream habitats of the vegetated zone in the most downstream reach (R1) was not significantly affected by the restoration as only very small changes occurred from 2000 to 2003 (Fig. 2). From 2003 to 2011 there was some development in in-stream habitats but these changes were not significant ($P=0.897$; Fig. 2).
