Hydromorphological changes on multiple scales in River Skjern

Published in:
Ecological Engineering

10 years after the largest river restoration project in Northern Europe: Hydromorphological changes on multiple scales in River Skjern

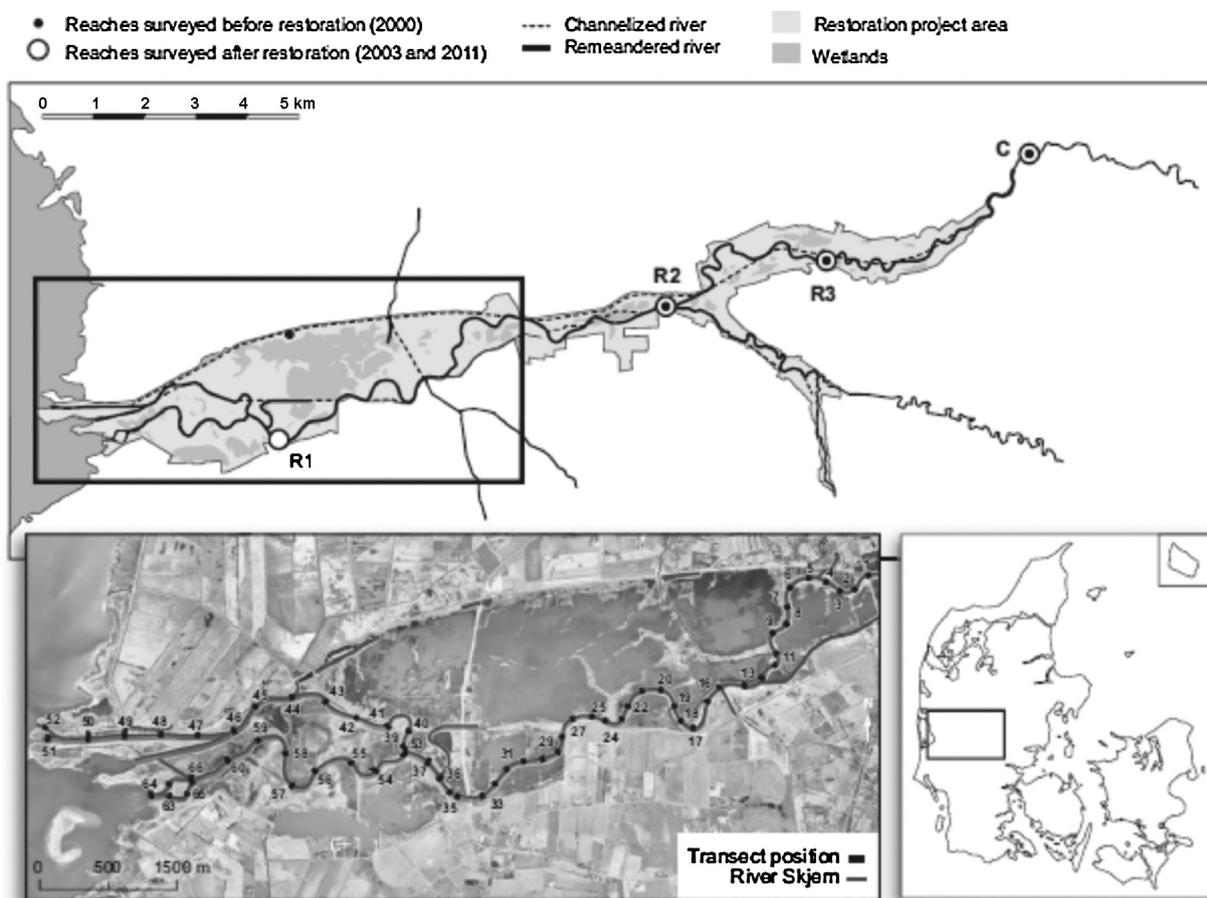
Fig. 1. Map showing the study area, study sites for in-stream habitats (R1, R2, R3 and C), and the position of transects used to measure channel stability (1–66).

the restored River Skjern (R1, R2, R3, Fig. 1) based on a comparison with a 300 m long control reach (C, Fig. 1) located upstream of the restoration area (Pedersen et al., 2007b). All four reaches were sampled once before the restoration (2000) and again immediately after the restoration (2003; Pedersen et al., 2007b). After the restoration the location of R2, R3 and C remained at the same location as pre-restoration, while, as a result of the restoration and filling-up of major parts of the channelized river, reach R1 was in 2003 moved from the northern drainage channel to the newly excavated river channel located app. 2 km south (Fig. 1). For this study, we re-sampled these four reaches in 2011 providing data for a long-term evaluation (app. 10 years) of the restoration on in-stream habitats. Identical surveying methods were used in all three years to allow for cross-year comparison, for a detailed description of the methodology, see Pedersen et al. (2007b). In brief, six transects were placed equally spaced along each of the four reaches and each transect was divided into 1 m × 1 m quadrats across the entire width. A GPS was used to exactly identify location of each transect. At each quadrat, depth (to nearest cm), current velocity (at 10 cm above the stream bed), dominating substrates (using seven categories according to the Wentworth-scale (Wentworth, 1922) and macrophyte coverage (%) was recorded. Recording of in-stream variables was done in September 2000, August 2003 and September 2011 and it was aimed to collect data at similar discharge levels. However, the summer 2003 was drier than normal and mean monthly discharge for August 2003 was 12.7 m³/s, while mean monthly discharge for September 2000 and September 2011 was 19.4 m³/s and 19.1 m³/s, respectively.

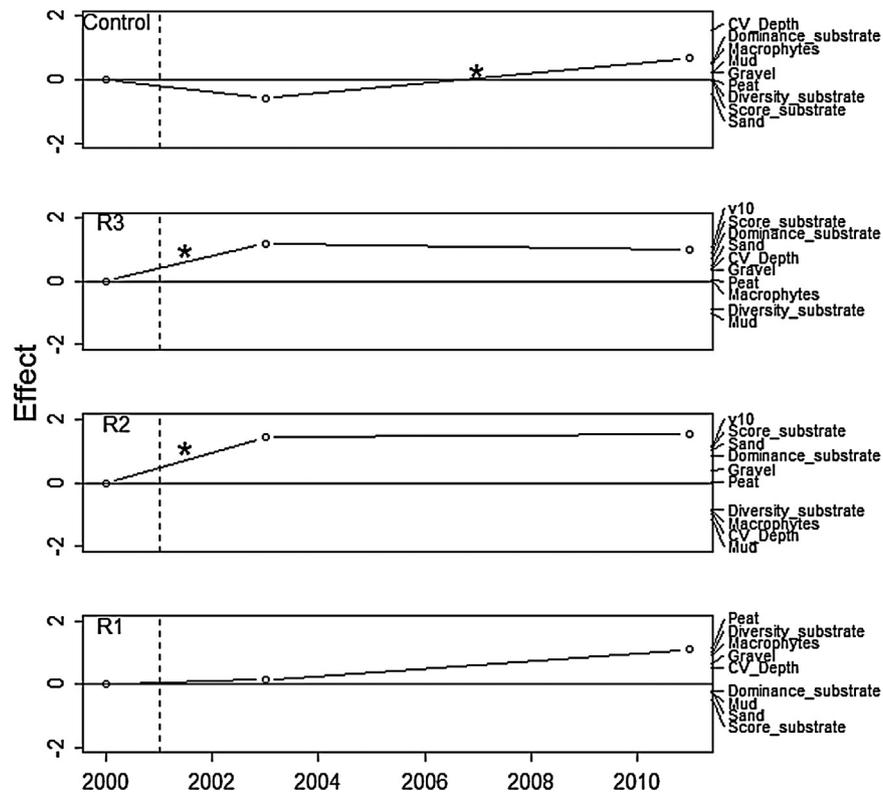
Fig. 2. Principal response curve analyses of the development of in-stream habitat parameters in four different sites of the vegetated zone (depths 0–130 cm) of River Skjern: control upstream the restored reaches (R1, R2, R3).

When comparing RDA scores, we found no significant overall change to in-stream habitats in the vegetated zone of the control reach from 2000 to 2003 ($P=0.493$; Fig. 2) however, from 2003 to 2011 there was a significant change ($P=0.0008$; Fig. 2). This change was primarily caused by an increase in CV Depth, indicating more heterogeneous stream profiles with larger variation in depth in

2011 compared to 2003. In the vegetated zone of R3 and R2 the restoration resulted in a significant change to in-stream habitats ($P=0.022$ and $P=0.026$, respectively). In this zone of R3, the restoration resulted in higher current velocities (v_{10}), a coarser substrate (Score_substrate) although still dominated by sand, a higher coverage of gravel, a reduction in coverage by mud and consequently a lower substrate diversity (Fig. 2). In the vegetated zone of R2, the restoration also resulted in increased current velocities (v_{10}), a coarser substrate (Score_substrate) although still dominated by sand, a relatively higher coverage of gravel, lower coverage of mud and a lower substrate diversity (Fig. 2). In addition, the analysis showed that the overall significant changes to in-stream habitats of the vegetated zone of R3 were also related to a reduction in macrophyte coverage (Fig. 2).

The observed changes to in-stream habitats in the vegetated zone of R3 and R2 were stable over time showing no change from 2003 to 2011 ($P=0.906$ and $P=0.722$; Fig. 2). The in-stream habitats of the vegetated zone in the most downstream reach (R1) was not significantly affected by the restoration as only very small changes occurred from 2000 to 2003 (Fig. 2). From 2003 to 2011 there was some development in in-stream habitats but these changes were not significant ($P=0.897$; Fig. 2).

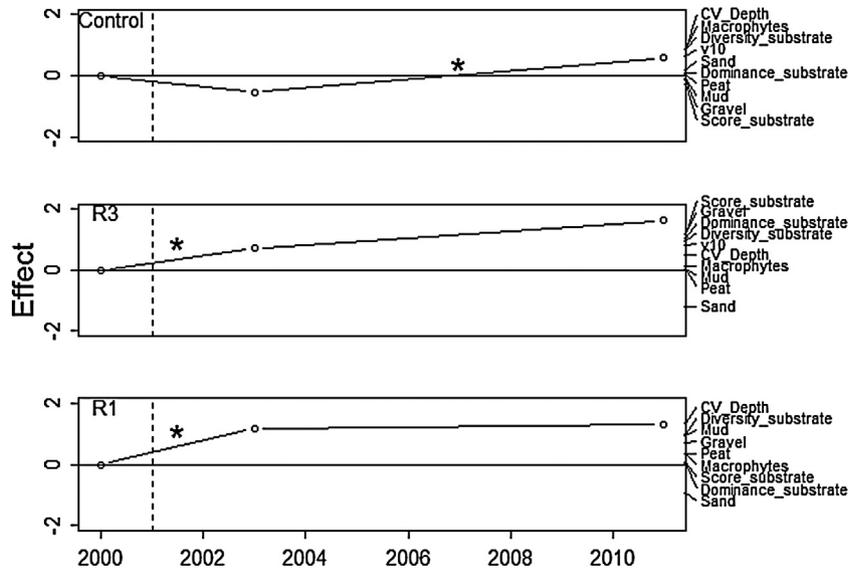
Fig. 3. Principal response curve analyses of the development of in-stream habitat parameters in four different sites of the current zone (depths >130 cm) of River Skjern: control upstream the restored reaches (R1, R2, R3).

Similar to the vegetated zone, we found no significant overall change to in-stream habitats in the main current zone of the control reach from 2000 to 2003 ($P=0.460$; Fig. 3) and a small but significant change from 2003 to 2011 ($P=0.011$; Fig. 3). This change was primarily driven by an increase in CV depth, macrophyte coverage and substrate diversity over the period (Fig. 3). In the main current zone of R3 and R1, the restoration resulted in a significant change to in-stream habitats ($P=0.02$ and $P=0.011$ respectively; Fig. 3), primarily caused by a higher variation in depth (CV depth) and higher coverage by gravel and consequently a higher substrate score, a higher substrate dominance score and a higher substrate diversity (Fig. 3). As found for the vegetated zone of R3 and R1, the observed changes to in-stream habitats following restoration, stayed stable over time in the main current zone of R3 and R1 ($P=0.161$ and $P=0.897$, respectively; Fig. 3). No analysis was performed for R2 for the main current zone as only very few quadrates had depths over 130 cm.

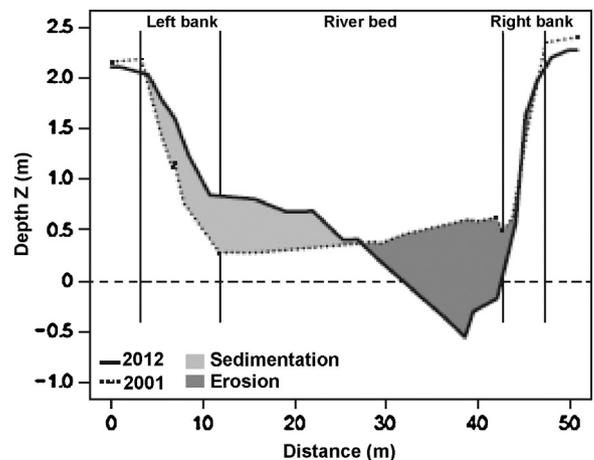
Fig. 4. Example of cross-sectional adjustments of the River Skjern between 2001 and 2012.

The survey of 65 cross-sectional transects along the lower 10 km of River Skjern in 2001 and again in 2011 revealed marked morphological adjustments through erosion and sedimentation in the newly restored stream channel (Fig. 4). There was large variations in the morphological adjustments among transects during the 10 year period (Fig. 5). Average sedimentation and erosion volume (\pm SD) measured at the left bank amounted to $231 \pm 360 \text{ m}^3$ and $274 \pm 325 \text{ m}^3$, respectively, resulting in a net erosion of 43 m^3 sediment. For the right bank, average sedimentation and erosion volume (\pm SD) was $192 \pm 340 \text{ m}^3$ and $536 \pm 740 \text{ m}^3$, respectively, yielding a net erosion of 344 m^3 sediment. However, the most pronounced morphological changes were observed at the river bed. Average sedimentation (\pm SD) for this part of the cross-sectional transects was $2259 \pm 2333 \text{ m}^3$ sediment and average erosion (\pm SD) was $707 \pm 996 \text{ m}^3$ resulting in a net sedimentation of 1552 m^3 sediment. Combined, the net balance resulted in a gain of 1166 m^3

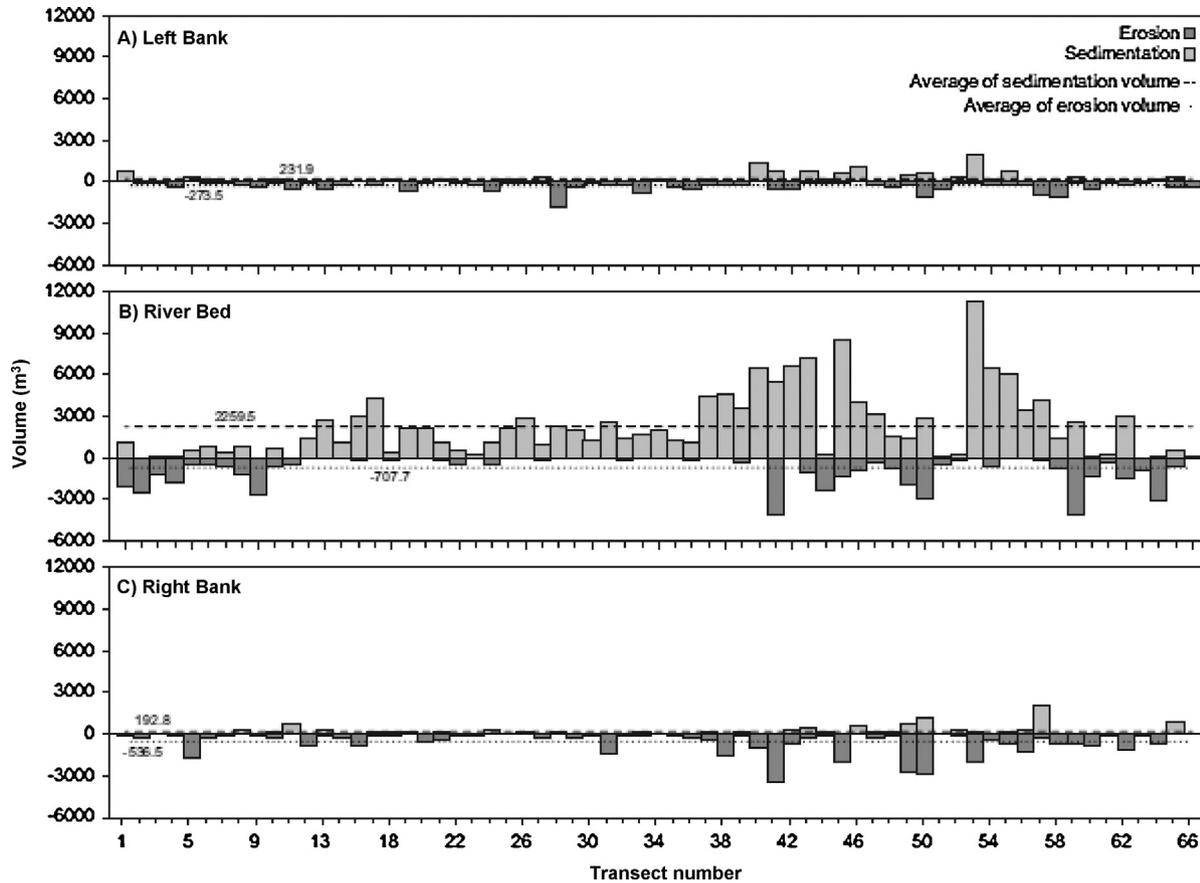
Fig. 5. Erosion and sedimentation in the lower 10 km of the restored River Skjern over a 10 year period (2001–2011).

sediment over the 10 years in the restored river channel. The net result is a slightly wider and shallower river in 2011 than in 2001.

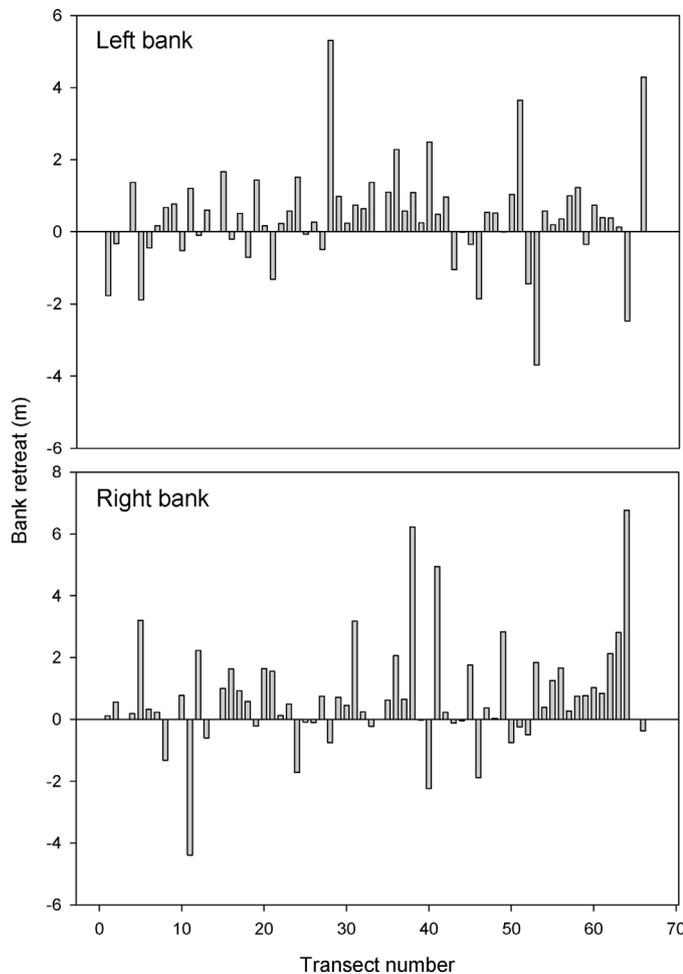
Fig. 6. Bank retreat in the lower 10 km of the restored River Skjern over a 10 year period.

There was large variation in bank retreat among transects (Fig. 6) and average bank retreat for left banks was 39 cm and 68 cm for right banks. This corresponds to a forecasted bank retreat of 3.9 m for left banks and 6.8 m for right banks over a 100 years period.
