*Published in:*  
Ecological Engineering

*Publication date:*  
2014

## 10 years after the largest river restoration project in Northern Europe: Hydromorphological changes on multiple scales in River Skjern

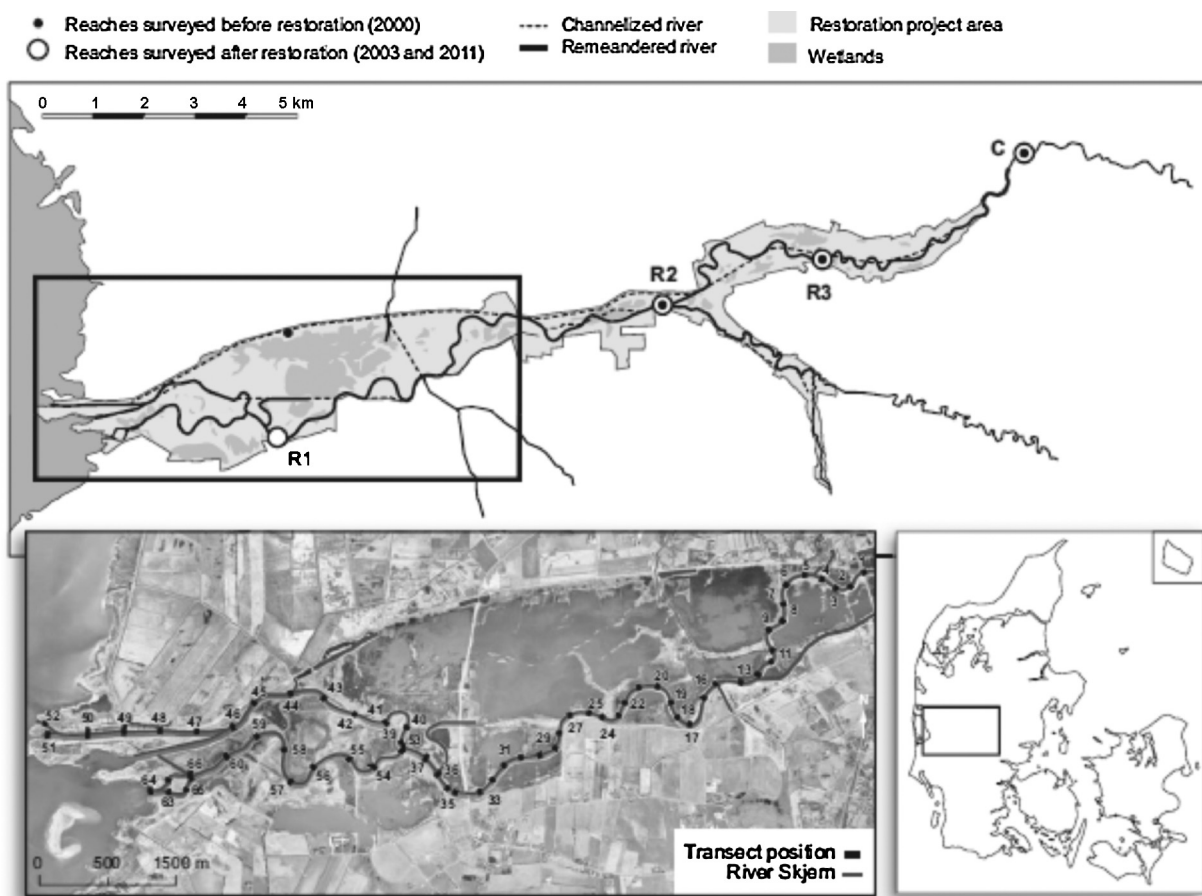
Fig. 1. Map showing the study area, study sites for in-stream habitats (R1, R2, R3 and C), and the position of transects used to measure channel stability (1–66).

The short-term effects of the restoration on in-stream habitats have previously been evaluated in three 300 m long reaches along

the restored River Skjern (R1, R2, R3, Fig. 1) based on a comparison with a 300 m long control reach (C, Fig. 1) located upstream of the restoration area (Pedersen et al., 2007b). All four reaches were sampled once before the restoration (2000) and again immediately after the restoration (2003; Pedersen et al., 2007b). After the restoration the location of R2, R3 and C remained at the same location as pre-restoration, while, as a result of the restoration and filling-up of major parts of the channelized river, reach R1 was in 2003 moved from the northern drainage channel to the newly excavated river channel located app. 2 km south (Fig. 1). For this study, we re-sampled these four reaches in 2011 providing data for a long-term evaluation (app. 10 years) of the restoration on in-stream habitats. Identical surveying methods were used in all three years to allow for cross-year comparison, for a detailed description of the methodology, see Pedersen et al. (2007b). In brief, six transects were placed equally spaced along each of the four reaches and each transect was divided into 1 m × 1 m quadrats across the entire width. A GPS was used to exactly identify location of each transect. At each quadrat, depth (to nearest cm), current velocity (at 10 cm above the stream bed), dominating substrates (using seven categories according to the Wentworth-scale (Wentworth, 1922) and macrophyte coverage (%) was recorded. Recording of in-stream variables was done in September 2000, August 2003 and September 2011 and it was aimed to collect data at similar discharge levels. However, the summer 2003 was drier than normal and mean monthly discharge for August 2003 was 12.7 m<sup>3</sup>/s, while mean monthly discharge for September 2000 and September 2011 was 19.4 m<sup>3</sup>/s and 19.1 m<sup>3</sup>/s, respectively.

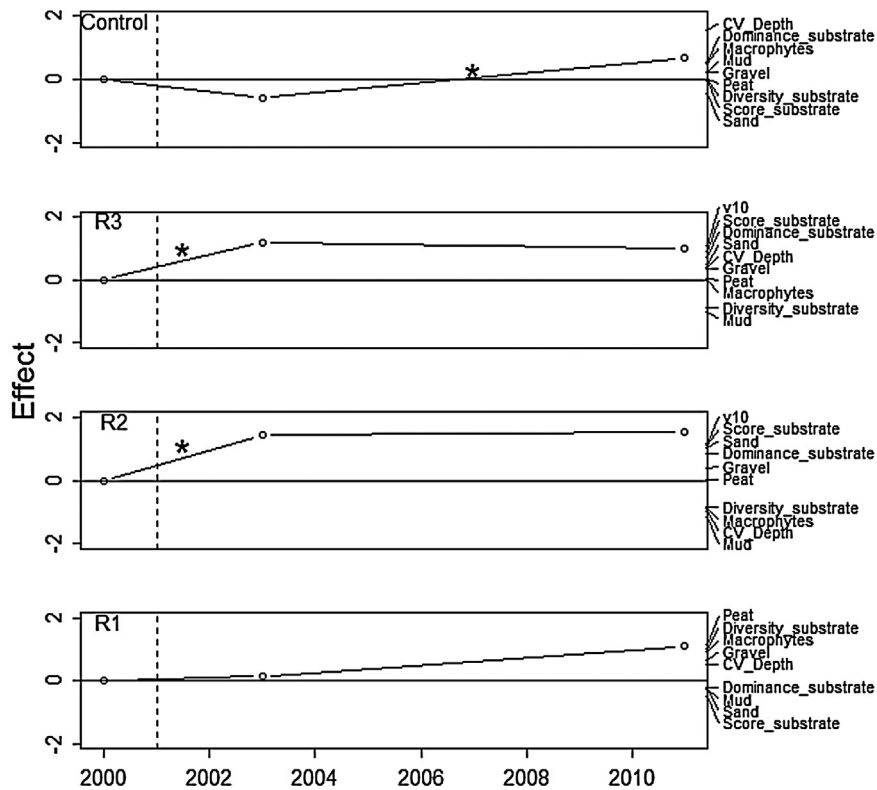
Fig. 2. Principal response curve analyses of the development of in-stream habitat parameters in four different sites of the vegetated zone (depths 0–130 cm) of River Skjern: control upstream the restored reaches (R1, R2, R3).

When comparing RDA scores, we found no significant overall change to in-stream habitats in the vegetated zone of the control reach from 2000 to 2003 ( $P=0.493$ ; Fig. 2) however, from 2003 to 2011 there was a significant change ( $P=0.0008$ ; Fig. 2). This change was primarily caused by an increase in CV Depth, indicating more heterogeneous stream profiles with larger variation in depth in

2011 compared to 2003. In the vegetated zone of R3 and R2 the restoration resulted in a significant change to in-stream habitats ( $P=0.022$  and  $P=0.026$ , respectively). In this zone of R3, the restoration resulted in higher current velocities ( $v_{10}$ ), a coarser substrate (Score\_substrate) although still dominated by sand, a higher coverage of gravel, a reduction in coverage by mud and consequently a lower substrate diversity (Fig. 2). In the vegetated zone of R2, the restoration also resulted in increased current velocities ( $v_{10}$ ), a coarser substrate (Score\_substrate) although still dominated by sand, a relatively higher coverage of gravel, lower coverage of mud and a lower substrate diversity (Fig. 2). In addition, the analysis showed that the overall significant changes to in-stream habitats of the vegetated zone of R3 were also related to a reduction in macrophyte coverage (Fig. 2).

The observed changes to in-stream habitats in the vegetated zone of R3 and R2 were stable over time showing no change from 2003 to 2011 ( $P=0.906$  and  $P=0.722$ ; Fig. 2). The in-stream habitats of the vegetated zone in the most downstream reach (R1) was not significantly affected by the restoration as only very small changes occurred from 2000 to 2003 (Fig. 2). From 2003 to 2011 there was some development in in-stream habitats but these changes were not significant ( $P=0.897$ ; Fig. 2).

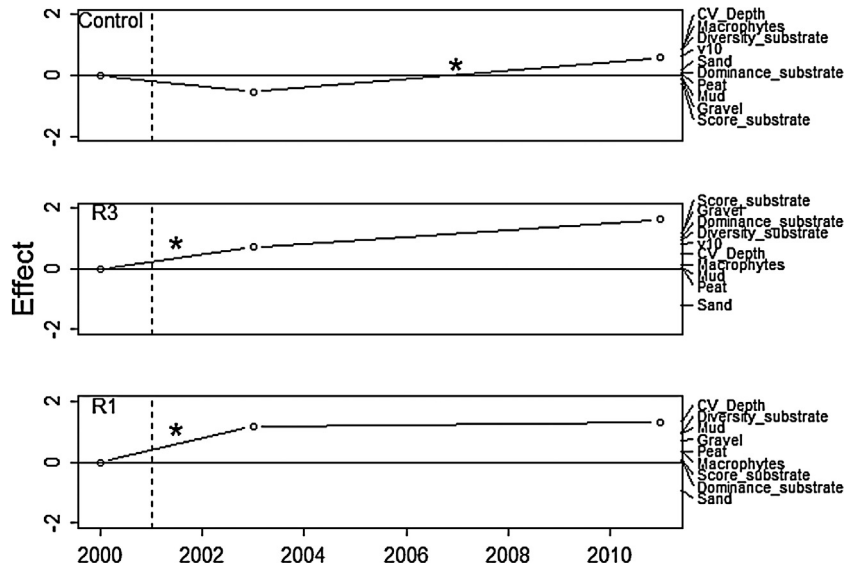
Fig. 3. Principal response curve analyses of the development of in-stream habitat parameters in four different sites of the current zone (depths >130 cm) of River Skjern: control upstream the restored reaches (R1, R2, R3).

Similar to the vegetated zone, we found no significant overall change to in-stream habitats in the main current zone of the control reach from 2000 to 2003 ( $P=0.460$ ; Fig. 3) and a small but significant change from 2003 to 2011 ( $P=0.011$ ; Fig. 3). This change was primarily driven by an increase in CV depth, macrophyte coverage and substrate diversity over the period (Fig. 3). In the main current zone of R3 and R1, the restoration resulted in a significant change to in-stream habitats ( $P=0.02$  and  $P=0.011$  respectively; Fig. 3), primarily caused by a higher variation in depth (CV depth) and higher coverage by gravel and consequently a higher substrate score, a higher substrate dominance score and a higher substrate diversity (Fig. 3). As found for the vegetated zone of R3 and R1, the observed changes to in-stream habitats following restoration, stayed stable over time in the main current zone of R3 and R1 ( $P=0.161$  and  $P=0.897$ , respectively; Fig. 3). No analysis was performed for R2 for the main current zone as only very few quadrates had depths over 130 cm.

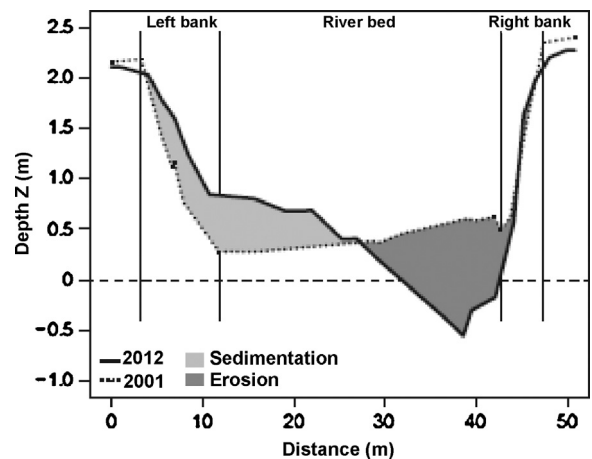
Fig. 4. Example of cross-sectional adjustments of the River Skjern between 2001 and 2012.

The survey of 65 cross-sectional transects along the lower 10 km of River Skjern in 2001 and again in 2011 revealed marked morphological adjustments through erosion and sedimentation in the newly restored stream channel (Fig. 4). There was large variations in the morphological adjustments among transects during the 10 year period (Fig. 5). Average sedimentation and erosion volume ( $\pm$ SD) measured at the left bank amounted to  $231 \pm 360 \text{ m}^3$  and  $274 \pm 325 \text{ m}^3$ , respectively, resulting in a net erosion of  $43 \text{ m}^3$  sediment. For the right bank, average sedimentation and erosion volume ( $\pm$ SD) was  $192 \pm 340 \text{ m}^3$  and  $536 \pm 740 \text{ m}^3$ , respectively, yielding a net erosion of  $344 \text{ m}^3$  sediment. However, the most pronounced morphological changes were observed at the river bed. Average sedimentation ( $\pm$ SD) for this part of the cross-sectional transects was  $2259 \pm 2333 \text{ m}^3$  sediment and average erosion ( $\pm$ SD) was  $707 \pm 996 \text{ m}^3$  resulting in a net sedimentation of  $1552 \text{ m}^3$  sediment. Combined, the net balance resulted in a gain of  $1166 \text{ m}^3$

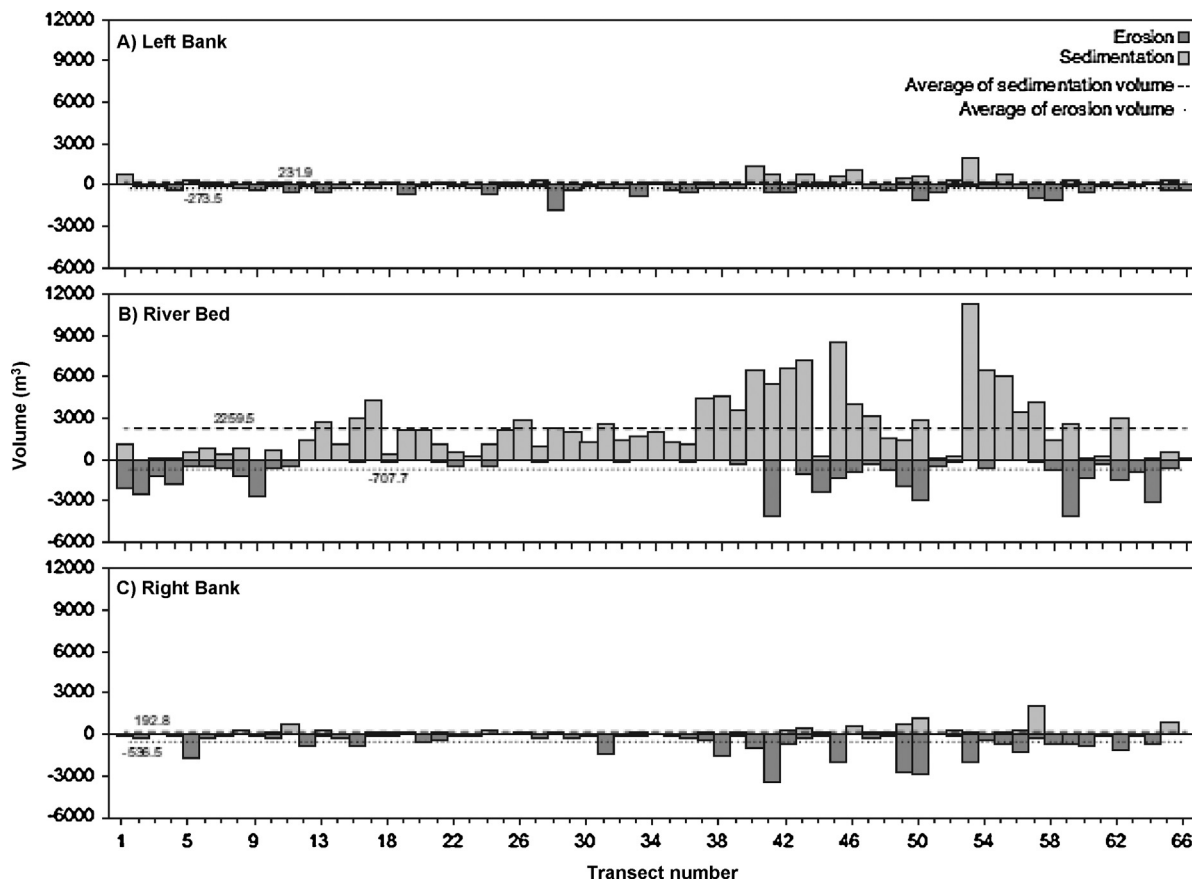
Fig. 5. Erosion and sedimentation in the lower 10 km of the restored River Skjern over a 10 year period (2001–2011).

sediment over the 10 years in the restored river channel. The net result is a slightly wider and shallower river in 2011 than in 2001.

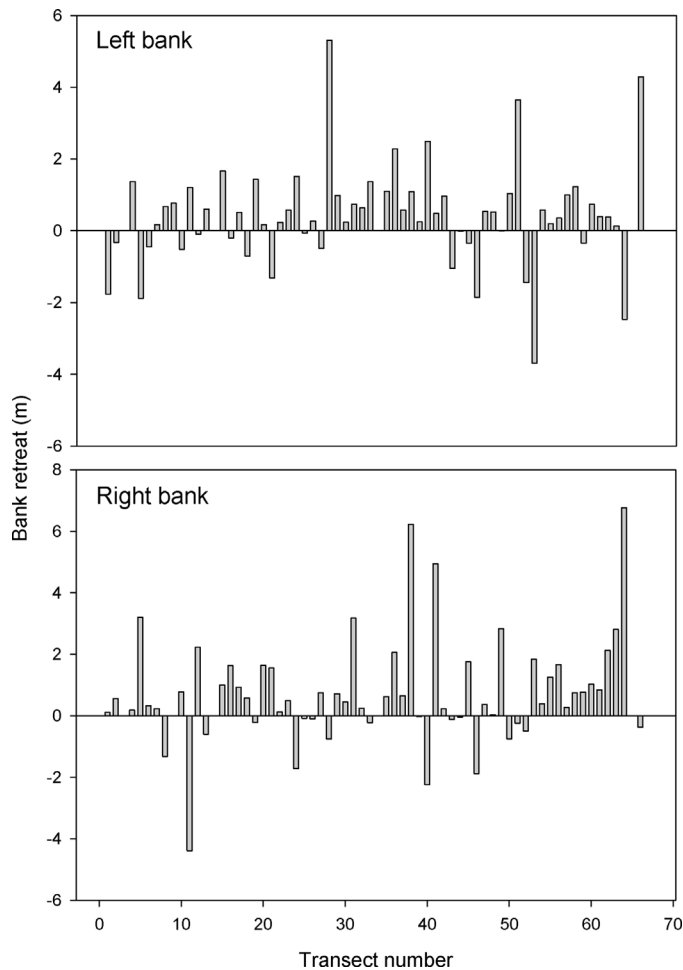
Fig. 6. Bank retreat in the lower 10 km of the restored River Skjern over a 10 year period.

There was large variation in bank retreat among transects (Fig. 6) and average bank retreat for left banks was 39 cm and 68 cm for right banks. This corresponds to a forecasted bank retreat of 3.9 m for left banks and 6.8 m for right banks over a 100 years period.
