2-D Model Test Study of the Suape Breakwater, Brazil

Report No. 70

This report deals with a two-dimensional model test study of the extension of the breakwater in Suape, Brazil. One cross-section was tested for stability and overtopping in various sea conditions. The length scale used for the model tests was 1:35. Unless otherwise specified all values given in this report are prototype values by assuming Froude scaling.

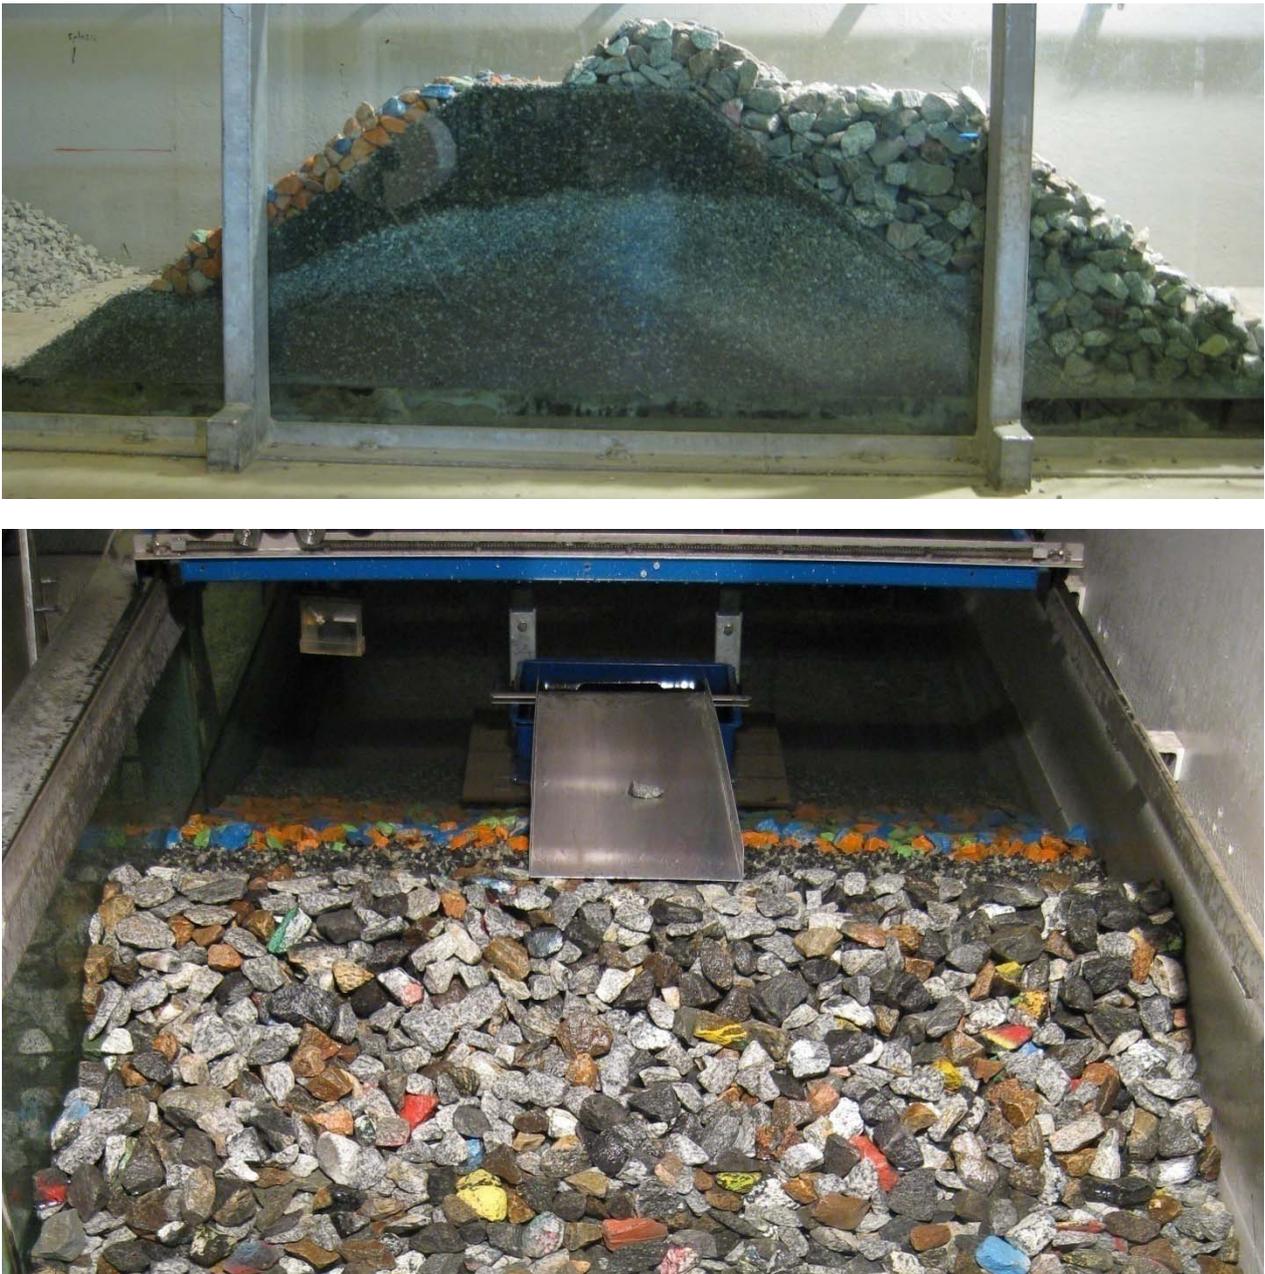
Pictures of examples of the cross-section tested are shown in Fig. 2. As seen from these pictures the overtopping water is led to an overtopping tank by a 0.3 m wide ramp extending from the rear corner of the crest. The overtopping volume was registered by weighting the tank after each test.

Figure 2: Pictures of the cross section and the overtopping ramp and tank.

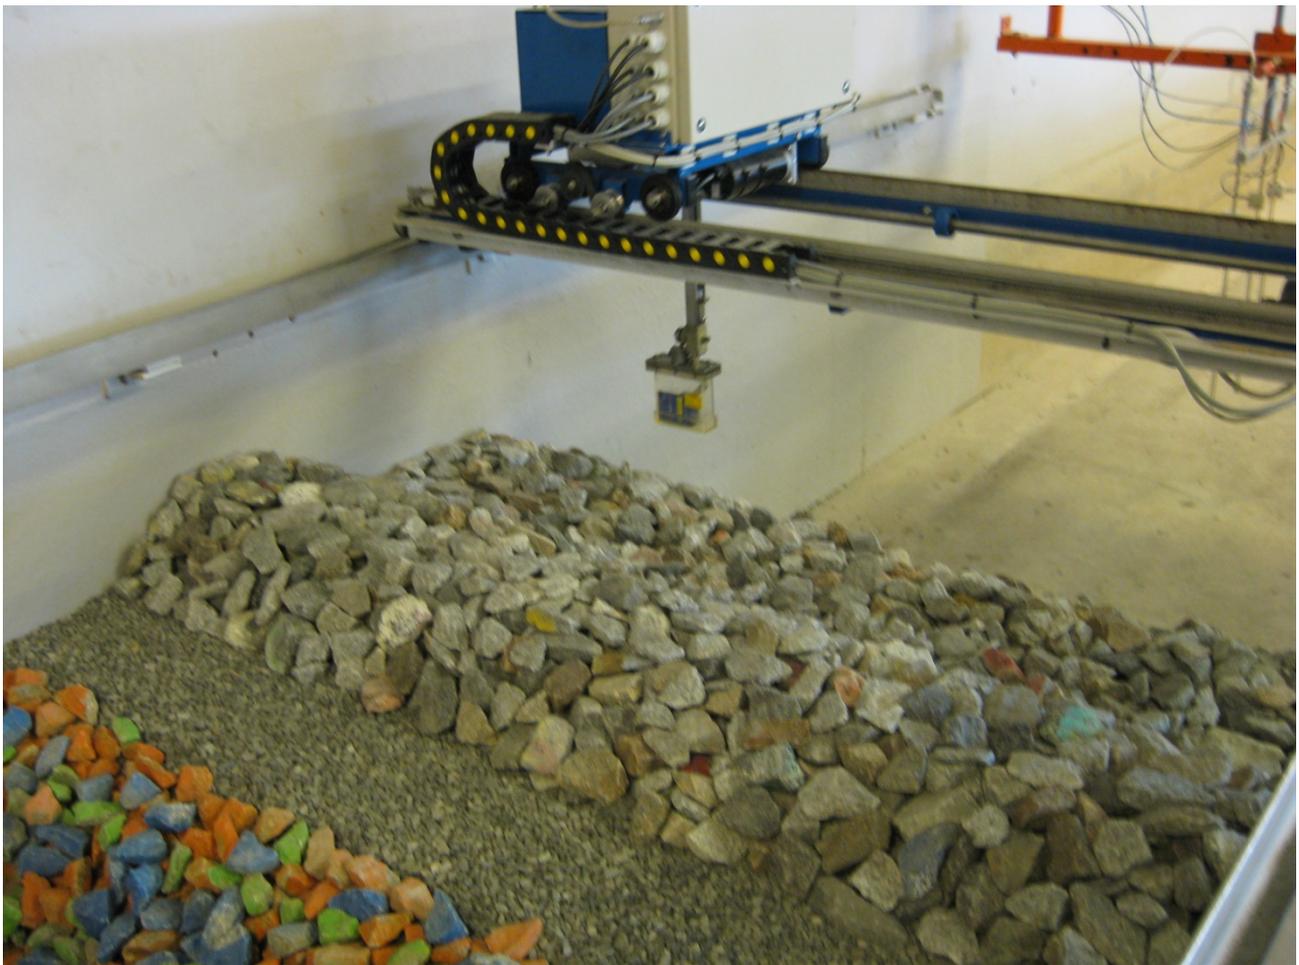
Damage/deformation of the breakwater was registered by photo-technique in all tests and supplemented by some profiling by an in-house developed PC-controlled laser profiler with step motors to move the profiler in all three directions, cf. Fig. 3. The profiler is controlled from the

computer program EPro also developed in-house [Aalborg University 2008b]. In the present case the profiler was setup to measure the profile in a grid with 1 cm spacing across the flume and 2 cm along the flume.

Figure 3: Pictures of laser profiler and the initial cross section viewed from the harbour side.

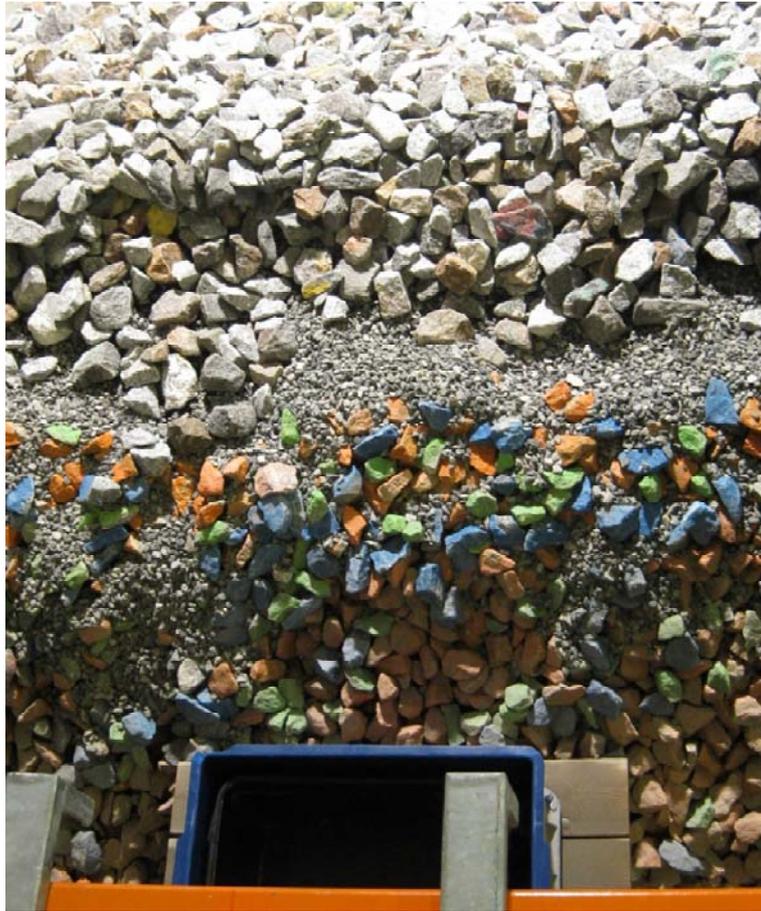
At high water level overtopping discharges were so large that significant damages to the crest took place for significant wave heights above 4.0 m. However, erosion of the core material on the roadway started already around $H_{m0} = 3$ m.

Figure 11: Damages to crest of structure after test 15.

A model test study for the new breakwater in Suape, Brazil has been carried out. Different design wave conditions were tested. For the low water level acceptable damages of the structure were measured and overtopping was below 1 l/sm even for extreme sea states. At high water level the recession is larger probably partly due to the cumulative effect. At high water level overtopping discharges are very high for the extreme sea states and significant damages to the crest occurred for significant wave heights above 4.0 m. Erosion of the unprotected core material in the roadway started for significant wave heights larger than app. 3.0 m for both wave periods tested. The eroded core material was deposited on the rear slope armour layer. This erosion could probably be prevented by covering the area with secondary armour stones (2t to 3t).
