The Integrated Renovation Process

case studies detailed report

DCE Technical Report No. 165

February 2014

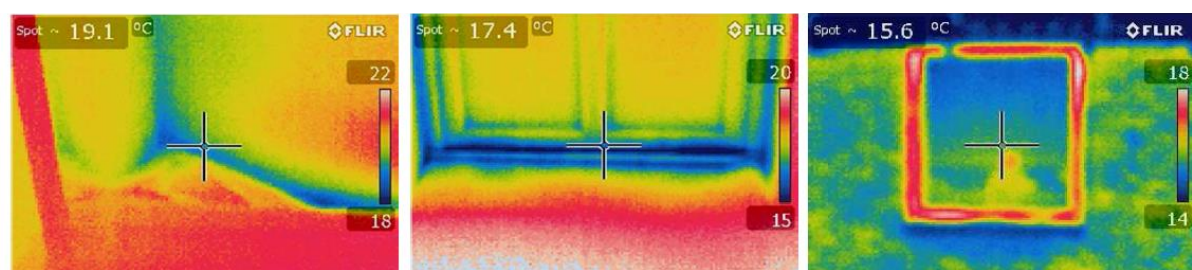
Figure 19: Thermal infrared images of the studied house (illustration of lack of airtightness, air leaks and thermal bridges)

Concepts such as air leaks, airtightness and thermal bridges were explained and illustrated thanks to the support of thermal infrared images (see Figure 19).
