Earthquake Tests on Midbroken Scale 1:5 Reinforced Concrete Frames

Skjærbæk, P. S.; Nielsen, Søren R. K.; Kirkegaard, Poul Henning; Taskin, B

FRACTURE & DYNAMICS
PAPER NO. 99

MAY 1997

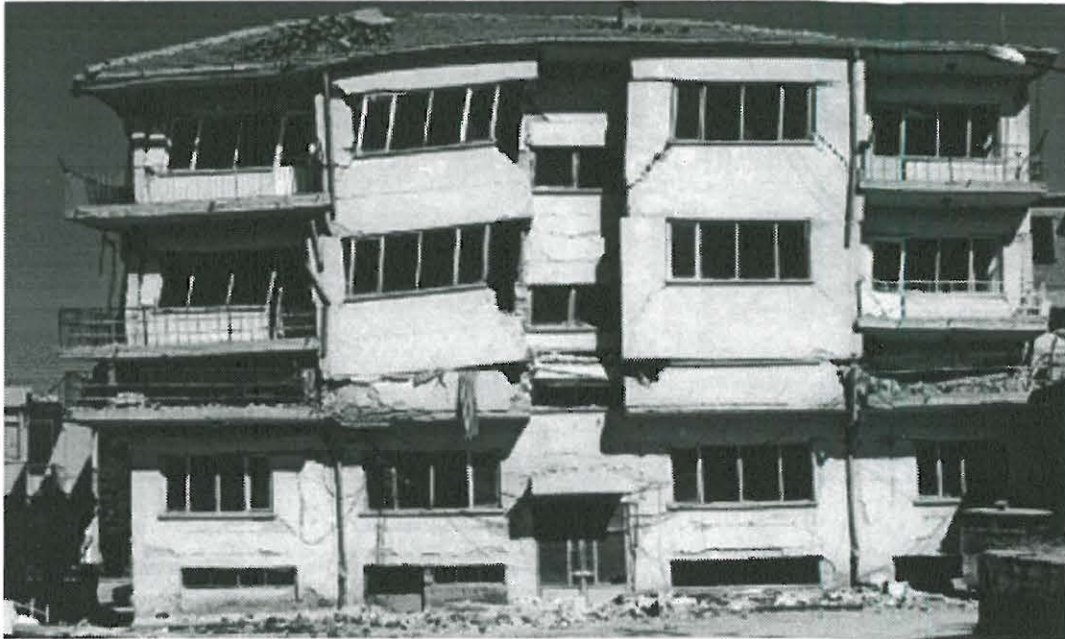
Figure 1.1: Collapse of an intermedia floor due to the October 1995 Earthquake, Dinar, Turkey.

An example of such a failure can be seen in Figure 1.1 below.

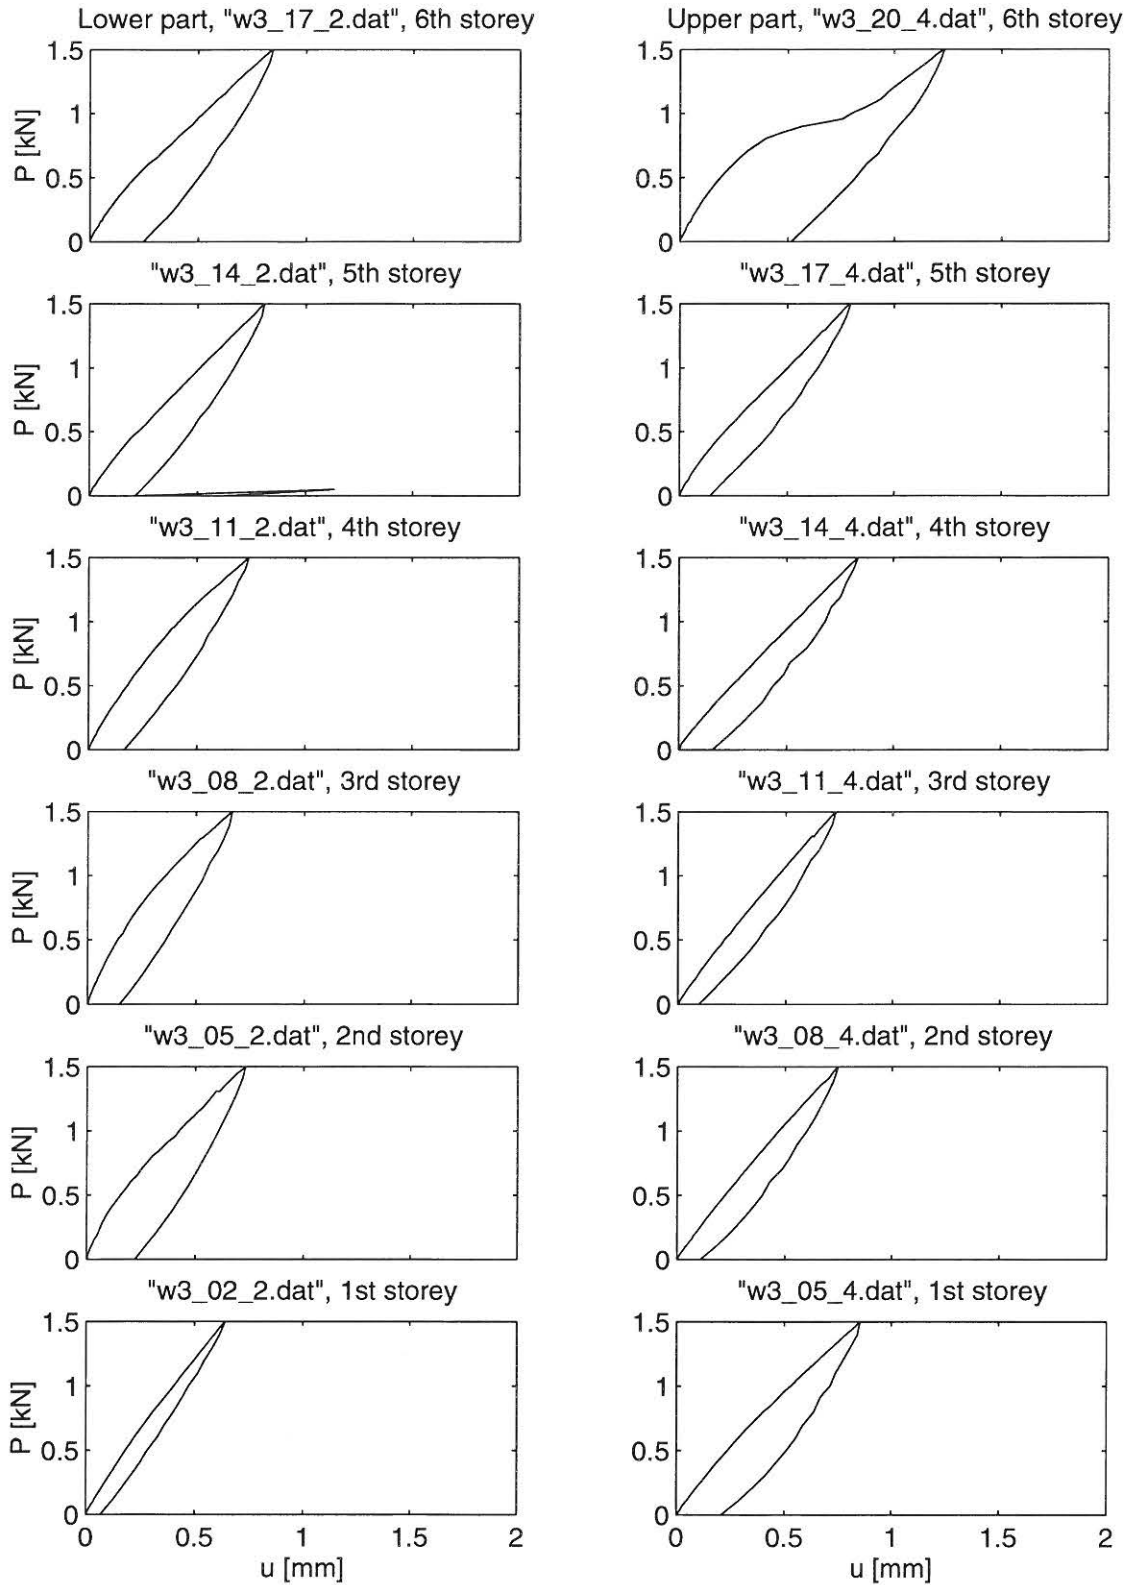
Figure 6.6: Force-deformation curves for the center columns obtained from the static tests. Undamaged frame AAUW3.

The force-deformation curve obtained for each of the half-beams and half-columns are shown in figures 6.6-6.11.

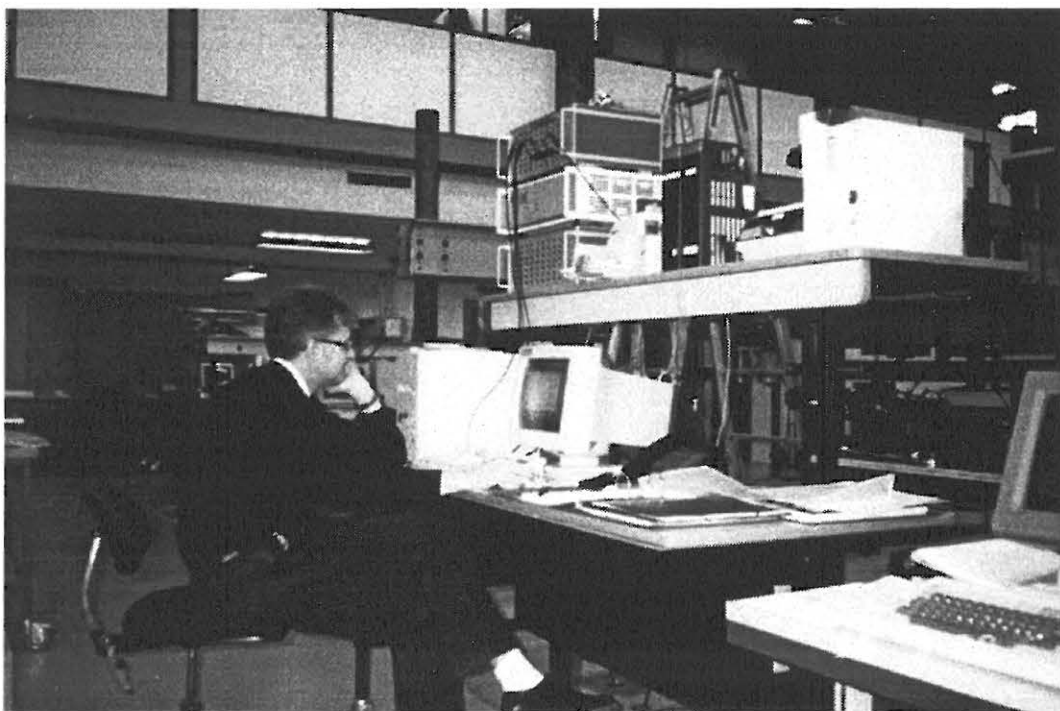
Figure A.5: Data acquisition system.
