# **Architectural qualities of Danish office buildings built between 1960 and 1980, seen in a contemporary sustainable perspective**

This study is about evaluating the past and present architectural quality of office buildings built between 1960 and 1980 in Denmark. The evaluation will focus on the expression of these buildings in relation to their context, combined with the present sustainable performance of the buildings and their critical problems.

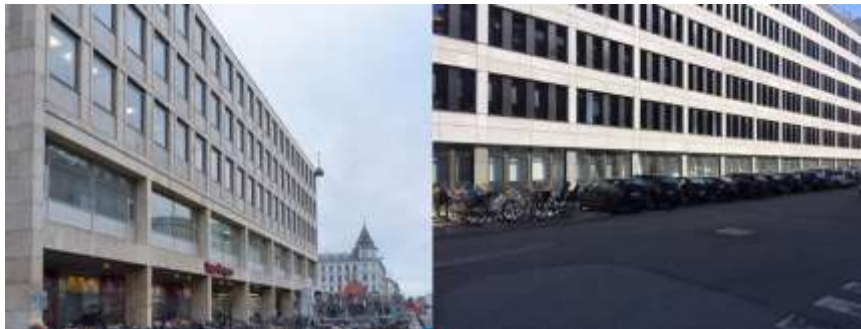
Figure 1: Concrete facades will often be dominated by white or light grey colours.

In this period, concrete was used in many buildings as a facade material, and it was thought to be a durable material. However, later it was shown that it was prone to cracking and the steel reinforcement to rust. The result was discoloration and in many situations the bearing elements were weakened and needed repairing (A. Dragheim) [8]. Due to using different components in the facade, there was a need to use sealing materials and techniques between them. Not all of these materials showed long-term durability, and there were many problems regarding water and wind tightness. Many types of wood used were of low quality and the wood wasn't impregnated properly, which led to some parts, such as window frames, rotting within a short time (A. Dragheim) [8].

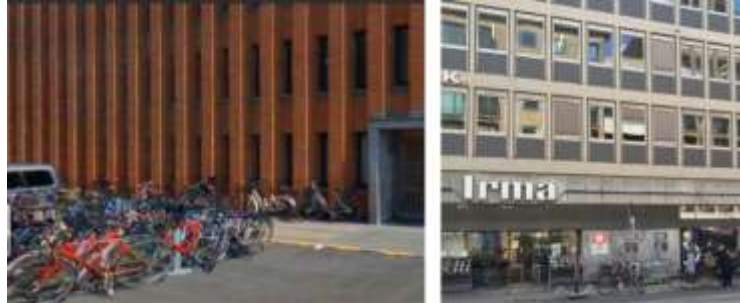
Figure 2: The repetition of similar squared or vertical elements of the facades.

Regularity introduced rhythm and repetition that were achieved by standardized elements and modular coordination. The repetition of similar elements in the facades of the office buildings was noticed in many cases. In some cases, the repetition can, with the help of other effects like shadows, give the facade an interesting pattern that changes with the movement of the shadows through the day.

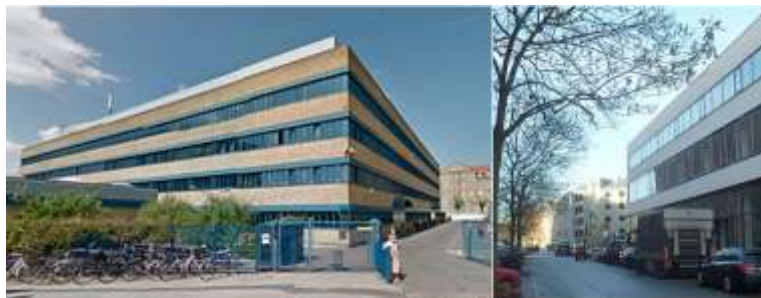
Figure 3: The dominating horizontal lines in some of the facades.

featured horizontal lines and no holes in the facades and which bear only their own weight. Many facades are made of light constructions with continuous window strips and parapets, preferably based on fibre cement plate (A. Dragheim) [8]. The new facade components, such as curtain walls and glass, have aesthetic qualities which are expressed through the concept of surface of volume. The aesthetic principle of surface of volume has been derived from the fact that such architecture has no solid supporting facade walls.

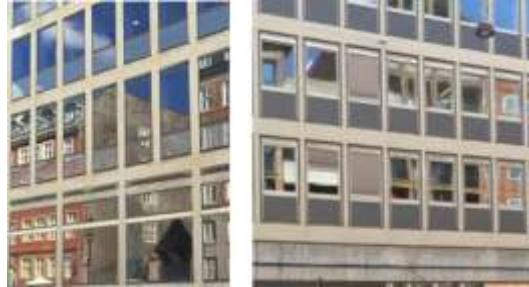
Figure 4: Some of the new cladding materials like metal and dark glass.

There was a focus on the intrinsic elegance of many materials such as aluminium, glass, and concrete, excluding all kinds of decoration with a preference for machine-made architectural details created by new technologies. The most-used materials for facade cladding are fibre cement plates, aluminium plates, steel, pressed mineral wool and glass fibre plates. Heavy materials like bricks were used only exceptionally (A. Dragheim) [8].

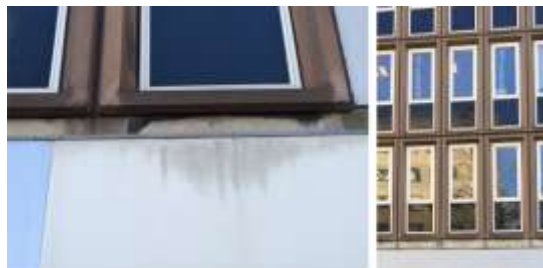
Figure 5: Problems like mould in the façade.

There was a great need for industrialized building components for the construction of office buildings in the sixties and the seventies due to the large demand for office buildings in that period. There were many economic benefits and time savings with this new system, but there were also many characteristic problems that faced the office buildings later on, such as cracks in the concrete carbonates and corrosion of the reinforcements. Some parts of the facades faced problems like mould and fungus, and there were problems with sealing materials (A. Dragheim) [8].

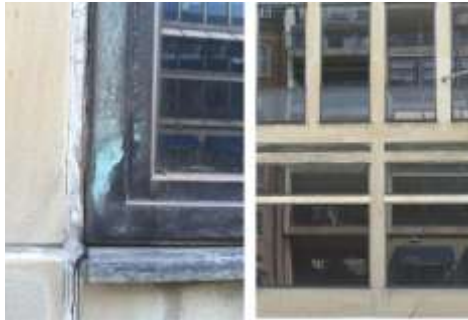
Figure 6: Problems in sealing materials in some parts of the facades.
