Ex-situ X-ray computed tomography, tension clamp and in-situ transilluminated white light imaging data of non-crimp fabric based fibre composite under fatigue loading

Published in:
Data in Brief

Data Article

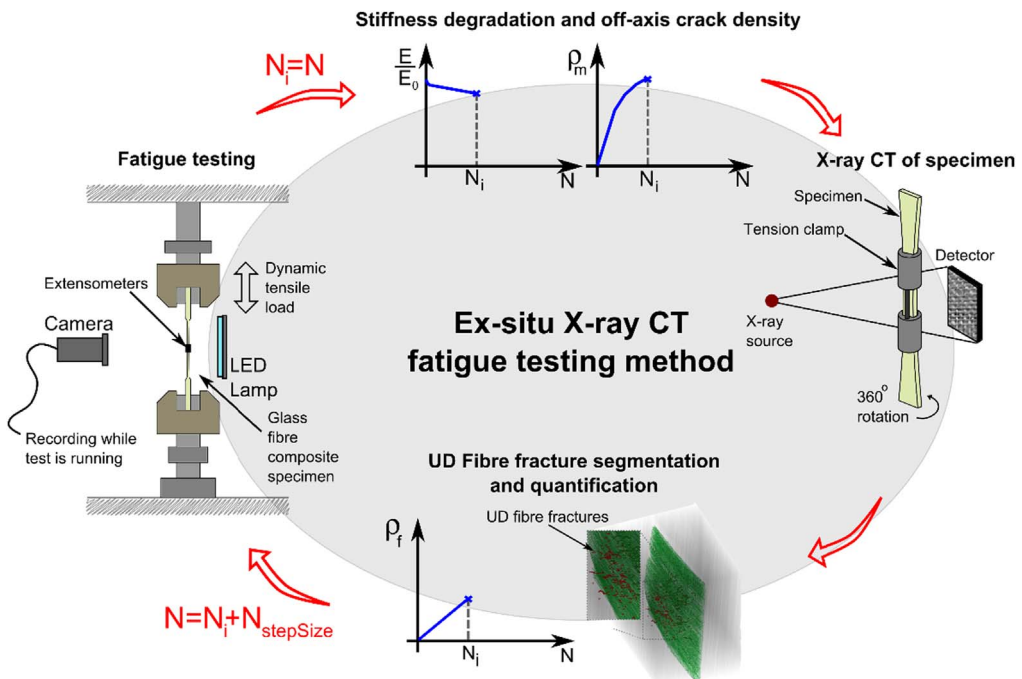
Fig. 1. Overall idea behind ex-situ X-ray CT fatigue testing approach supplemented by TWLI and tension clamp.

The methods used to obtain the data provided with this paper are based on the idea shown in Fig. 1, which shows the general principle of the ex-situ X-ray CT fatigue testing method. To overcome some of the challenges of X-ray CT, TWLI and tension clamp experiments were also carried out as supplements. The TWLI was carried out during the fatigue test as illustrated by the camera and LED lamp in the left-hand image of Fig. 1. The tension clamp data provided with this paper is not included in the ex-situ testing loop this time, however it could be included in future work as illustrated in the left-hand image of Fig. 1 to improve the crack visibility. The below sections outline the specifics of the individual testing methods.

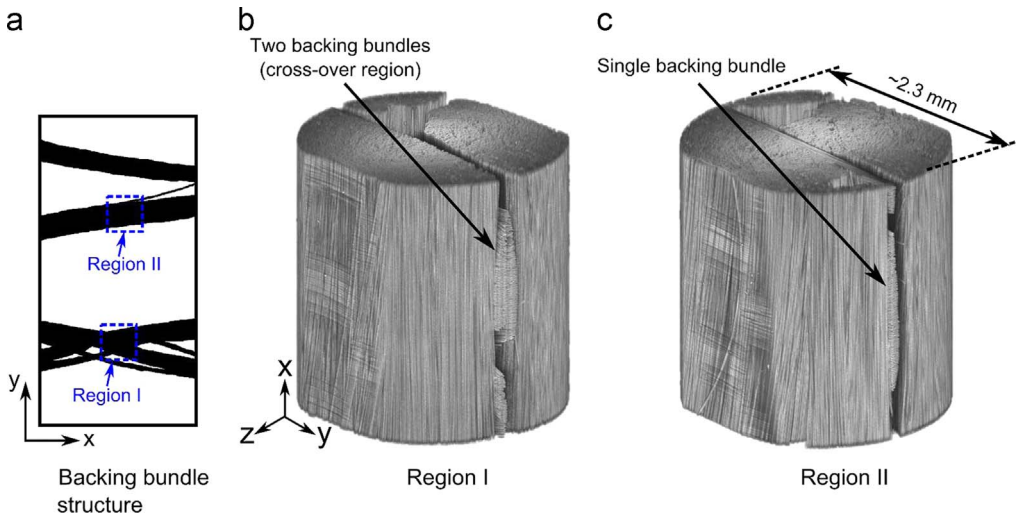
Fig. 2. The approximate locations of the two regions considered by X-ray CT in specimen EPS06-1 are shown on top of the bundle structure in (a) and the 3D volumes obtained by X-ray CT are shown in (b) and (c) for region I and II, respectively.

High resolution X-ray CT with a pixel size of $2.25 \mu\text{m}$ was used for both the ex-situ study and the tension clamp experiments. For the ex-situ experiments, the source-to-sample and detector-to-sample distances were 20 mm and 40 mm respectively, and the exposure time was 2.5 s. Two regions were considered ex-situ in the specimen (EPS06-1 in Table 1) as illustrated by region I and II in Fig. 2. Region I was scanned before any testing had been done to the specimen at each of the interruption points (100,000, 150,000, 200,000, and 500,000 cycles). Region II was only scanned at the last three interruption points (150,000, 200,000, and 500,000 cycles). Fig. 3 shows an example of a 2D slice view of region II for the three interruption points. This results in 8 datasets for the ex-situ study. For clarity the data for the tension clamp have “ex-situ_” in front of the file name. The detailed scan settings are also provided as “ex-situ_info1.png” and “ex-situ_info1.png”.
