Proceedings of 7th World Conference on Photovoltaic Energy Conversion

Enhancement of electroluminescence images for fault detection in photovoltaic panels

Abstract — Good quality images are necessary for electroluminescence (EL) image analysis and failure quantification in solar panels. In this work, a method for determining image quality in terms of more accurate failure detection in PV panels through EL imaging is proposed. The goal of the paper is to highlight the different methods for image quality improvement and to determine if the enhanced image provides more useful diagnostic information for accurate micro cracks and fracture detection. From the work carried out in this paper, it is to be noted that averaging technique helps in improving the SNR value. Additionally, subtracting the background from the obtained averaged EL image proves to be an enhancing method for cell fracture identification and more number of edges are also detected which can be useful for micro crack quantification.

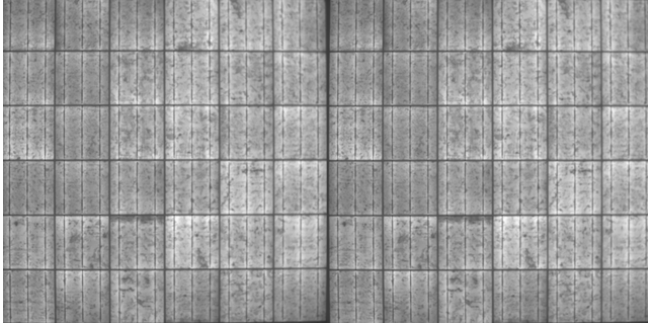
Fig. 4 EL images of Panel A imaged with camera 1 at 15ms IIT. Left side displays the original image and right side Averaged image with 16 number of repeats.

One of the reasons for this little difference is due to the fact, the sensor noise assumed to be Gaussian distributed, reduces as the images are averaged but their Pixel to SNR value saturates after a given point. The noise level reduction and an increase in SNR value is evident from Fig. 3 and Fig. 5. The same analysis cannot be witnessed on the EL images displayed in Fig. 4.
