The PICO OWC Project

The full scale wave energy converter, that was in continuous operation for more than 7 years in roughest conditions and finally was very close to reach a load factor of 0,19

Winands, Victor Wolf Etienne

Publication date:
2019

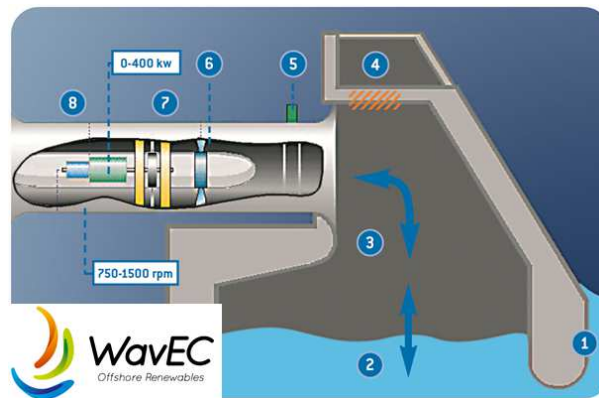
Figure 2.2 Cross-sectional illustration of the Pico OWC (1) the incident wave, (2) the chamber oscillation, (3) the bound air pressure chamber, (4) by-pass relief valve, (5) Main isolation valve, (6) Fast acting isolation valve, (7) Wells turbine, (8) Asynchronous generator

The main plant structure consists of a tower, which stands on the sea floor and reaches up several meters above sea level. Above sea level the structure forms an closed air chamber, which is only connected to the atmosphere through an air turbine. Below the surface the structure has an always submerged opening towards the incident waves. The waves in the air chamber act as a piston compressing and expanding the enclosed air volume. The oscillating pressure inside the air chamber creates an reciprocal air flow through an air turbine, which is connected to a generator. In general either the air flow can be rectified to be used with an unidirectional turbine or a self rectifying turbine, such as the in Chapter 2. 2.3. introduced Wells turbine can be used without air flow rectifying valve system. Figure 2.2 shows a schematic of the Pico plant. Source: (Monk, Winands and Lopes, 2018).

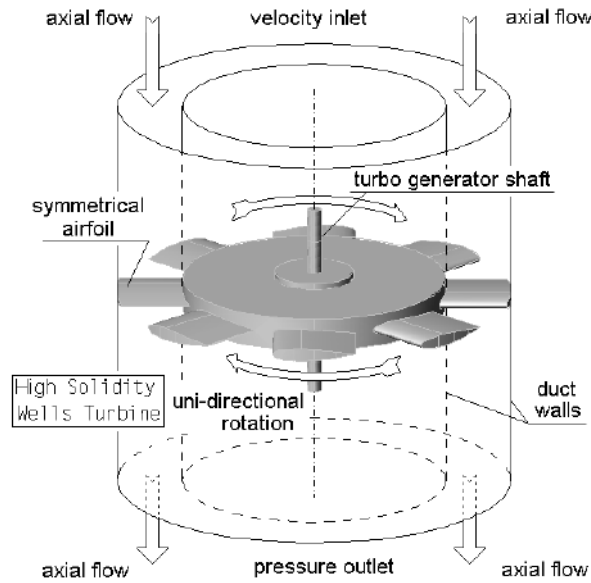
Figure 2.3 Schematic of a vertical Wells turbine

Figure 2.3 Is obtained in (Torresi *et al*, 2008). It shows the principle schematic of a vertical Wells turbine. The Pico device uses a horizontal Wells turbine but the principle is similar. An air flow is guided through the ring shaped turbine duct and hits the symmetrical Wells turbine blades perpendicularly. The exact occurrences and the the fact that the device is bidirectional can be obtained in Figure 2.4 where the cross section of a blade and the forces on it is shown. It is extracted from (Mohamed and Shaaban, 2013). It can be obtained that as long as the turbine is not spinning exclusively a drag force F_D (force in flow direction W) is created and therefore the turbine would theoretically not start to spin. Only when the turbine is spinning the in Figure 2.4 visible resulting direction of the flow W causes an angle of attack α between the chord of the blade and the flow W , which creates a lift force F_L (force perpendicular to the flow direction W).

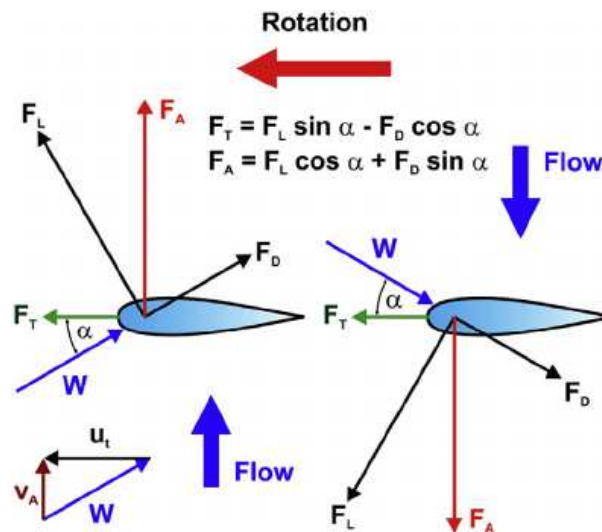
Figure 2.4 Forces at the blades of a Wells turbine

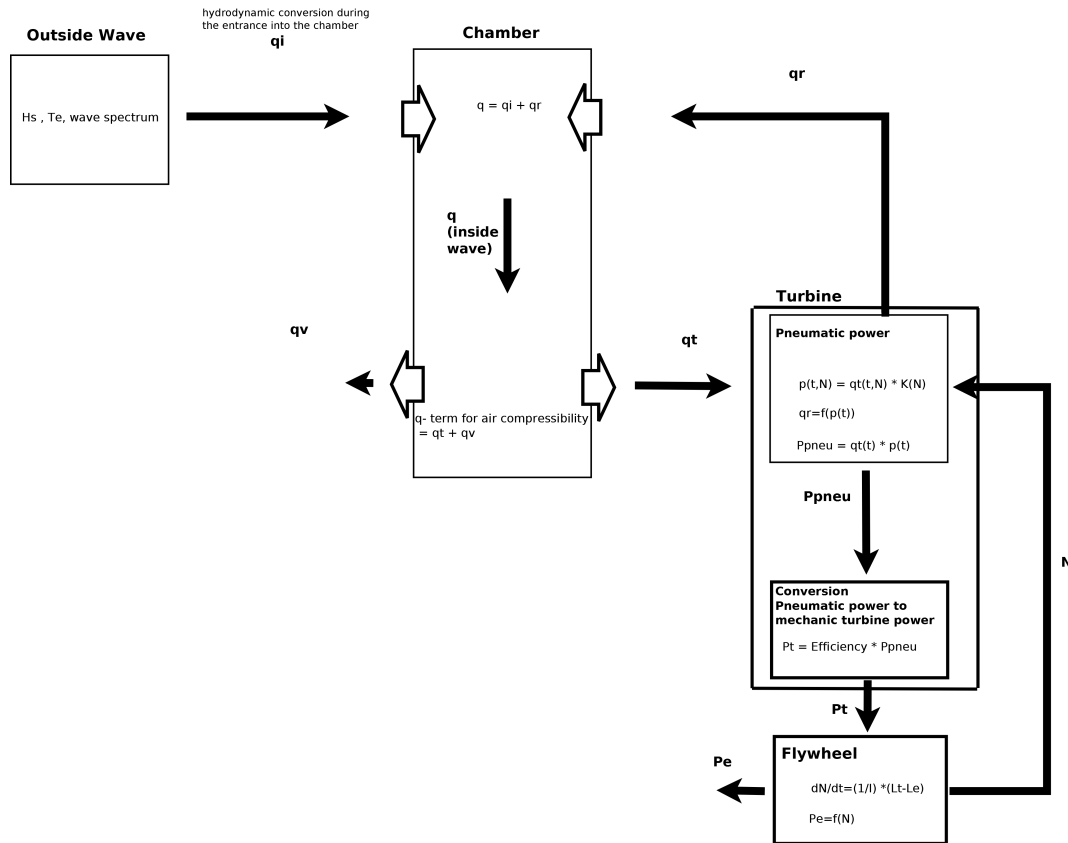
Figure 2.5 Flow diagram of the OWC wave to wire model

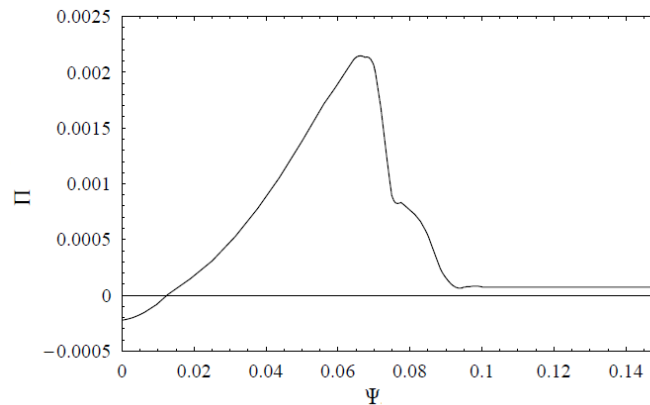
Figure 2.6 Characteristic curve of the designed Pico turbine

For the Pico turbine the designed characteristic curve can be obtained in Figure 2.6, which can be found in (Falcao, 2002).

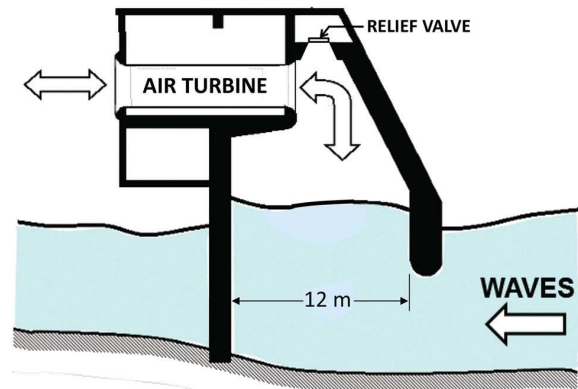
Figure 3.2 Civil structure cross section

The device was designed to be built in prefabricated concrete blocks but was finally realized as a reinforced concrete structure. It consisted one air chamber with an area of 144m^2 ($12\text{m}\times 12\text{m}$) and a volume of 1050m^3 . The structure contains the air chamber, a closed turbine hall and a basement, which initially housed the electrical equipment. The structure is built into a rocky coastline with a connection to the land only at one lateral side. The device entrance is from this lateral side. Water depth inside the chamber was scheduled to be about 8m but has decreased due to bolder movement to about 6m or less. In Figure 3.1 and Figure 3.2, which are both extracted from (Falcao, Henriques and Gato, 2016), the orientation and a cross section of the device structure can be found.

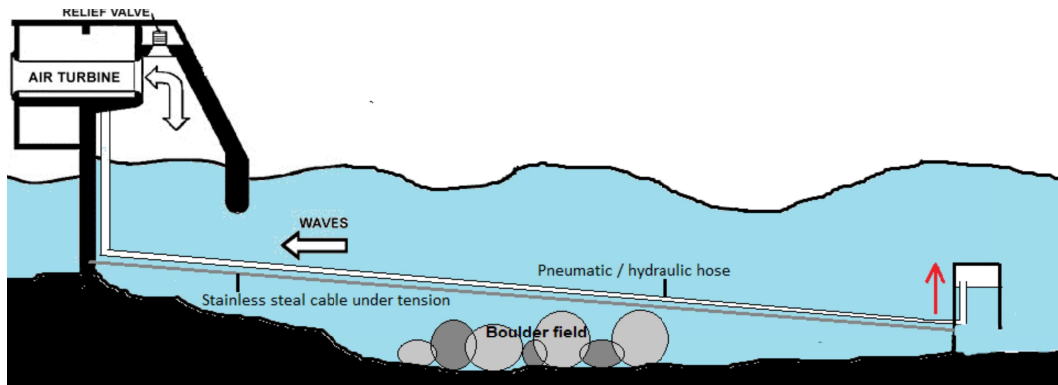
Figure 3.3 Schematic of the self developed nearshore wave sensor.

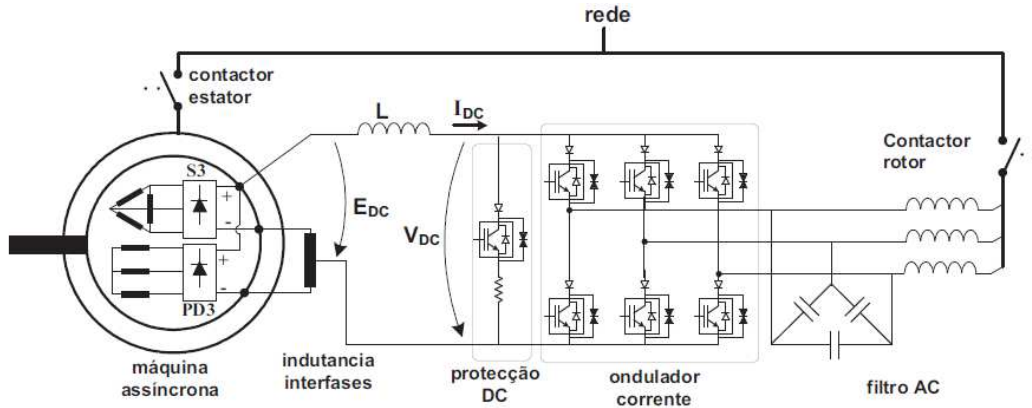
Figure 3.4 Schematic of the Power electronics

The stator of the applied double fed inductive asynchronous generator is directly connected to the grid phases with the use of two transformers which lower the voltage from 15 kV to 380V. The coils on the rotor deliver a alternating potential, which is rectified with the use of a spinning diode rectifier inside the generator. The dc currents are later transferred into the alternating grid currents by the use of current converter (based on IGBT technology). A schematic of the system, which originates from the original device documentation, can be seen in Figure 3.4.

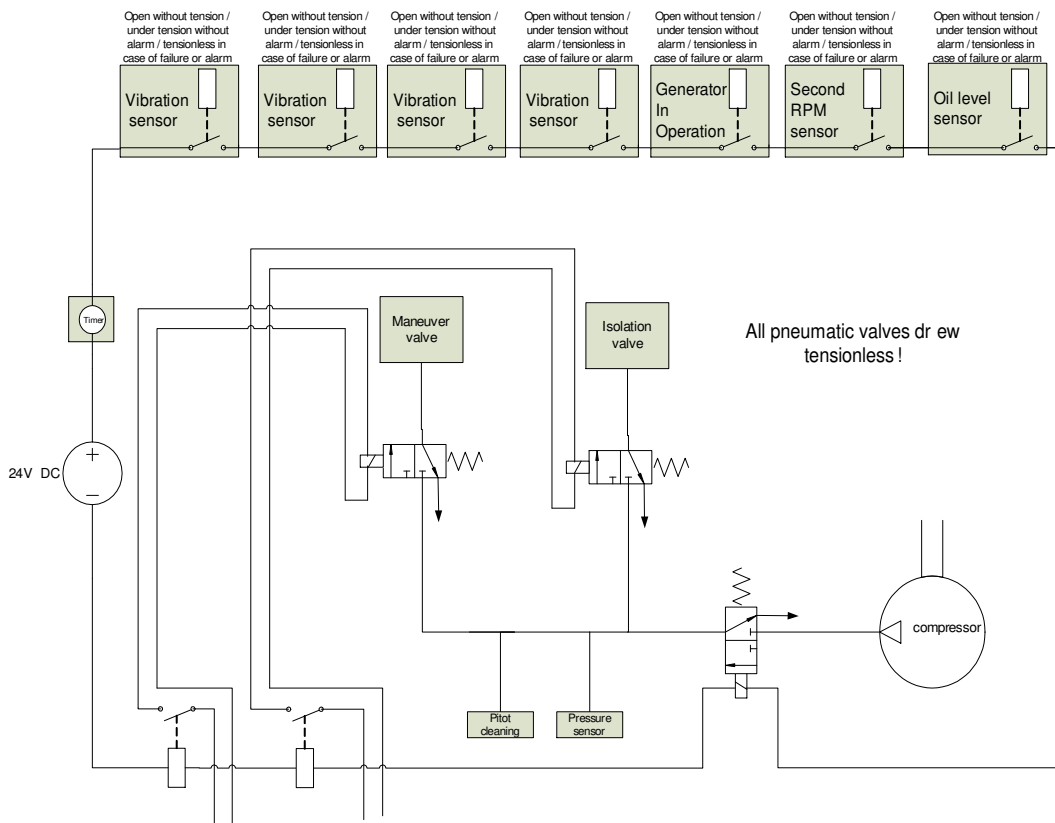
Figure 3.6 Independent security system

Safety systems were not installed or foreseen on the device. Only a control system was installed, which was not suitable to also address safety functions. Due to the not reliable automatic system and the attempted remote controlled operation it was required to develop and install a suitable redundant safety system. To indicate the possible worst case failures, a risk analysis was executed. A initial schematic of the developed system can be seen in Figure 3.6. The finally installed system reacted on elevated vibrations, over speed (which was measured with the rotational speed sensor at the turbine), low oil level (this function was later removed) and the loss of connection between the main control unit to the device. When ever a failure was detected relays were deactivated which in turn caused the closing of the duct valves via solenoid valves. All relays and solenoid valves were doubled, the same was the case for the duct valves and also applies for the event of over speed because the consequence was elevated vibrations. Hence the system was redundant and has never failed.

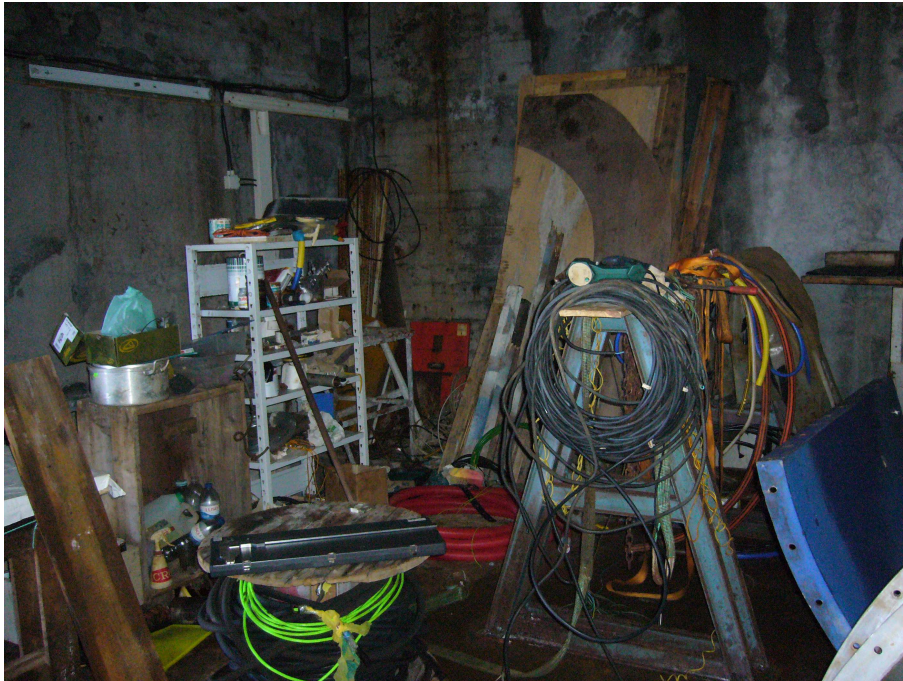
Figure 4.1 Pico turbine hall in 2007

- A machine that was hardly operational
- The floor of the turbine hall was covered in a solid layer mixed of sand, corrosion, oil, salt, water and garbage (remaining from the refurbishment project in 2004).
- Two different light systems were installed but none was functioning.
- All power sockets were damaged.
- No fresh water system existed in the device to clean the machine from salt.
- The turbine hall was used as a storage of corroding materials as can be obtained in Figure 4.1.
- Only few of the bolts in the turbine were installed but bar clamps were installed instead.
- Works were focused on the DAQ system and the new guide vanes.
- No concept and no employer existed to change this situation.
- Project engineers were concentrated on scientific tasks.
- Engineering problems were only reported and transmitted to mostly not local sub contractors.

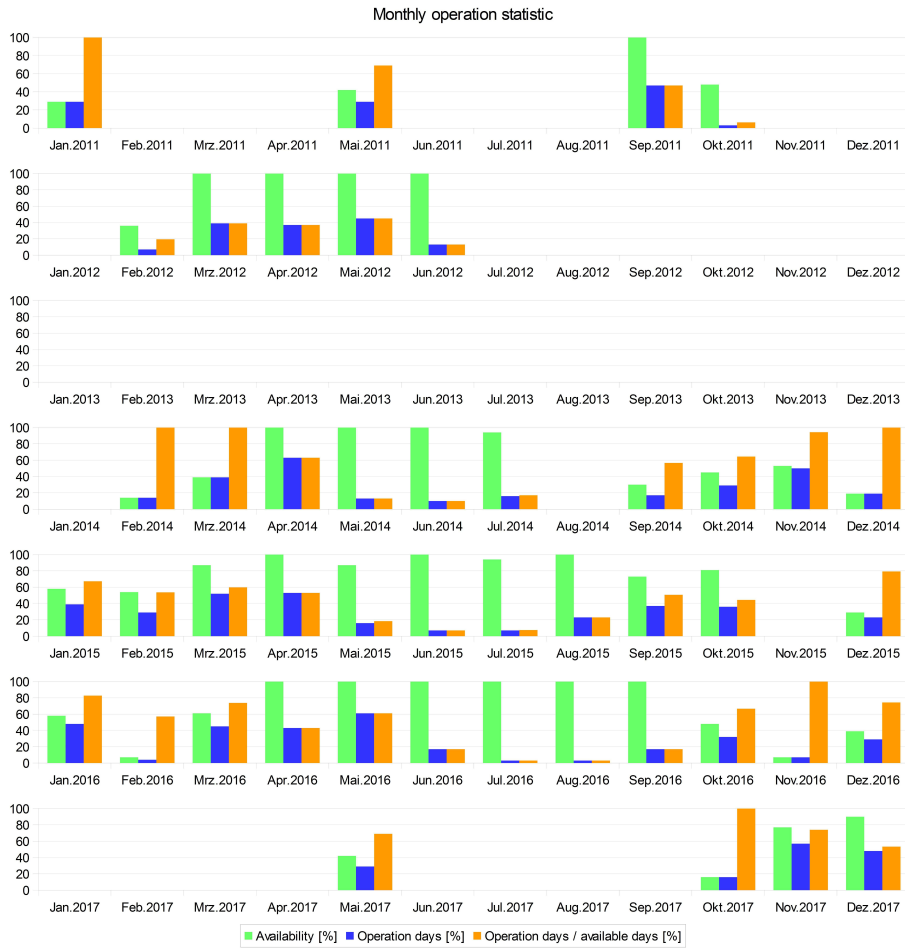
Figure 4.2 Monthly operation statistic

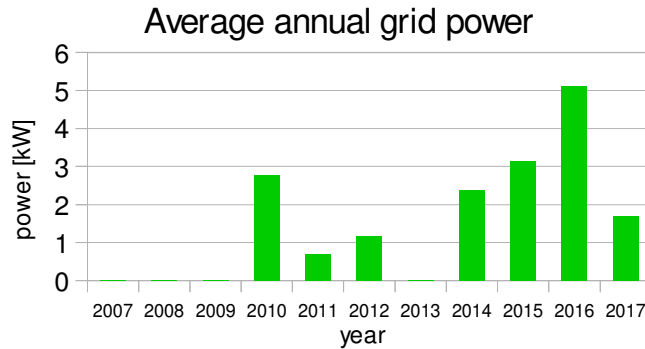
Figure 4.3 Annual average power

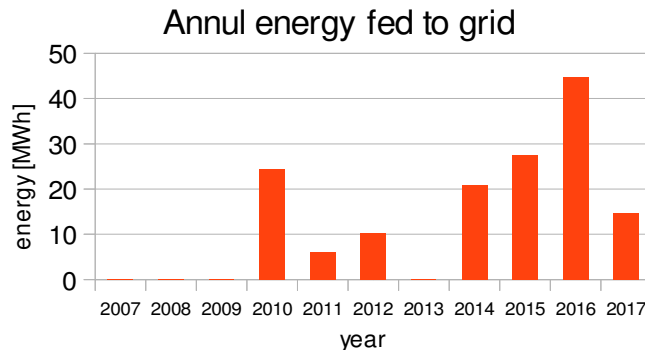
Figure 4.4 Energy fed to grid

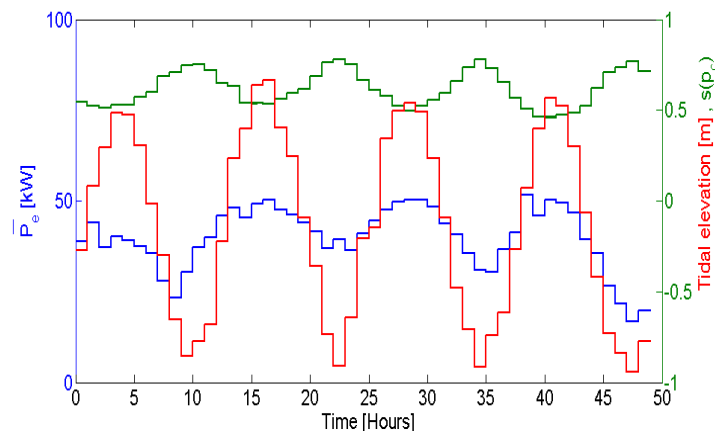
Figure 4.5 Pressure skewness
Tide (red), pressure skewness (green), power (blue)

Pressure asymmetry (skewness) can be obtained with increasing influence at low tide. The pressure asymmetry is at least partly caused by intermittently emerged holes in the submarine chamber walls, which create non linear air passage to the atmosphere. Further influence is assumed to be caused by wave shoaling due to a reduced water depth from bolder movement on the sea floor and possible other hydrodynamic inaccuracies. Figure 4.5 below is extracted from (Monk, Winands and Lopes, 2018). Here detailed information about the pressure asymmetry can be found.

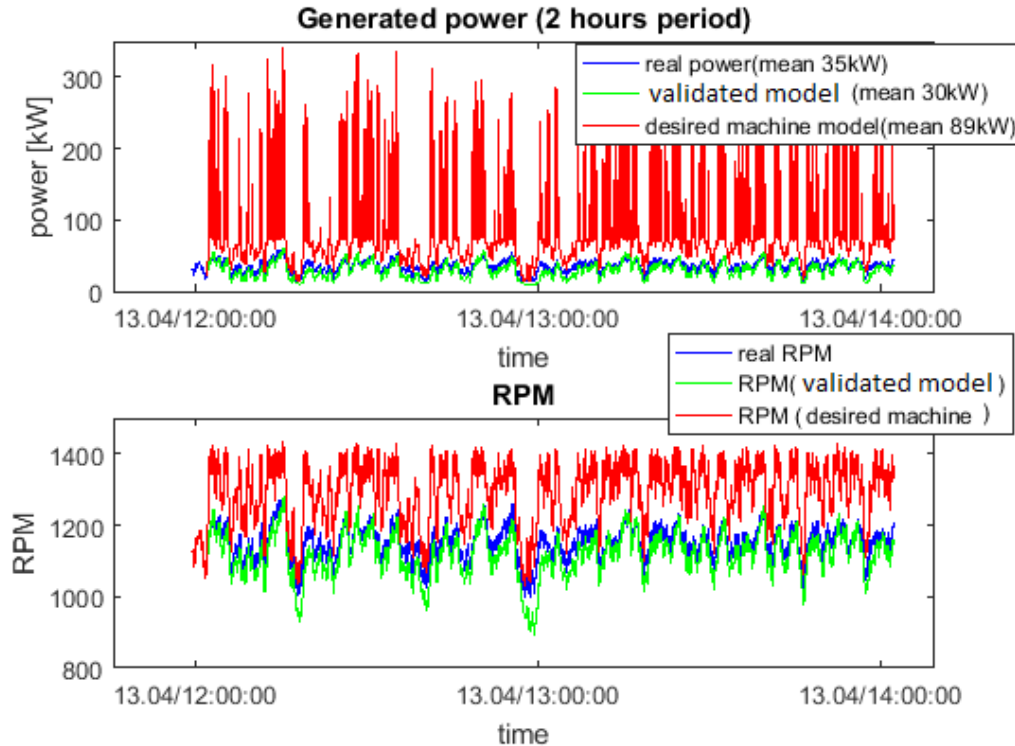
Figure 4.6 Generated power and RPM comparison (real device (blue), “validated model” (green) model with designed turbine (desired) (red))

accidentally divided the turbine performance by two. Once the mistake was removed both codes showed similar results but were far from the real device performance. Consequently the real device performance matched with the model performance when reducing the modeled turbine power by the factor two. This can be obtained in Figure 4.6, which shows a comparison of a 2 hours plot between the real device (blue), the “validated model” (green) and the validated model with designed turbine performance (red). The generated power and the rotational speed is displayed.

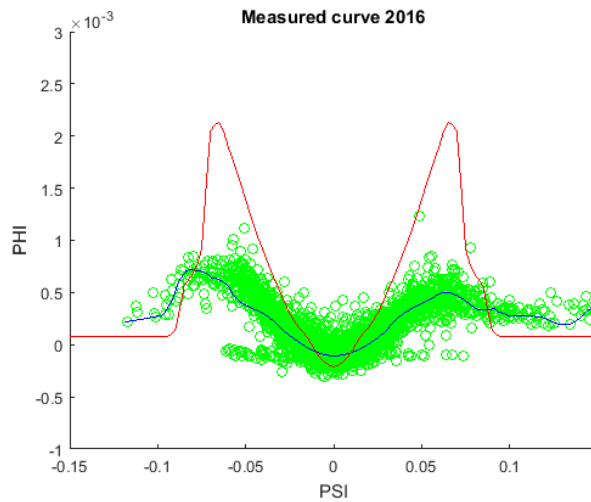
Figure 4.7 Measured turbine curve (green), best fit curve (blue), the designed curve (red)

Because this was an essential discovery and hard to believe, the characteristic turbine curve of the real turbine was captured with the available equipment. This was already done in the past but misinterpretation of the measured results excluded the turbine as a potential problem source. The measurement of the characteristic turbine curve is not trivial because no torque meter is available and the quality of the rotational speed measures is not optimal for this purpose. However it was possible to measure the curve and confirm the extremely reduced performance compared to the theoretic turbine. It was further attempted to detect the reason for the reduced turbine performance in a first turbine performance analysis, which can be found in Appendix 3. The final reason for it could not be detected but degradation and missing rotor guide vane could be widely excluded as possible reasons. The drawn conclusion is that the rotor design causes the poor performance but the reasons for it remains unclear. Figure 4.7 shows the measured and already significantly filtered real turbine curve compared to the designed curve.

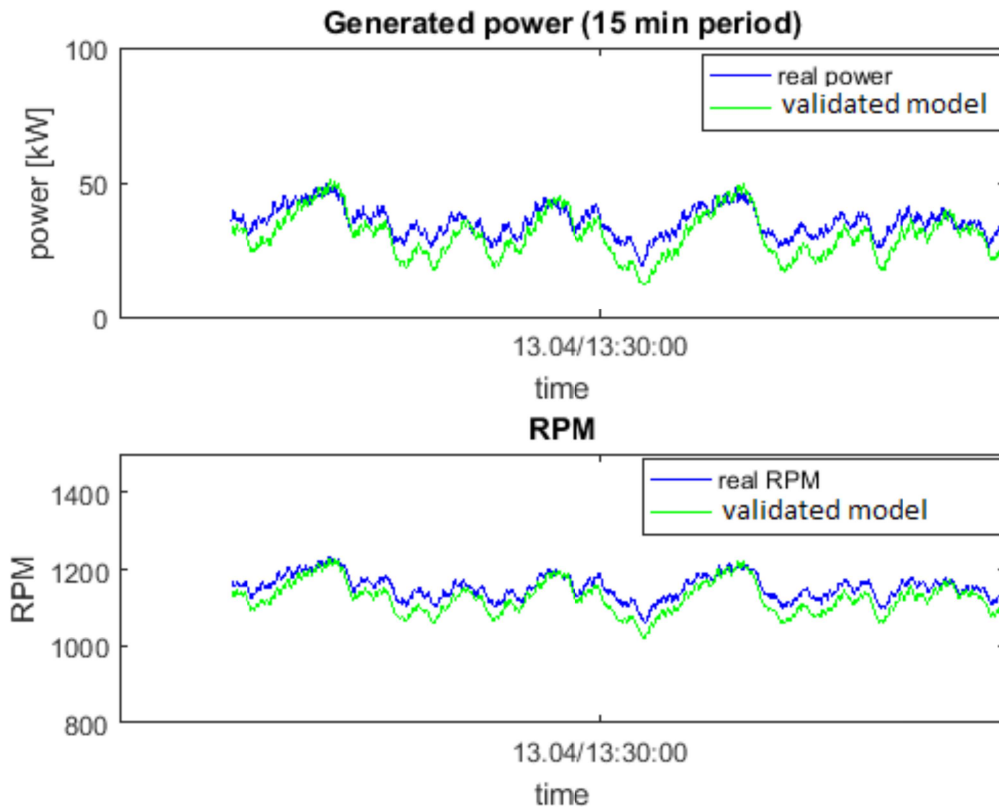
Figure 4.8 Model match of the “validated model” with real plant data

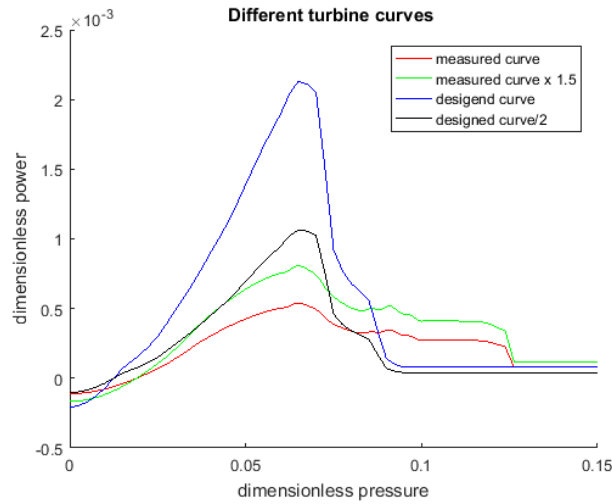
Figure 4.9 Different characteristic turbine curves

From that point in time the reduced turbine performance was regarded as real and introduced into the model. The finally for the “validated model” used characteristic turbine curve corresponds to the measured curve, which was multiplied by factor of 1,5 to compensate filtering effects. The factor 1,5 was found empirically and appears reasonable. The model fit can be obtained in Figure 4.8 and in Figure 4.9 it can be seen that this turbine curve is in the range of the initial curve divided by two.

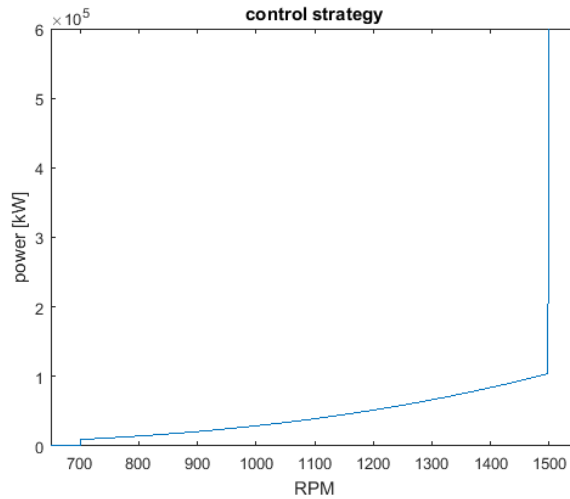
Figure 4.10 Theoretical RPM limitation approach

It was possible to reproduce a similar annual average power result with the “validated design model” as was predicted. The in (Falcao, 2002) predicted annual average generated power is 100 kW. Here 104 kW could be modeled with some assumptions regarding the procedure of breaking the turbine close to rated speed in order to avoid over speed situations. It was found that the results are fairly sensitive to this breaking procedure. In the frequency domain approach used in (Falcao, 2002), moments with speed above the max speed of 1500 RPM are simply regarded with max speed. This is impossible in reality and in a time domain approach. The here selected method can be obtained in Figure 4.10. The generated power is increased about approximately 500 kW in the operational speed range from 1498 to 1500 RPM. The required installed capacity to provide this breaking torque is about 600 kW but only 400 kW are installed. This strategy cannot fulfill the grid constrains of allowed power fluctuations and additionally cannot avoid over speed completely. Thus the “validated design model” is only a theoretical approach, which cannot be realized.

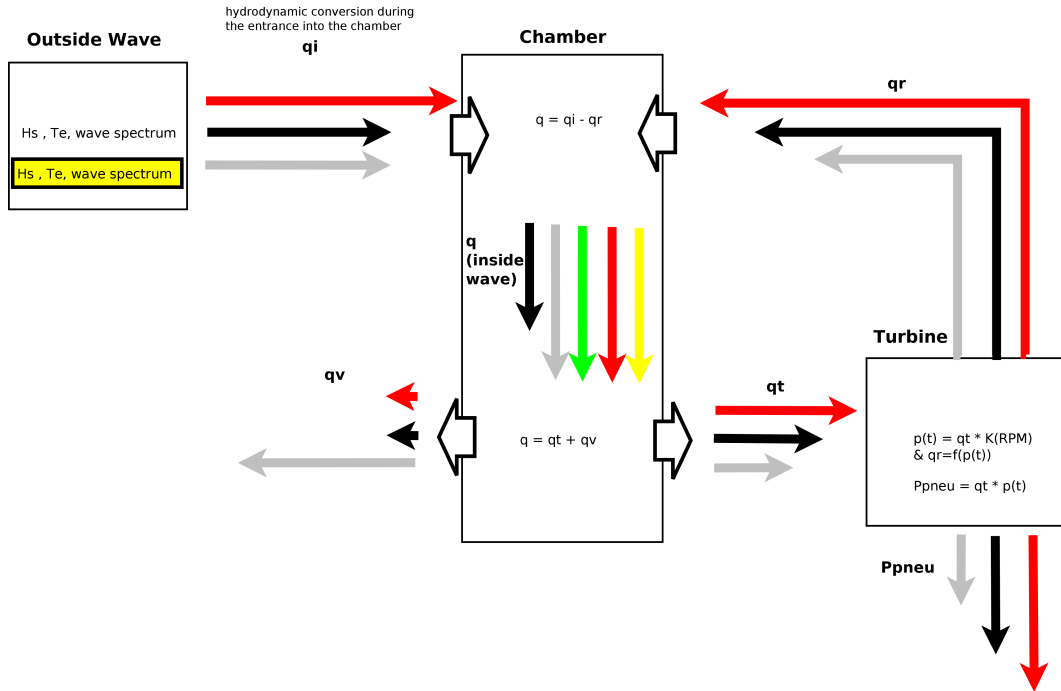
Figure 4.11 Influence of the hydrodynamic defects to the sea state classification. (Arrows: black:device performance with designed hydrodynamic performance; gray: performance with assumed hydrodynamic losses; green: stage of comparisons; yellow: input values; red: tendency to predict too large sea conditions)

The tendency of this selected method, to predict too large outside sea states can be observed by the red arrows in Figure 4.11. In the figure the green arrow shows the stage of comparison and the yellow color shows the chosen input values for the comparison.

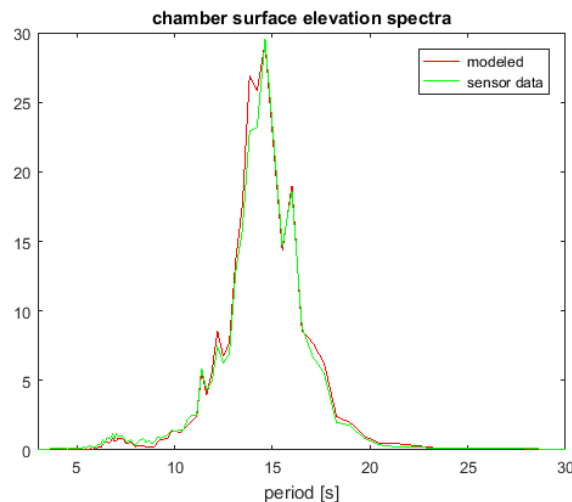
Figure 4.12 Chamber surface elevation spectra at high tide in average waves

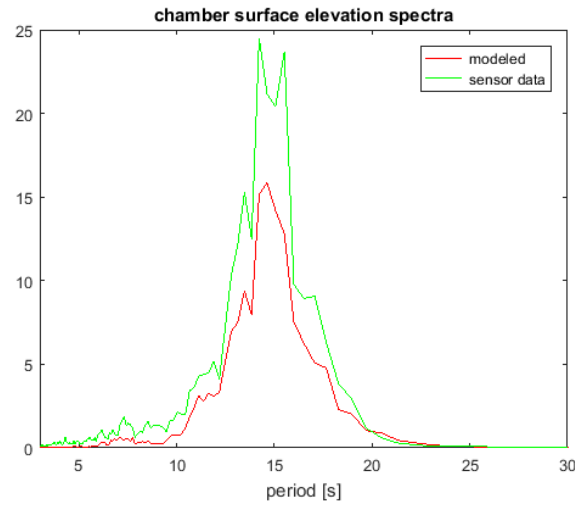
Figure 4.13 Chamber surface elevation spectra at low tide in average waves

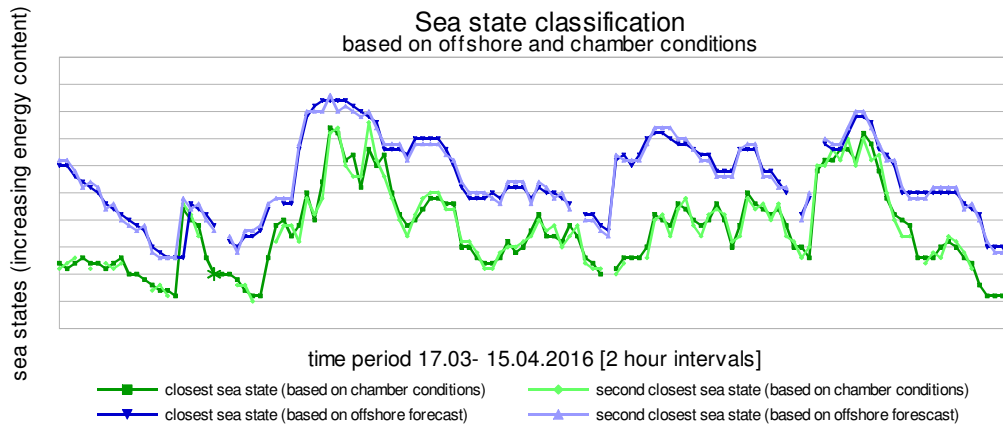
Figure 4.15 Chronological plot of the sea state classification

- The found classification appears plausible because the found local wave conditions follow the general trend of the forecast offshore sea conditions but with significantly lower energy content. This can be obtained in Figure 4.15 where a chronological plot of the found local wave conditions is shown. The green points shows the two best fitting of the 44 predefined sea states when using the measured surface elevation inside the chamber as base for the classification. The blue points show the two best fitting of the 44 predefined sea states when the offshore forecast sea conditions are used as local wave condition. On the Y axis the 44 predefined sea states are arranged with increasing energy content.

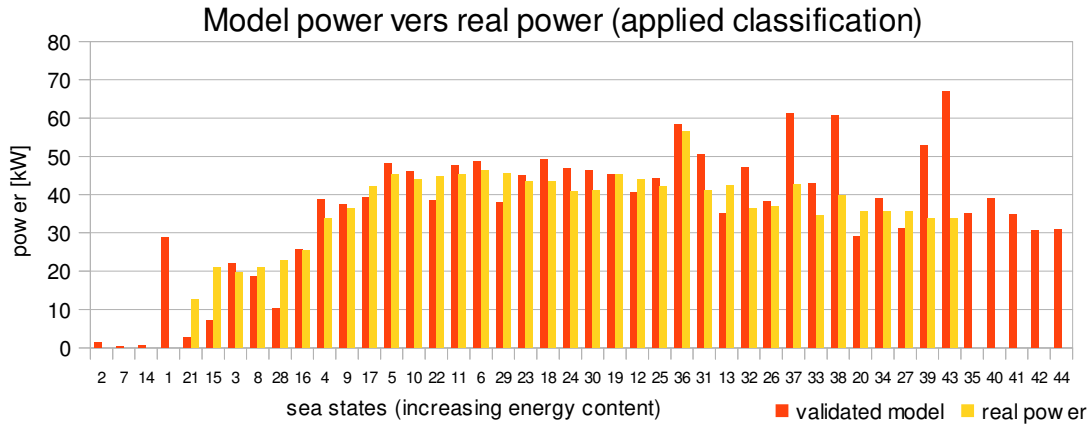
Figure 4.16 Power comparison in 44 sea states listed with increasing contained energy (applied classification)

- Further evidence for the reasonable quality of the classification can be found when comparing the power production results of the “validated model” to the real production in the single sea states. When doing this for the applied classification the power results show a reasonable match. When doing it for the alternative classification based on offshore forecast data it can be obtained that the pattern is shifted as expected towards more energetic sea states. These observations can be found in Figure 4.16 and Figure 4.17.

- The differences, which are assumed to be caused by the hydrodynamic defects, are fairly low. This can be obtained in Figure 4.16 and Figure 4.18. For the majority of the sea states it is in the range of 20 %, which corresponds to an absolute values in the range of 7 kW (whit 36 kW average power over all sea states).
- Only for very energetic sea states an increasing power difference of up to 50 % can be obtained. This corresponds to a maximal found difference of approximately 35 kW.

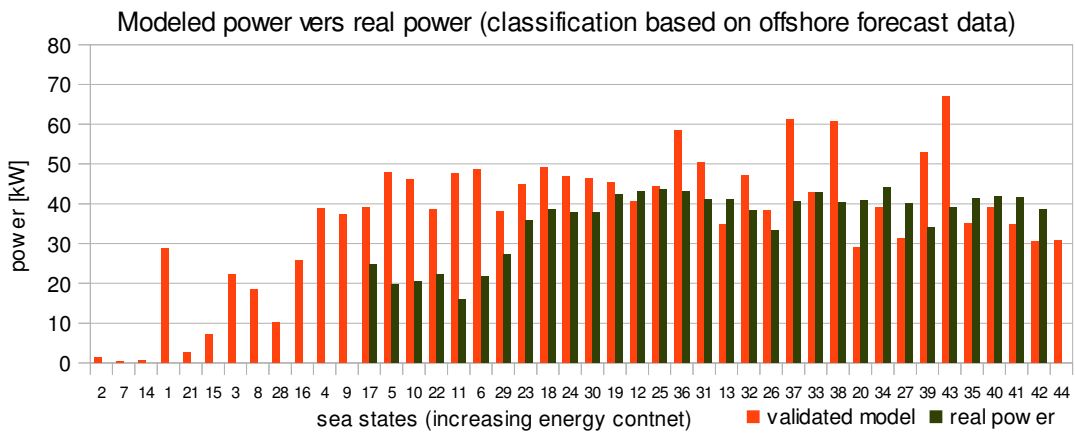
Figure 4.17 Power comparison in 44 sea states listed with increasing contained energy (offshore forecast data classification)

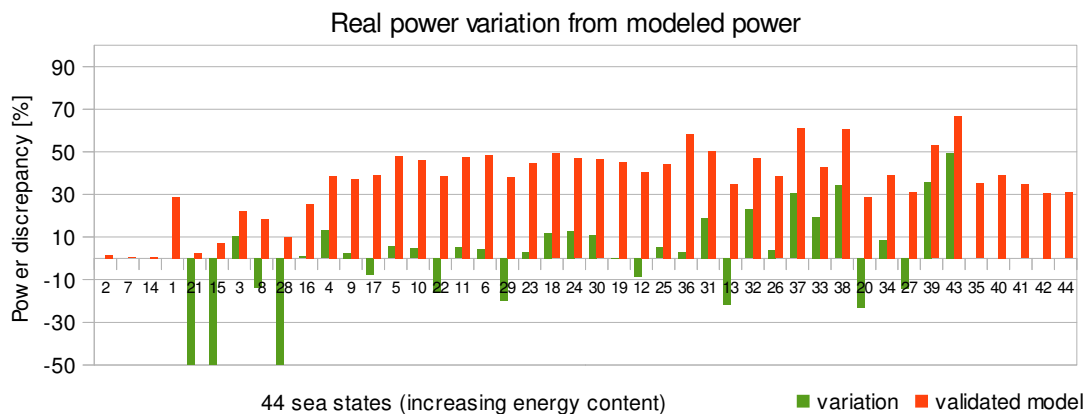
Figure 4.18 Power difference in 44 sea states listed with increasing energy content (applied classification) Sea states without real power value did not occur more than once in the observed period.

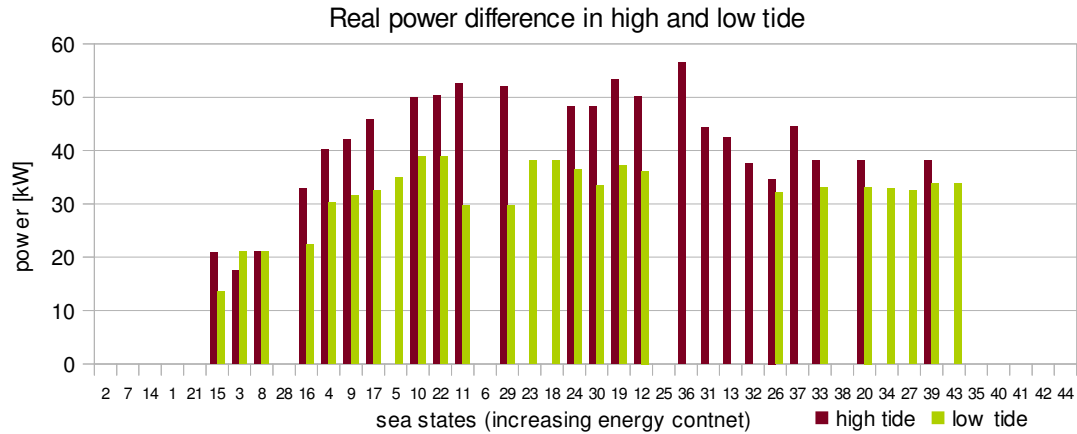
Figure 4.19 Power difference between low and high tide (applied classification)

- For low energetic sea states the match of the classification is poor.
- The expected increasing influence of the hydrodynamic defects with low tide and more energetic sea states could be confirmed as can be seen in Figure 4.20. Here the classification is done for low tide and high tide periods separated and the results are compared. It can be observed that for all more energetic sea state the real power in high tide is significantly larger than in low tide. Only for very small sea states it is in a similar range. The observation of absolute values here is assumed nonsense due to the high influence of classification mistakes caused by the small number of real data sets.

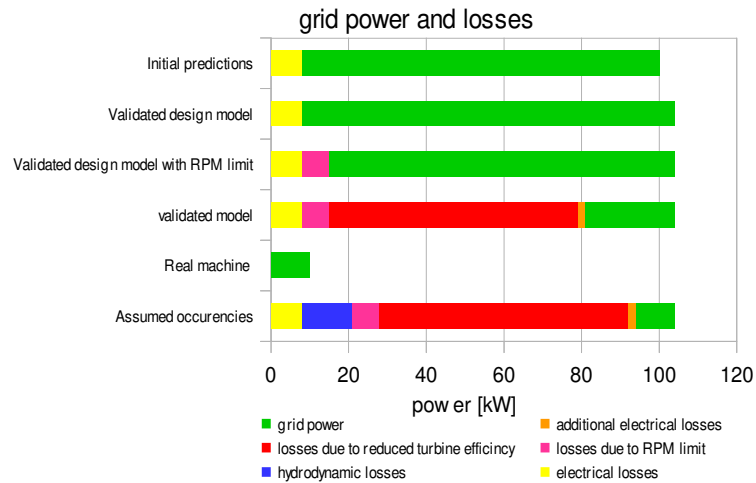
Figure 4.20 Modeled losses and remaining grid power

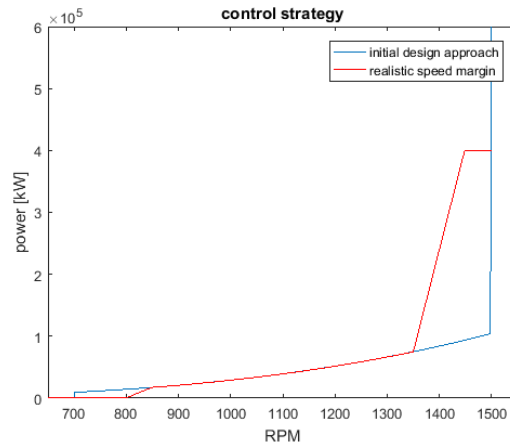
Figure 4.21 Rotational speed margin and breaking procedure [real (red); theoretical approach (blue)]

torque compared to the designed machine. In order to still guaranty the respect of the rotational speed limit at 1500 RPM a significant rotational speed “breaking” margin is required to allow further excess energy storage in the flywheel. The resulting smoother breaking procedure also copes better with the grid constrains for power fluctuation. In operation a minimum margin of 100 RPM was successfully tested for short periods and a more conservative margin of 150 RPM is generally used. Accordingly the real rated speed in most operation periods was 1350 RPM. The real rated speed and the smoother breaking procedure are implemented to the “validated design model” by using the in Figure 4.21 displayed generator control strategy.

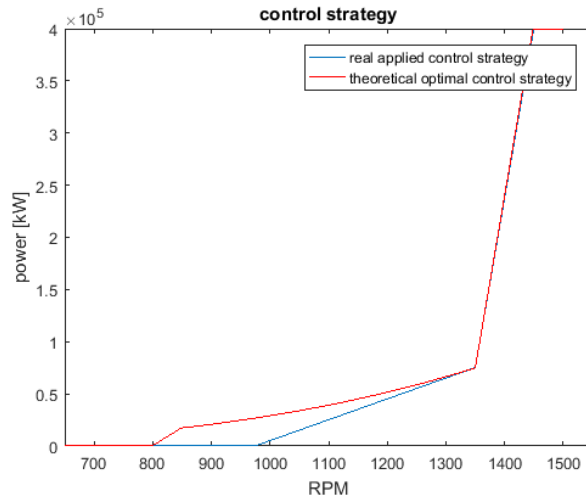
Figure 4.22 Control strategy [theoretically optimal (red); real “best practice” (blue)]

The blue curve corresponds to the “best practice” real operation strategy. Both curves are directly applicable to the system because the rated speed is already reduced to 1350 RPM and the smooth breaking procedure is implemented. Whilst the curves match at about rated speed the optimal curve aims to extract significantly more power at lower speed, which the turbine is apparently not able to deliver. Therefore the power is drawn from the flywheel, which reduces the rotational speed. The reduced rotational speed in turn provokes further aerodynamic stall, which causes a further dramatic loss of turbine power from which the system is unable to recover. The avoidance of this determining feedback loop is done by the implementation of the “best practice” blue curve that can also be obtained in Figure 4.22 .The curve corresponds to the empirically in operation found and since than generally used control strategy, which enables relatively smooth plant operation. It is implemented to the “validated model” and the “validated design model”.

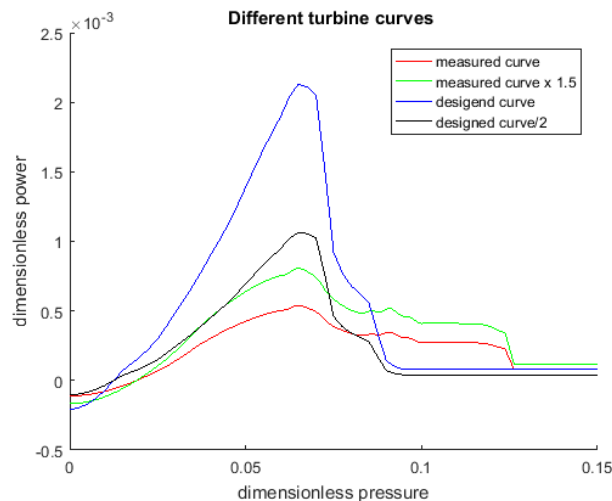
Figure 4.23 Characteristic turbine curve comparison

The turbine performance deficit is modeled once for the use with the proposed optimal control strategy and a second time with the in reality used “best practice” strategy. The reduced rated speed and the smoother breaking procedure are always assumed. Here the turbine curve that was found for the “validated model” is used and displayed green in Figure 4.23. The figure corresponds with Figure 4.7 and as explained there it is the real measured turbine curve that is multiplied by an empirically found factor of 1,5. The higher power values on the right side of the curve compared to the designed curve were found in the measurements. They are likely to be caused by the absence of the rotor guide vanes downstream of the rotor. In (Brito-Melo, Gato and Sarmento 2002) a similar effect is described. The rotor guide vanes do increase the peak height but also narrow the range with a higher turbine efficiency. However, as explained in Appendix 3 the missing guide vane does not appear to be the cause of the lower turbine peak.

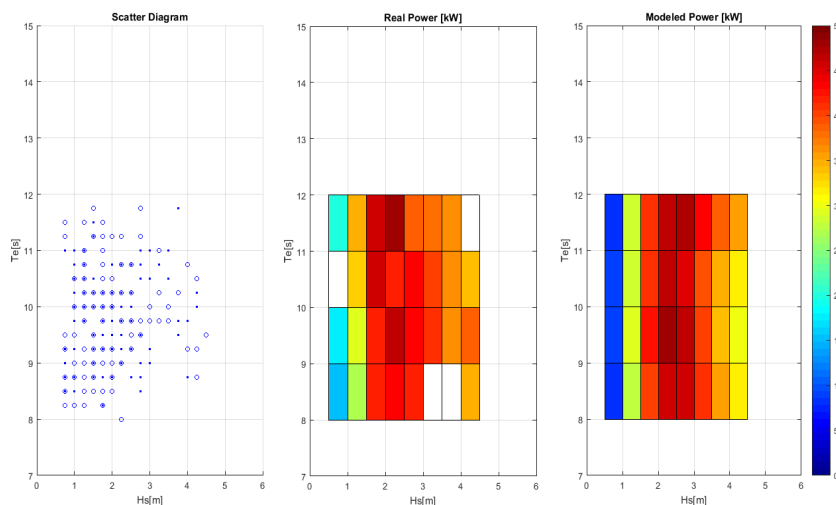
Figure 4.24 General scatter diagram of the Pico device today (Left: the used performance points (The filled and empty dots both indicate one performance point. Due to the classification procedure the points are sometimes overlapping. Therefore two different point types are used.); Middle: the real device average power per sea state; Right: Validated model average power per sea state)

In the scatter diagram of Figure 4.24 the real produced generator power and the generator power results of the “validated model” are shown. It can be obtained that the trend is similar and the power levels of the model results are approximately 10 kW higher in most sea states. This matches with the expectations. Here the generated power instead of grid power was chosen to enable a direct comparison to the prior performance evaluation presented in (Pecher *et al*, 2011).

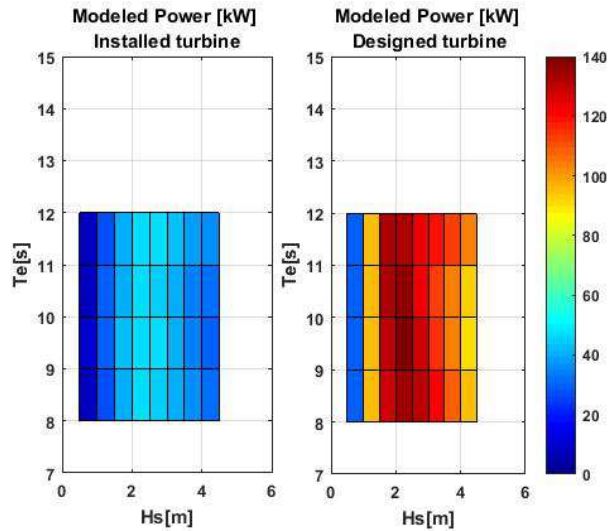
Figure 4.25 Pico scatter diagram for the device with corrected turbine efficiency (Left: modeled average power per sea state for the “Validated model”; Right: modeled average power per sea state for the “Model with corrected turbine”)

In order to show what appears to be achievable when only the detected turbine performance deficit can be removed a second scatter diagram is shown in Figure 4.25. It shows again the generated power results of the “validated model” just as Figure 4.24 but additionally shows the expected increased generated power of the “Model with corrected turbine”.

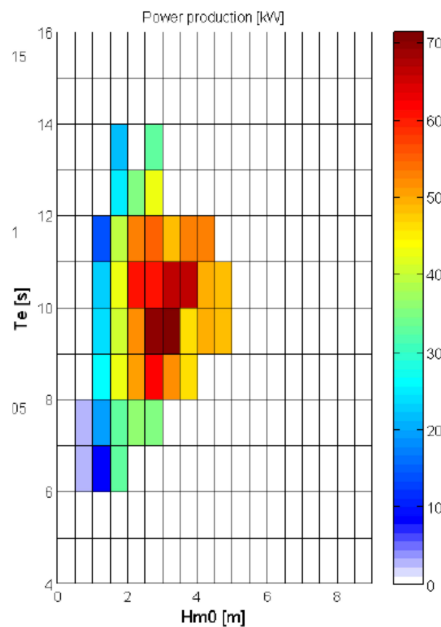
Figure 4.26 Pico performance scatter diagram presented in (Pecher et al, 2011)

Never the less the trend of the scatter diagram is similar. Additionally the magnitude of the overall power levels is fairly similar. It can further be obtained that the power levels are shifted towards higher H_s values. Such a result has to be expected because the used classification is based on offshore measurements and the significant wave height H_s decreases from offshore waves to near shore waves.

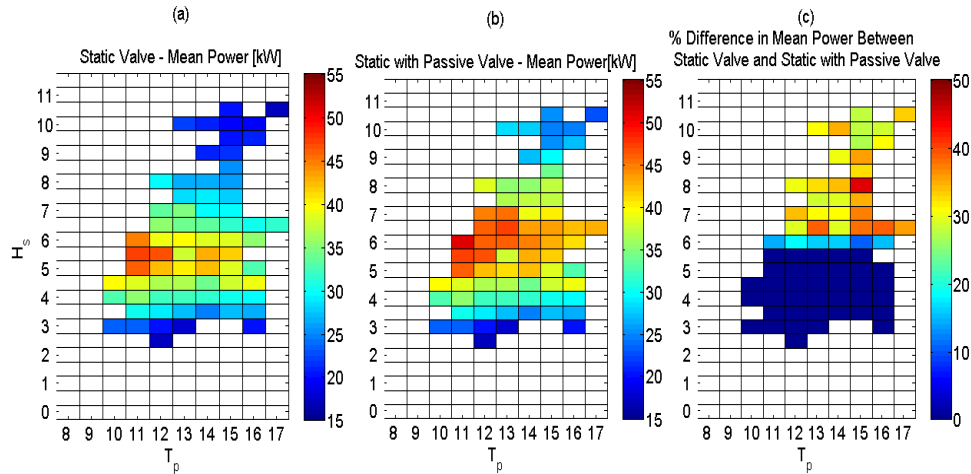
Figure 4.27 Pico scatter diagram with passive rectification valve (Monk, Winands and Lopes, 2018) (H_s and T_p values correspond to excitation flow surface elevation and not to outside wave).

states by using the proposed passive valve to reduce the pressure skewness. Due to the low production levels the found 45 % correspond with approximately 12 kW. Further it can be seen that the system only shows an influence at very large sea conditions. This is obviously caused by the type of system, which can only operate at large sea conditions and which further is only a correction system of the pressure asymmetry that cannot remove the asymmetry completely. However in the here presented thesis the assumed influence of hydrodynamic conversion problems is 11,5 kW, which is in the range of the maximal found modeled power increase in the passive valve study. Therefore the paper results are assumed to backs the results of the here presented study.

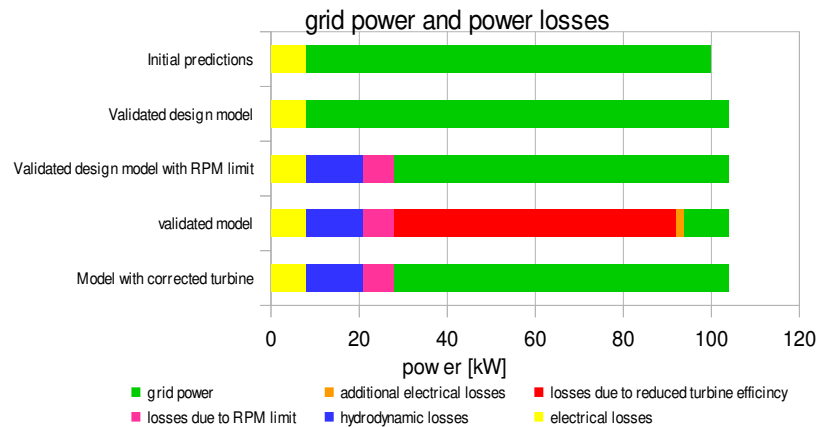
Figure 4.28 Expected power increase

In Figure 4.28 the power losses of the device in its current conditions is displayed and the possible benefit when removing the turbine performance deficit is displayed by the use of the “ Model with corrected turbine”. Similar to Figure 4.20 the length of the beams corresponds to the size of the displayed values.

- In Figure 4.28 it can be obtained that the grid power increases about the factor of 6,7 to about 77,5 kW. *Note: This high multiplication factor is essentially influenced by the currently very low power production.*
- If the additional hydrodynamic losses are not considered, for generated power an increase about the factor 2,9 from 33 kW to 97 kW can be obtained. This increase can be seen when comparing the model results. Similar to the method that was applied in Chapter 4. 3.3. , in Figure 4.29 results for both the “validated model” and the “Model with corrected turbine” are plotted in the 44 sea states. In Figure 4.30 a plot of a random operation period is given. The factor of approximately 2,9 can be obtained in both figures.

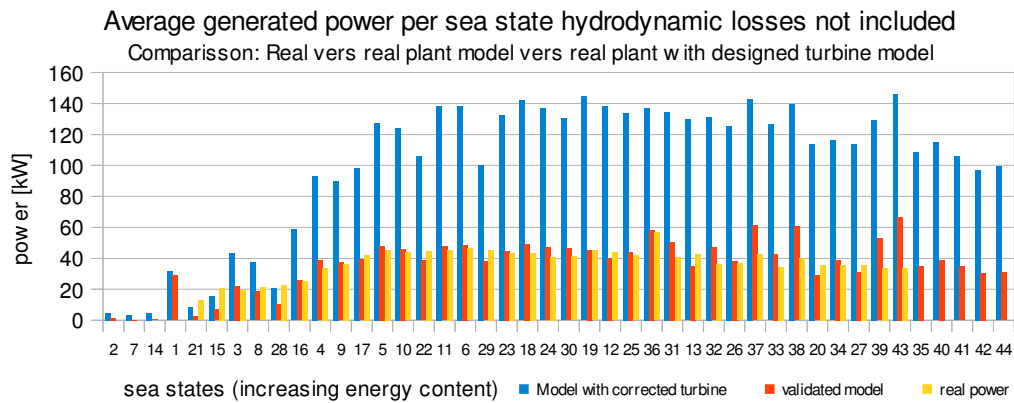
Figure 4.29 Generated power comparison per sea state

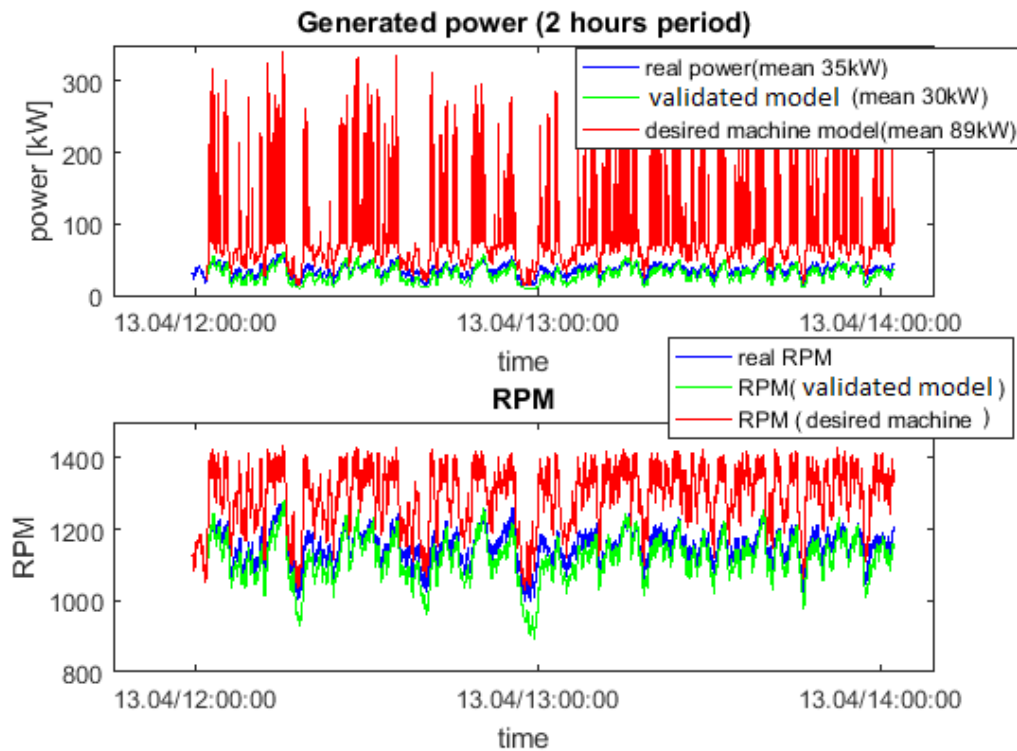
Figure 4.30 Factor 2,9 verification in real operation interval of 2 hours (Figure corresponds to Figure 4.8)
