The PICO OWC Project

The full scale wave energy converter, that was in continuous operation for more than 7 years in roughest conditions and finally was very close to reach a load factor of 0,19

Winands, Victor Wolf Etienne

Publication date:
2019

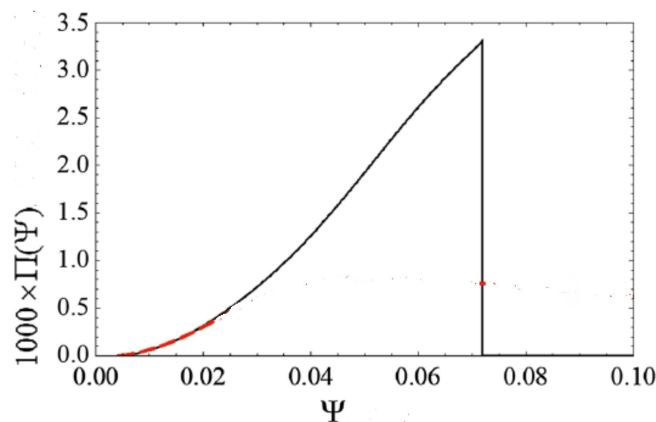
Figure 5.1 Turbine curve of a recent Wells turbine which is adapted to the Pico plant (presented in (Falcao, Henriques and Gato, 2016)).

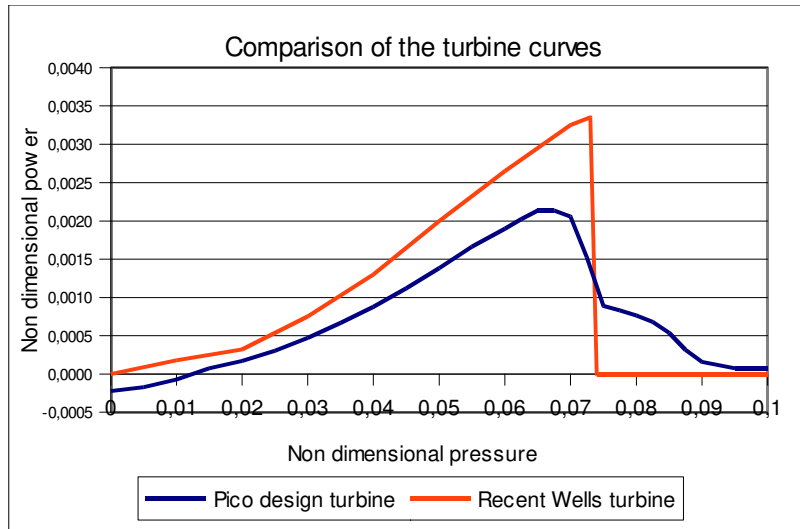
Figure 5.2 Curve comparison: Recent turbine to Pico design turbine
