Investigation of the effect of wrinkle features on wind turbine blade sub-structure strength

Bender, J. J.; Hallett, S. R.; Lindgaard, E.

Published in:
Composite Structures

Keywords: *Sub-structure, Wrinkle defect, Tapered beam, Cohesive Zone*

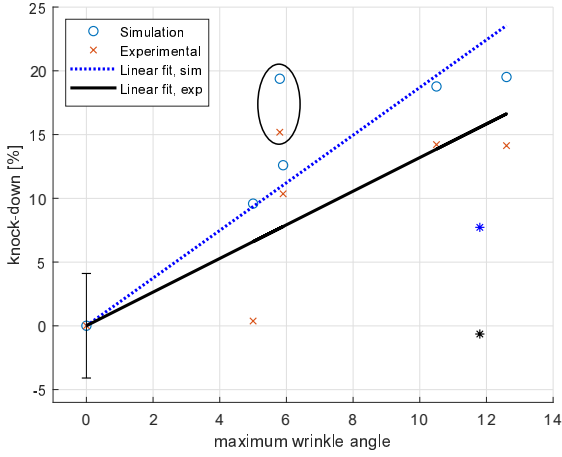
Fig. 15 Knock-down compared to the pristine laminate as a function of the maximum wrinkle angle. (The ellipse indicates the data from sub-structure 4, and the asterisks represent the data from sub-structure 7, which are considered outliers)

There is a good agreement between the knock-down in the simulations and the experiments as indicated by the errors in the last column in Table 2. Furthermore, the knock-down of the wrinkled sub-structures is more than 10% for most of the sub-structures, meaning that there is a difference between the strength of the pristine sub-structures and the wrinkled ones. The minimum and maximum of the experimental load at final failure for the pristine sub-structures was 4.1% in either direction of the average, indicating that the wrinkle knock-downs are outside of the experimental scatter. This is also shown in Fig. 15 and 16 where the results from Table 2 are illustrated.

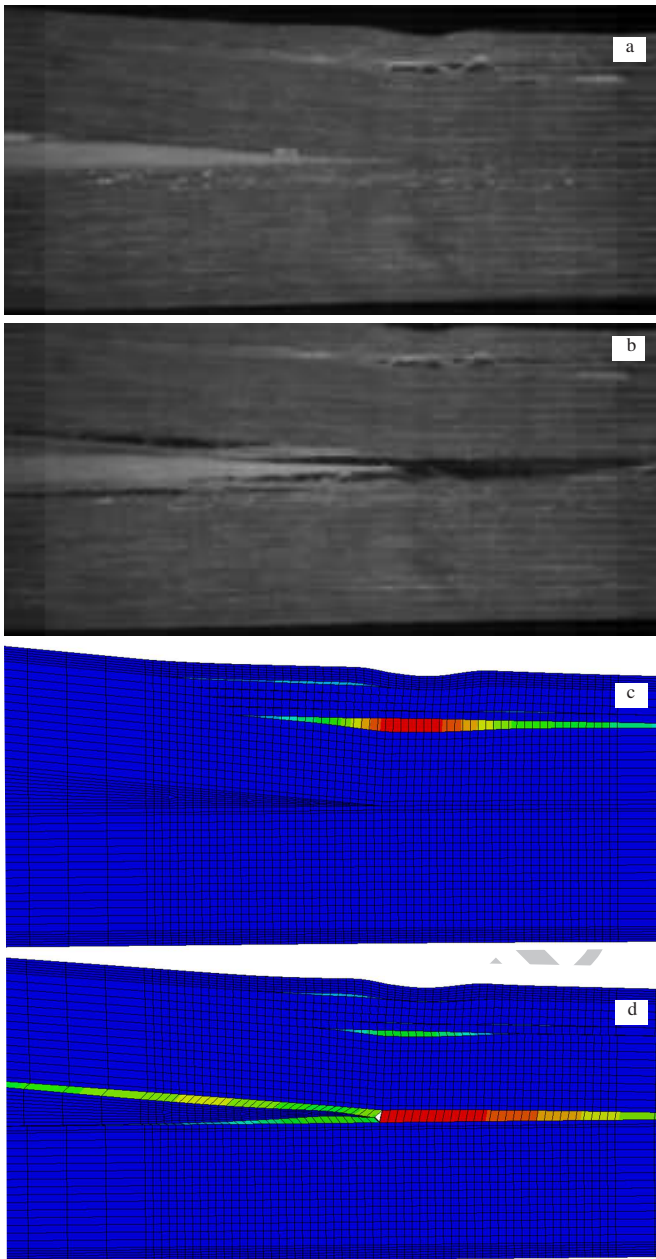
Fig. 17 High speed images of sub-structure 7 (a) before and (b) after insert delamination. Simulation results from a full 3D model (c) before and (d) after insert delamination for comparison. The color scale in (c,d) indicates the mode I opening displacement where red is highest.

rest of the wrinkled sub-structures. A wrinkle delamination occurred at a load of 87% of the load for insert delamination. This damage progression is shown in Fig. 17. The behaviour was only captured in the simulation when a wide 3D model of 15 elements in the width direction was used instead of the slice model. This wide 3D model had a total number of degrees of freedom 498576.

The load at wrinkle delamination is predicted at 8% lower load than the wrinkle delamination in the experiment. Furthermore, the location of the wrinkle delamination is predicted with reasonable accuracy, as shown in Fig. 17. However, the predicted and actual knock-down of sub-structure 7 does not agree with the trend of the other tests w.r.t. the average wrinkle angle. This is to be expected because the failure mechanism for sub-structure 7 is different than the rest. Therefore, it would be unlikely that the trend would be similar for both failure mechanisms. For the other simulations it was not necessary to expand the slice model as similar results were obtained compared to a full 3D model.

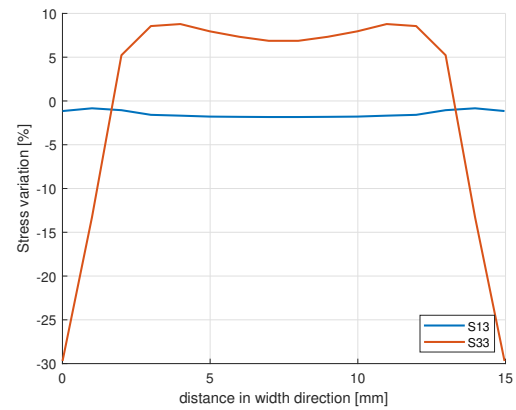
Fig. 18b Percent stress variation from slice to full 3D model at the tip of the insert w.r.t. the width of the wide model
