North Sea small scale mineral deposition tests

DCE Technical Report No 272.

This report has been prepared by Lucia Margheritini under the investigations financed by the EUDP project
“ New material for wave energy substructures”
(<https://www.civil.aau.dk/Project+websites/newmaterialwes/?page=1>).

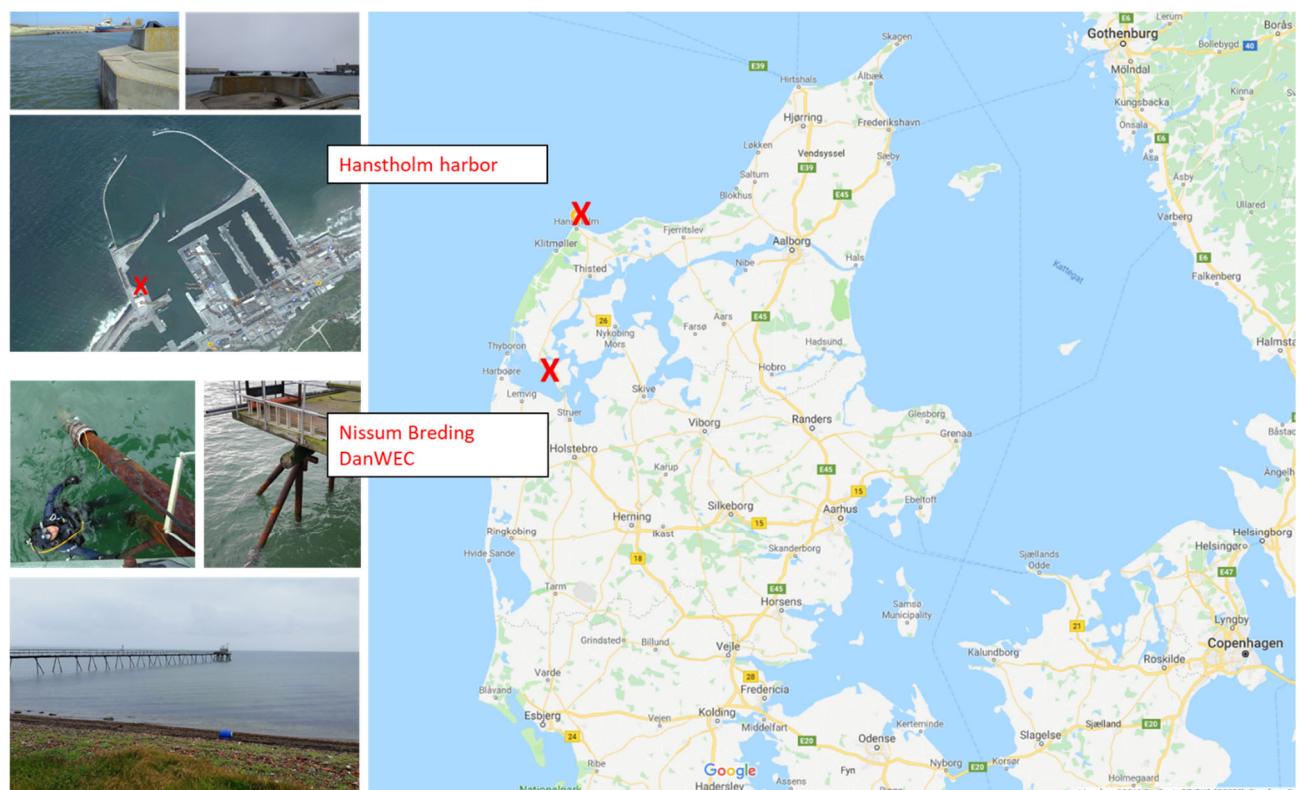
Figure 1. The two locations of the Sea Trials.

The Real sea cold water investigations were thought to be performed in two different locations: Hantholm Harbour (in kind donation) and Nissum Bredning, under a contract with DanWEC (Fig. 1)

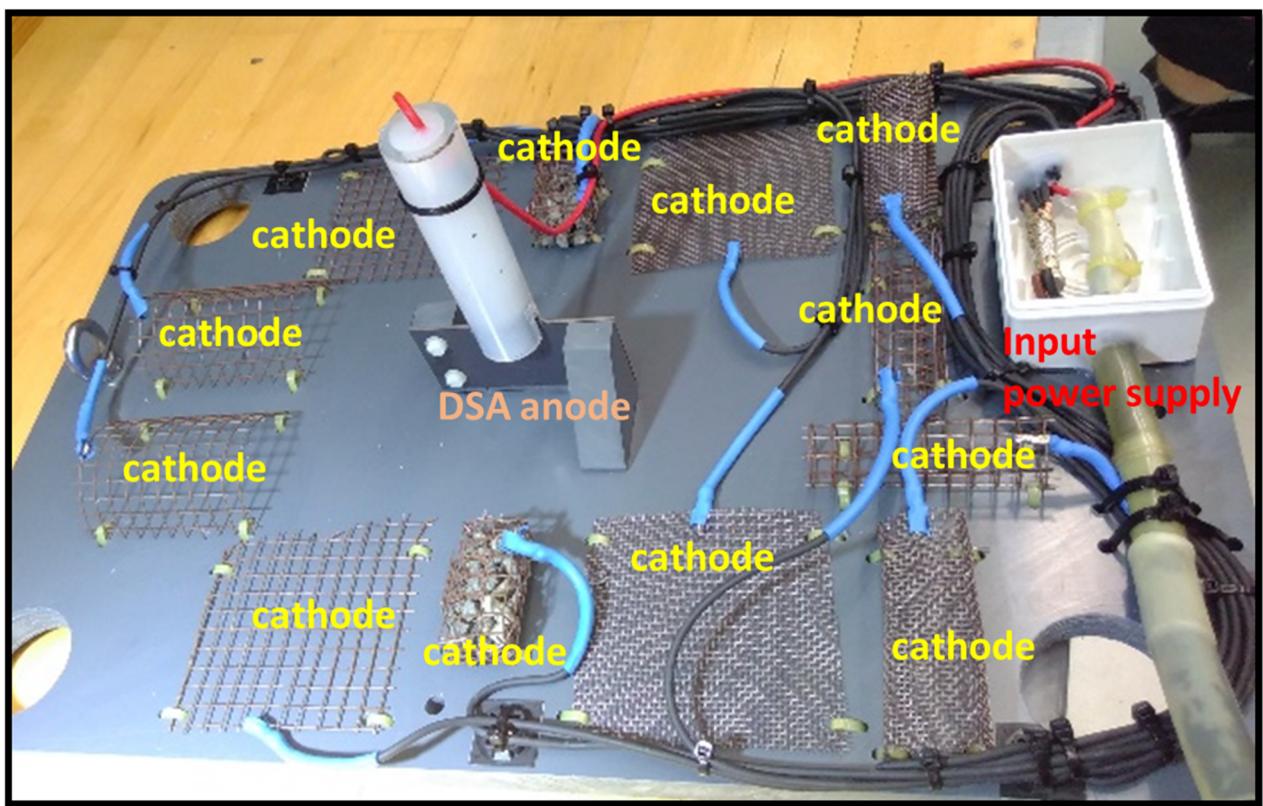
Figur 1. Setup previous installation.

The set up in Hanstholm consisted of a self-contained hard plastic box adequately perforated to allow water circulation, containing the 6 sets of cathodes (2 par shape, all weighted), anode, HOBO data logger and secured connections. The entire electrode setup fitted the bottom of the box over an area of circa $0.55 \times 0.38 = 0.21$ sqm. The cathodes were placed around the anode at an average distance of circa 16 cm from centroids. All electrical connection were isolated and the anode connection waterproof (silicon) (Fig. 1).

The cathodes are connected to the negative pole and the anode to the positive. A water proof box hosted the split connections.

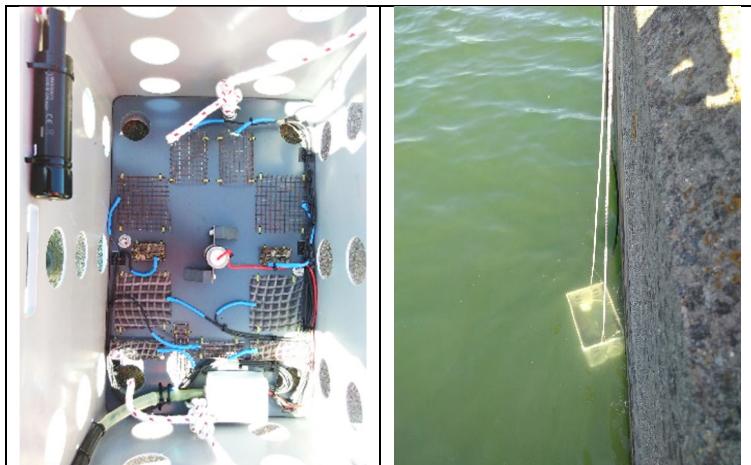
Figur 2. Hanstholm setup at location.

The setup was lowered circa 20 cm above the sea bottom at - 5 m below surface with a rope. The "suspended solution" was chosen in order to try to avoid massive deposition of fine particles over the electrodes, typically occurring in harbours (but unfortunately, it did not serve the purpose), (Fig 2). The lowering was monitored with an underwater camera with led lights. Visibility is generally very poor, almost complete darkness at 5 m depth. Marine life seem to be abundant and identifications of anemones, crabs and fish could be done.

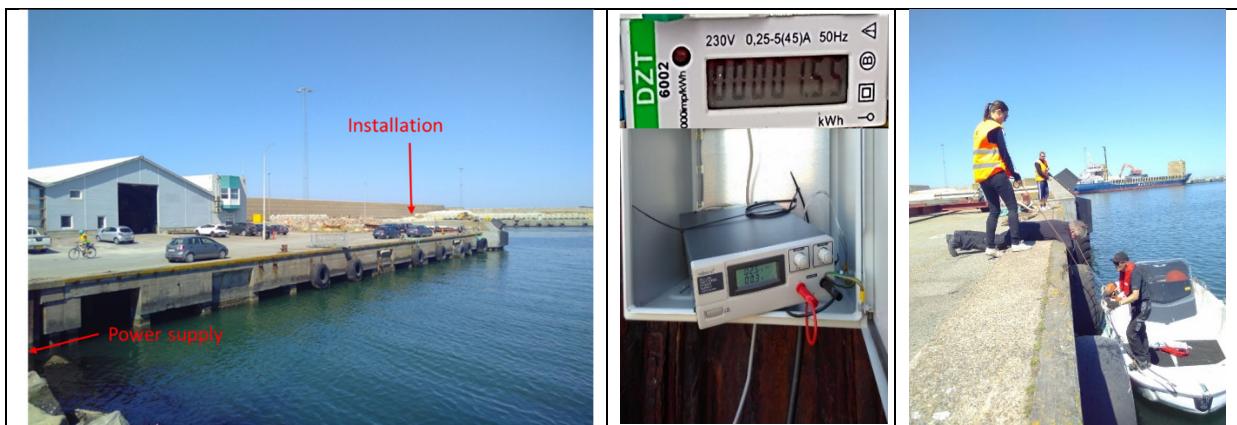
Figur 3. Overview of installation at Hanstholm Harbour.

Once in the water, a V pf 5 – 5.5 was applied for few seconds until bubbling, and after the voltage was set to 2.5 V, corresponding to 0.3 A. The power was sourced from the electrical grid from a pole 100 m away

from the installation (Fig 3). Power consumption was monitored. The test were run at constant 2.5 V. The current was initially 0.3 A and then shifted to 0.2 A till the end of the tests (Fig. 3).

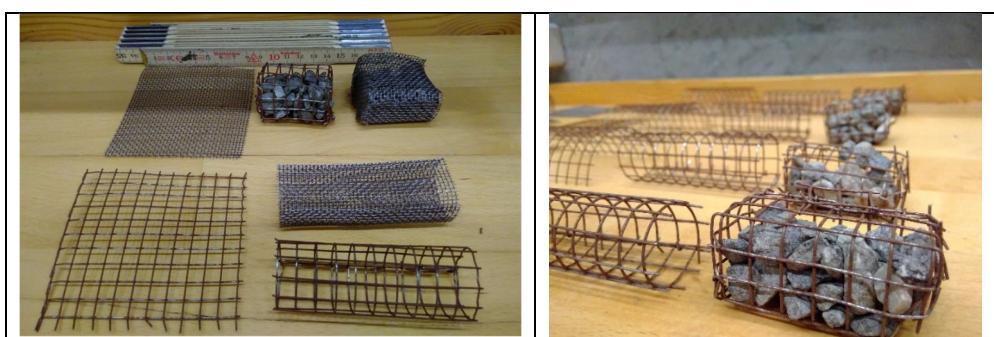
Figur 4. Cathodes for Hanstholm installation.

The cathodes were pieces of circa 10x10 cm of metal grid and net shaped by hand into cylinders and blocks (Fig 4). The cathodes materials, untreated steel, have the characteristics in Table 3.

FINE GRID	WIDE GRID
Maske 8,5 mm Tråd 0,8 mm	Maske 1,6 Tråd 0,5
Maske: 8,5 x 8,5 mm	Maske: 1,6 x 1,6 mm
Trådtykkelse: 0,8 mm	Trådtykkelse: 0,5 x 0,5 mm
Bredde: 1000 mm	Mesh: 12 x 12
Materiale: Ubh stål	Åbent areal: 58
	Bredde: 1020
	Vægt (kg/m ²): 1,527
	Materiale: Ubh stål

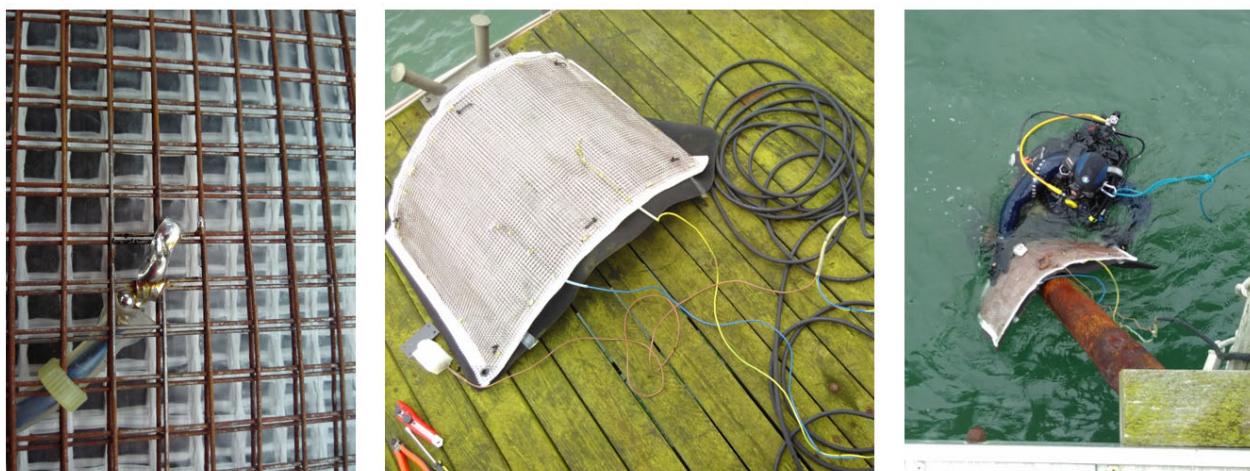
Figur 5. Electrodes installation at Nissum Bredning

The set up in Nissum Bredning consisted of a mesh of circa 1x1 sqm of the small mesh kind in Table 3 as a cathode. The mesh was secured around one of the poles/legs of the bridge. A thick rubber insulation made of a black and white layers of several mm was placed between the cathode and the metal leg of the bridge in order to avoid electrical connections. The anode was 9.5 x 4.6 x 0.2 cm DSA provided by Electrocell, with waterproof connection (silicon) (Fig. 5). The tests were set to run with constant 2.5 V. the current at installation was then 0.449 A.

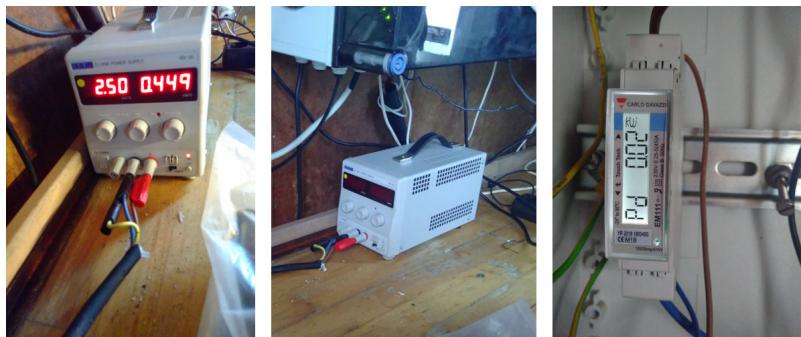
Figure 6. The power supply at installation (lf) and on the day of decommission with indication of energy consumption (ce and rt).

Few meters (4-6) of cables where connecting the electrodes to the power supply inside the protected DanWEC container. Power consumption was monitored. Unfortunately, as mentioned in chapter 3, a shortcut occurred few days after installation and the overall power consumption was only 0.02 kWh (Fig. 6). This also means that the setup was never properly running. Regretfully, even when we indicated to DanWEC that there was no power flowing to the cathode, they did not do anything to reestablish the necessary conditions for the tests. This accident, and the later storm that damaged the bridge making it impossible for us to go there, led to the decision of decommissioning (Fig. 7). Without the protection of the electric current, the cathode rusted as expected (Fig. 8).

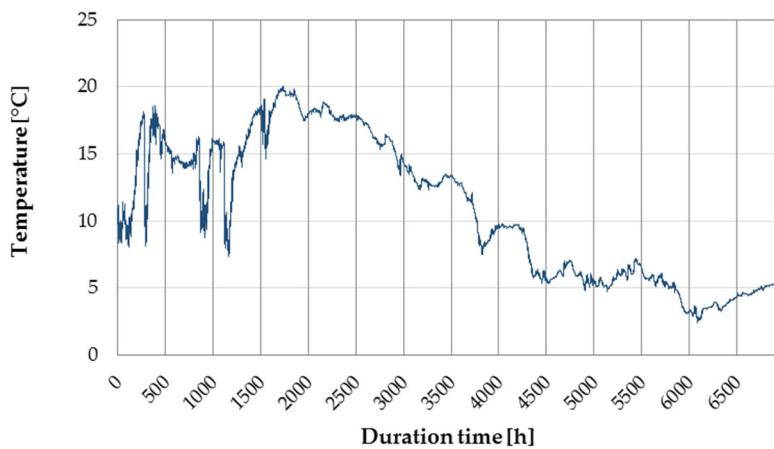
Figur 9. Water Temperatures from 24th of May 2018, 1:30 PM, to the 7th of March 2019 1:00 PM

The data logger for salinity and temperature was installed in the setup. Continuous measurements are therefore available from installation besides malfunctioning of the instrument. The logger recorded the temperatures and conductivity of the water in the exact setup every 30 minutes during installation, for a total of circa 13770 data points each.

The maximum and minimum temperatures recorder were 20.0 °C and 2.4 °C respectively.

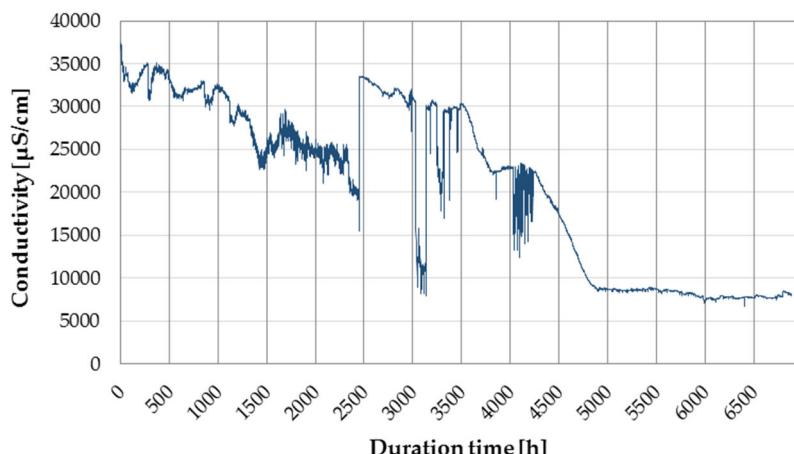
Figur 10. Water Temperatures from 24th of May 2018, 1:30 PM, to the 7th of March 2019 1:00 PM

The maximum and minimum conductivities recorded were 37530 and 6666 $\mu\text{S}/\text{cm}$.

The harbor can be considered a small basin of water and rain can influence the salinity. Additionally, bio-fouling might have affected the conductivity measures in the last 3 months of testing.

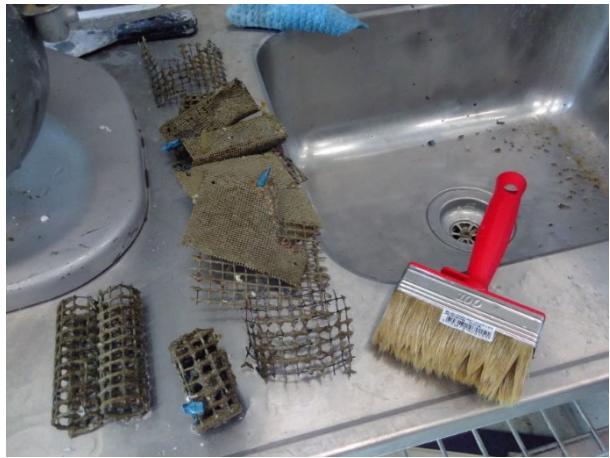
Figur 11.

The layer of deposited material was between 2-7 mm depending on location, showing thicker deposition where the mashes on the cathodes intersect. The material was also easily detached from the cathode.

The cathodes were removed for the setup and washed in the laboratory. Suspended material was removed with a soft brush.
